Contract #: 04-0120F4Cty: SF/ALA Rte: 80 PM: 13.2/13.9File #: 1.28**WELDING INSPECTION REPORT****Resident Engineer:** Casey, William**Address:** 333 Burma Road**City:** Oakland, CA 94607**Report No:** WIR-027297**Date Inspected:** 10-Mar-2012**Project Name:** SAS Superstructure**OSM Arrival Time:** 800**Prime Contractor:** American Bridge/Fluor Enterprises, a JV**OSM Departure Time:** 1630**Contractor:** American Bridge/Fluor Enterprises, a JV**Location:** Job Site**CWI Name:** Bernie Docena**CWI Present:** Yes No**Inspected CWI report:** Yes No N/A**Rod Oven in Use:** Yes No N/A**Electrode to specification:** Yes No N/A**Weld Procedures Followed:** Yes No N/A**Qualified Welders:** Yes No N/A**Verified Joint Fit-up:** Yes No N/A**Approved Drawings:** Yes No N/A**Approved WPS:** Yes No N/A**Delayed / Cancelled:** Yes No N/A**Bridge No:** 34-0006**Component:** SAS Tower**Summary of Items Observed:**

Caltrans Office of Structural Material (OSM) Quality Assurance Inspector (QAI) Joselito Lizardo was present at the Self Anchored Suspension (SAS) job site as requested to perform observations on the welding of components for the San Francisco Oakland Bay Bridge (SFOBB) Project.

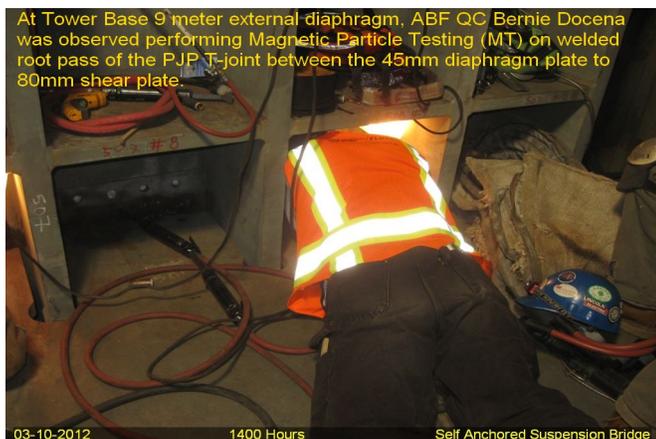
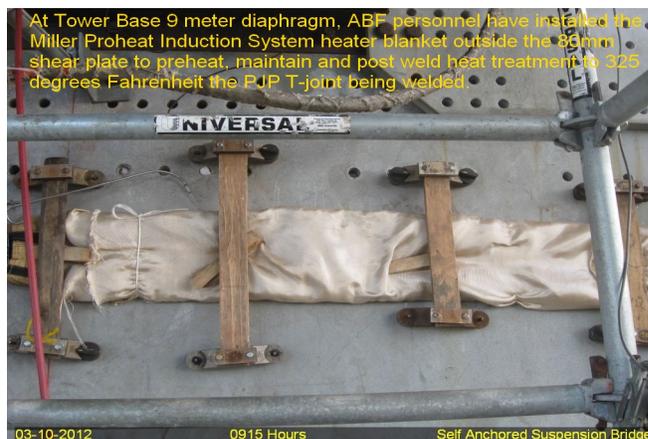
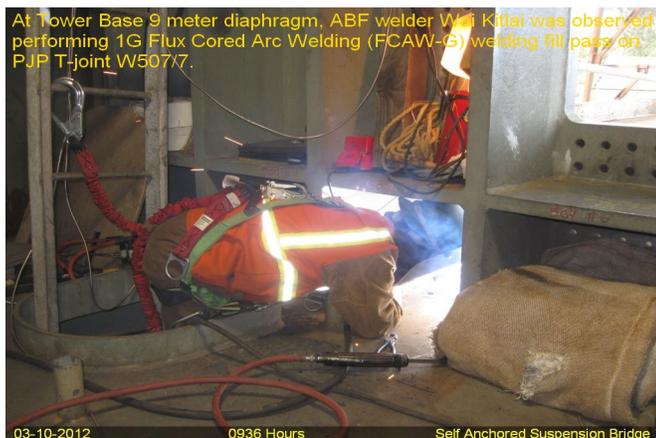
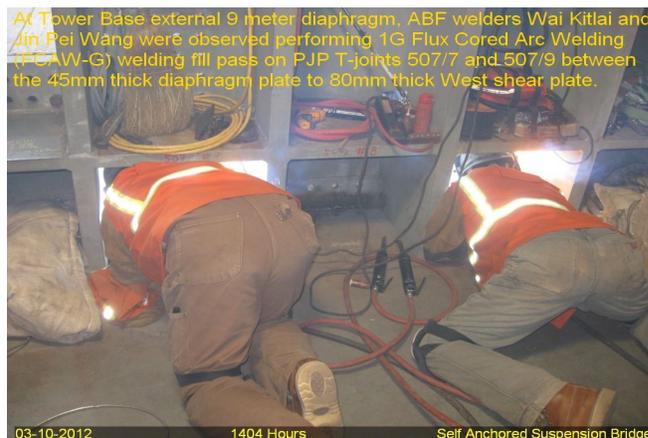
At Tower Base Shear Plate (80mm) to Diaphragm Plate (45mm) weld joint #040(5 & 6), this QA Inspector randomly observed ABF personnel Wai Kitlai continuing to perform production 1G welding on the Partial Joint Penetration (PJP) of T-joint between the 80mm thick West shear plate and 45mm thick outer West external diaphragm plate. The welder was using the dual shielded Flux Cored Arc Welding (FCAW-G) with E71T-1M, 1/16" diameter wire electrode and implementing Caltrans approved Welding Procedure Specification (WPS) ABF-WPS-D15-3160-1. This QA Inspector observed ABF personnel using Miller Proheat 35 Induction Heating System to preheat the plates being welded prior to and after welding. This QA Inspector observed QC Inspector Bernie Docena using a Fluke infra red temperature gauge to verify the preheat temperature of more than 325°F. This QA Inspector performed a verification of the welding parameters and observed 286 amperes and 24.5 volts. The welding appeared to comply with Welding Procedure Specification (WPS) ABF-WPS-D15-3160-1. During the shift, the welder has completed the PJP weld joint and right after the completion of the weld joint, ABF personnel were noted covering the weld with heater blanket in preparation for the three hours holding of preheat temperature of more than 325°F as required. ABF personnel were using Miller Proheat 35 Induction Heating System to hold the preheat.

After the welding completion of the weld joint mentioned above, the welder moved to PJP T-joint # W040/7. This QA Inspector randomly observed ABF personnel Wai Kitlai perform root pass production 1G welding on the

Partial Joint Penetration (PJP) of T-joint between the 80mm thick West shear plate and 45mm thick outer West external diaphragm plate. The welder was using the dual shielded Flux Cored Arc Welding (FCAW-G) with E71T-1M, 1/16" diameter wire electrode and implementing Caltrans approved Welding Procedure Specification (WPS) ABF-WPS-D15-3160-1. This QA Inspector observed ABF personnel using Miller Proheat 35 Induction Heating System to preheat the plates being welded prior to and after welding. This QA Inspector observed QC Inspector Bernie Docena using a Fluke infra red temperature gauge to verify the preheat temperature of more than 325°F. After the welding completion of the root pass, ABF QC Bernie Docena was observed performing MT on the root welded T-joint. No relevant indications were observed. This QA also performed random MT on the same welded root pass with noted same result. At the end of the shift, the welder has completed the PJP weld joint and right after the completion of the weld joint, ABF personnel were noted covering the weld with heater blanket in preparation for the three hours holding of preheat temperature of more than 325°F as required. ABF personnel were using Miller Proheat 35 Induction Heating System to hold the preheat that was programmed to shut off after three hours.

At Tower Base Shear Plate (80mm) to Diaphragm Plate (45mm) weld joint #040(9), this QA Inspector randomly observed ABF personnel Jin Pei Wang continuing to perform root pass production 1G welding on the Partial Joint Penetration (PJP) of T-joint between the 80mm thick West shear plate and 45mm thick outer West external diaphragm plate. The welder was using the dual shielded Flux Cored Arc Welding (FCAW-G) with E71T-1M, 1/16" diameter wire electrode and implementing Caltrans approved Welding Procedure Specification (WPS) ABF-WPS-D15-3160-1. This QA Inspector observed ABF personnel using Miller Proheat 35 Induction Heating System to preheat the plates being welded prior to and after welding. This QA Inspector observed QC Inspector Bernie Docena using a Fluke infra red temperature gauge to verify the preheat temperature of more than 325°F. This QA Inspector performed a verification of the welding parameters and observed 270 amperes and 25.5 volts. After the welding completion of the root pass, ABF QC Bernie Docena was observed performing MT on the root welded T-joint. No relevant indications were observed. This QA also performed random MT on the same welded root pass with noted same result. The welding appeared to comply with Welding Procedure Specification (WPS) ABF-WPS-D15-3160-1. At the end of the shift, the welder has completed the PJP weld joint and right after the completion of the weld joint, ABF personnel were noted covering the weld with heater blanket in preparation for the three hours holding of preheat temperature of more than 325°F as required. ABF personnel were using Miller Proheat 35 Induction Heating System to hold the preheat.

At the request of Quality Control Field Supervisor, Bonifacio Daquinag, QA has randomly verified the QC VT/MT of the Complete Joint Penetration (CJP) welding of six (6) vent hole infill plates and two (2) lifting lug hole infill plates to top deck plate butt joints. The QA verification was performed to verify that the welding and the VT/MT inspection performed by the QC inspector meet the requirements of the contract documents. At the conclusion of the QA verification it appeared that the weld and the QC inspection complied with the contract documents.
