Contract #: 04-0120F4Cty: SF/ALA Rte: 80 PM: 13.2/13.9File #: 99.28**WELDING INSPECTION REPORT****Resident Engineer:** Casey, William**Address:** 333 Burma Road**City:** Oakland, CA 94607**Report No:** WIR-027307**Date Inspected:** 12-Mar-2012**Project Name:** SAS Superstructure**OSM Arrival Time:** 700**Prime Contractor:** American Bridge/Fluor Enterprises, a JV**OSM Departure Time:** 1530**Contractor:** L & M Industrial Fabrication**Location:** Tangent, Oregon**CWI Name:** Tom Dreyer**CWI Present:** Yes No**Inspected CWI report:** Yes No N/A**Rod Oven in Use:** Yes No N/A**Electrode to specification:** Yes No N/A**Weld Procedures Followed:** Yes No N/A**Qualified Welders:** Yes No N/A**Verified Joint Fit-up:** Yes No N/A**Approved Drawings:** Yes No N/A**Approved WPS:** Yes No N/A**Delayed / Cancelled:** Yes No N/A**Bridge No:** 34-0006**Component:** Tower Chimney Parapet**Summary of Items Observed:**

WELDING INSPECTION REPORT

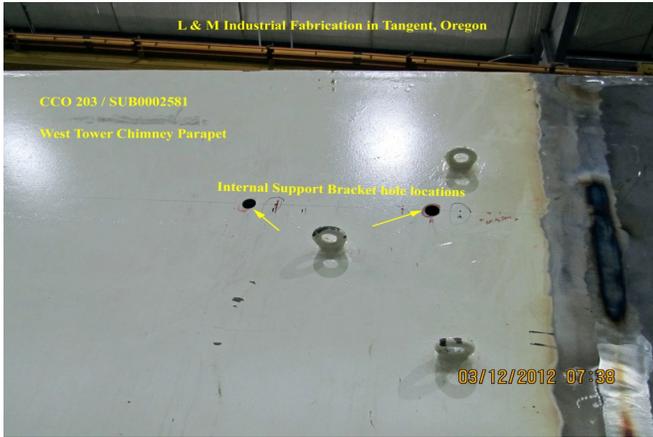
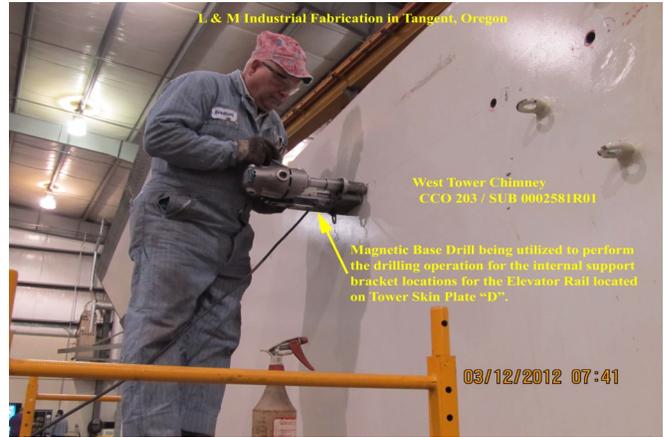
This QA Inspector observed L & M Industrial Fabricators Quality Control (QC) NDT Inspector Leo Jim Jr, performing ultrasonic test (UT) inspection on the complete-joint penetration (CJP) corner-joint groove welds on the A11, A12, A13, and A15 wall plates to base plates of the West Tower Chimney Parapet.

The NDT was performed in accordance with L & M Industrial Fabricator's Weld Quality Control Plan (WQCP) - ABF Submittal 2510 Rev. 1 and the results appeared to comply with the contract specifications.
