DEPARTMENT OF TRANSPORTATION

Quality Assurance and Source Inspection

Contract #: 04-0120F4Cty: SF/ALA Rte: 80 PM: 13.2/13.9File #: 1.28**WELDING INSPECTION REPORT****Resident Engineer:** Casey, William**Address:** 333 Burma Road**City:** Oakland, CA 94607**Report No:** WIR-027356**Date Inspected:** 23-Mar-2012**Project Name:** SAS Superstructure**OSM Arrival Time:** 700**Prime Contractor:** American Bridge/Fluor Enterprises, a JV**OSM Departure Time:** 1730**Contractor:** American Bridge/Fluor Enterprises, a JV**Location:** job site**CWI Name:** See below**CWI Present:** Yes No**Inspected CWI report:** Yes No N/A**Rod Oven in Use:** Yes No N/A**Electrode to specification:** Yes No N/A**Weld Procedures Followed:** Yes No N/A**Qualified Welders:** Yes No N/A**Verified Joint Fit-up:** Yes No N/A**Approved Drawings:** Yes No N/A**Approved WPS:** Yes No N/A**Delayed / Cancelled:** Yes No N/A**Bridge No:** 34-0006**Component:** Tower**Summary of Items Observed:**

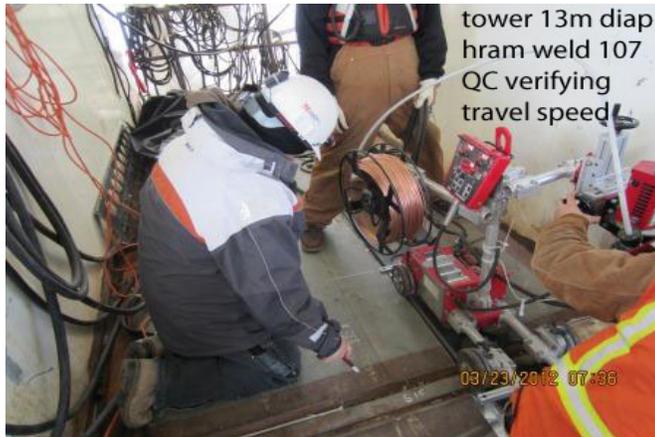
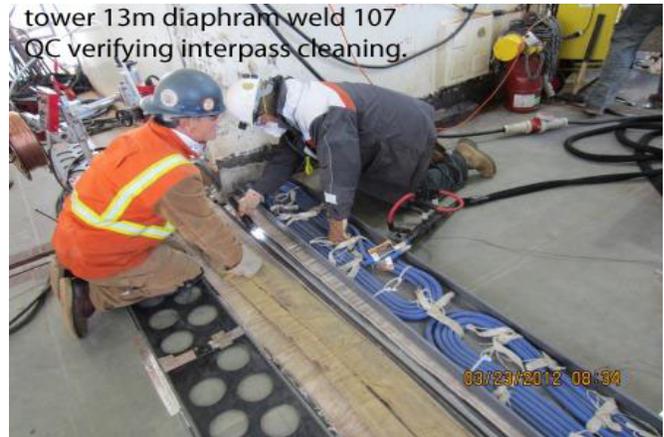
At Tower Base 13 meters diaphragm, weld joint number W107, QA randomly observed ABF certified welder James Zhen ID #6001 continuing to perform 1G (flat position) Submerged Arc Welding (SAW) on the Partial Joint Penetration (PJP) T- joint between the 45mm thick external center diaphragm and 60mm shear plate. The welder was utilizing F7A6-EM12K-H8, 3.2mm electrode with corresponding Esab OK Flux 10.62 flux and implementing Caltrans approved Welding Procedure Specification (WPS) ABF-WPS-D15-4062-1. The joint being welded has a 45 degree bevel groove T- joint with an average root opening of 4.2mm and C-channel installed underneath that will serve as the backing bar. The plates were preheated to more than 225 °F using Miller Preheat 35 Induction Heating System with one heater blanket located on top of each plate prior welding and moving it to the side and lifting the other during welding. ABF/QC Fred Von Hoff was noted monitoring the welding parameters of the welder with measured working current of 550 amperes, 32.5 volts with travel speed of 375 mm per minute.

Later in the shift the QA Inspector observed ABF/QC Fred Von Hoff was noted monitoring the welding parameters of the welder with measured working current of 550 amperes, 32.5 volts with travel speed of 400 mm per minute and calculated heat input of 2.7 joules/mm. At the end of the shift, SAW cover pass welding was

completed and the welder performed the post weld heat treatment (PWHT) after welding using the same preheat temperature and heating machine and held it for three hours as required.

Work performed appears to be in general compliance with contract documents.
