DEPARTMENT OF TRANSPORTATION

Quality Assurance and Source Inspection

Contract #: 04-0120F4Cty: SF/ALA Rte: 80 PM: 13.2/13.9File #: 1.28**WELDING INSPECTION REPORT****Resident Engineer:** Casey, William**Address:** 333 Burma Road**City:** Oakland, CA 94607**Report No:** WIR-027378**Date Inspected:** 27-Mar-2012**Project Name:** SAS Superstructure**OSM Arrival Time:** 700**Prime Contractor:** American Bridge/Fluor Enterprises, a JV**OSM Departure Time:** 1730**Contractor:** American Bridge/Fluor Enterprises, a JV**Location:** job site**CWI Name:** See below**CWI Present:** Yes No**Inspected CWI report:** Yes No N/A**Rod Oven in Use:** Yes No N/A**Electrode to specification:** Yes No N/A**Weld Procedures Followed:** Yes No N/A**Qualified Welders:** Yes No N/A**Verified Joint Fit-up:** Yes No N/A**Approved Drawings:** Yes No N/A**Approved WPS:** Yes No N/A**Delayed / Cancelled:** Yes No N/A**Bridge No:** 34-0006**Component:** Tower**Summary of Items Observed:**

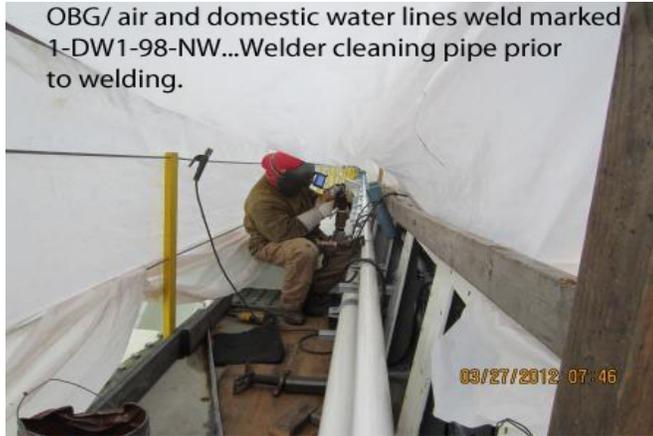
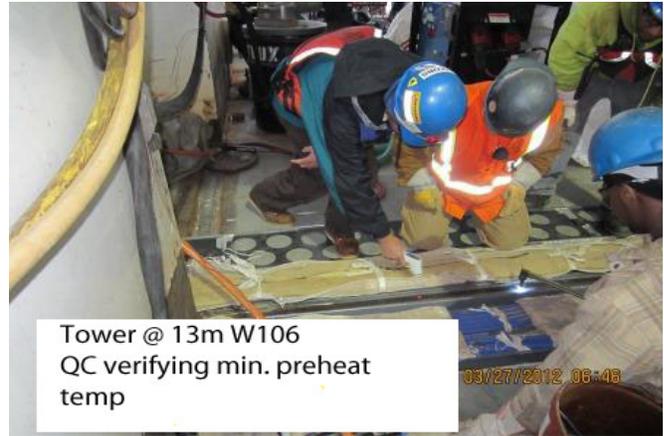
At Tower Base 13 meters diaphragm, weld joint number W107, QA randomly observed ABF certified welder James Zhen ID #6001 continuing to perform 1G (flat position) Submerged Arc Welding (SAW) on the Partial Joint Penetration (PJP) T- joint between the 45mm thick external center diaphragm and 60mm shear plate. The welder was utilizing F7A6-EM12K-H8, 3.2mm electrode with corresponding Esab OK Flux 10.62 flux and implementing Caltrans approved Welding Procedure Specification (WPS) ABF-WPS-D15-4062-1. The joint being welded has a 45 degree bevel groove T- joint with an average root opening of 4.2mm and C-channel installed underneath that will serve as the backing bar. The plates were preheated to more than 225 °F using Miller Preheat 35 Induction Heating System with one heater blanket located on top of each plate prior welding and moving it to the side and lifting the other during welding. ABF/QC Fred Von Hoff was noted monitoring the welding parameters of the welder with measured working current of 550 amperes, 32.5 volts with travel speed of 375 mm per minute.
