**DEPARTMENT OF TRANSPORTATION**

Contract #: 04-0120F4Cty: SF/ALA Rte: 80 PM: 13.2/13.9File #: 1.28**WELDING INSPECTION REPORT****Resident Engineer:** Casey, William**Address:** 333 Burma Road**City:** Oakland, CA 94607**Report No:** WIR-027384**Date Inspected:** 29-Mar-2012**Project Name:** SAS Superstructure**OSM Arrival Time:** 700**Prime Contractor:** American Bridge/Fluor Enterprises, a JV**OSM Departure Time:** 1730**Contractor:** American Bridge/Fluor Enterprises, a JV**Location:** job site**CWI Name:** See below**CWI Present:** Yes No**Inspected CWI report:** Yes No N/A**Rod Oven in Use:** Yes No N/A**Electrode to specification:** Yes No N/A**Weld Procedures Followed:** Yes No N/A**Qualified Welders:** Yes No N/A**Verified Joint Fit-up:** Yes No N/A**Approved Drawings:** Yes No N/A**Approved WPS:** Yes No N/A**Delayed / Cancelled:** Yes No N/A**Bridge No:** 34-0006**Component:** Tower**Summary of Items Observed:**

## WELDING INSPECTION REPORT

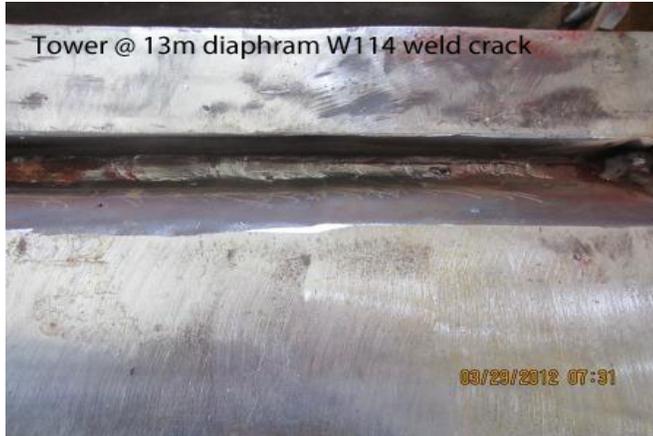
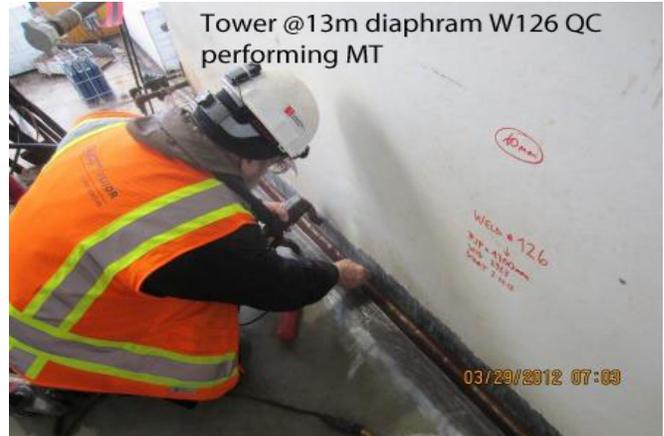
At Tower Base 13 meters diaphragm, weld joint number W115, QA randomly observed ABF certified welder James Zhen ID #6001 continuing to perform 1G (flat position) Submerged Arc Welding (SAW) on the Partial Joint Penetration (PJP) T- joint between the 45mm thick external center diaphragm and 60mm shear plate. The welder was utilizing F7A6-EM12K-H8, 3.2mm electrode with corresponding Esab OK Flux 10.62 flux and implementing Caltrans approved Welding Procedure Specification (WPS) ABF-WPS-D15-4062-1. The joint being welded has a 45 degree bevel groove T- joint with an average root opening of 4.2mm and C-channel installed underneath that will serve as the backing bar. The plates were preheated to more than 225 °F using Miller Preheat 35 Induction Heating System with one heater blanket located on top of each plate prior welding and moving it to the side and lifting the other during welding. ABF/QC Fred Von Hoff was noted monitoring the welding parameters of the welder with measured working current of 550 amperes, 32.5 volts with travel speed of 381 mm per minute.

Later in the shift At Tower Base 13 meters diaphragm, weld joint number W126, QA randomly observed ABF certified welder Dan Ieraci ID #3232 continuing to perform 1G (flat position) Submerged Arc Welding (SAW) on the Partial Joint Penetration (PJP) T- joint between the 45mm thick external center diaphragm and 60mm Tower. The welder was utilizing F7A6-EM12K-H8, 3.2mm electrode with corresponding Esab OK Flux 10.62 flux and implementing Caltrans approved Welding Procedure Specification (WPS) ABF-WPS-D15-4062-1. The joint being welded has a 45 degree bevel groove T- joint with an average root opening of 4.2mm and C-channel installed underneath that will serve as the backing bar. The plates were preheated to more than 225 °F using Miller Preheat 35 Induction Heating System with one heater blanket located on top of each plate prior welding and moving it to the side and lifting the other during welding. ABF/QC Fred Von Hoff was noted monitoring the welding parameters of the welder with measured working current of 550 amperes, 32.5 volts with travel speed of 381 mm per minute.

The QA Inspector observed the welding work at these locations was not yet completed on this date.
