DEPARTMENT OF TRANSPORTATION

Quality Assurance and Source Inspection

Contract #: 04-0120F4Cty: SF/ALA Rte: 80 PM: 13.2/13.9File #: 1.28**WELDING INSPECTION REPORT****Resident Engineer:** Casey, William**Address:** 333 Burma Road**City:** Oakland, CA 94607**Report No:** WIR-027436**Date Inspected:** 11-Apr-2012**Project Name:** SAS Superstructure**OSM Arrival Time:** 700**Prime Contractor:** American Bridge/Fluor Enterprises, a JV**OSM Departure Time:** 1530**Contractor:** American Bridge/Fluor Enterprises, a JV**Location:** Job Site**CWI Name:** Salvador Merino**CWI Present:** Yes No**Inspected CWI report:** Yes No N/A**Rod Oven in Use:** Yes No N/A**Electrode to specification:** Yes No N/A**Weld Procedures Followed:** Yes No N/A**Qualified Welders:** Yes No N/A**Verified Joint Fit-up:** Yes No N/A**Approved Drawings:** Yes No N/A**Approved WPS:** Yes No N/A**Delayed / Cancelled:** Yes No N/A**Bridge No:** 34-0006**Component:** OBG Components**Summary of Items Observed:**

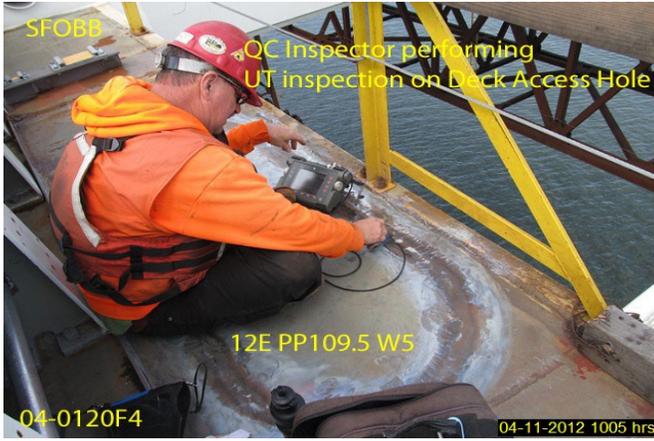
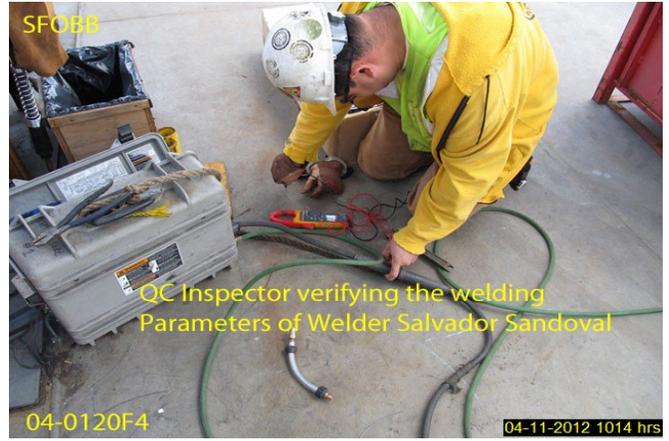
This QAI observed welder Salvador Sandoval placing the Shielded Metal Arc Welding (SMAW) root pass at 12W PP109.5 W2 with a 3.0mm diameter E7018 electrode for the Complete Joint Penetration (CJP) weld. The Welding Procedure Specification (WPS) used was ABF-WPS-D15-1040C with a measured welding amp of 128 F. The pre-heat for this location was measured at 65 degrees C (150 degrees F) using a weed burner which were verified using a tempstik and infrared gun by the QC. The welder was also observed by this QAI as using a chipping hammer, power grinder and power wire wheel for the interpass cleaning. Later in the shift the welder had switched to the Flux Cored Arc Welding (FCAW) process for the intermediate weld passes with the E71T-1M, 1.6mm electrode. The WPS for the Complete Joint Penetration was WPS-D1.5-3040A-1. The welding parameters were verified as 255 amps, 24.5 volts. The area for welding was then pre-heated prior to welding at 40 degrees Celsius (150 degrees F) which was verified using a tempstik and infrared gun by the QC. The welder began placing the intermediate weld passes for this location and using a power grinder and power wire wheel for the interpass cleaning. The QC inspector for this location was Salvador Merino and was observed verifying and documenting the welding parameters for this location, along with overseeing the welding operations. At the time of the observations no issues were noted by the QAI.

This QAI observed that welder Khit Lounechaney was using the Carbon Arc Cutting (CAC) process at 12W PP109.5 W5 (interior) to perform the back gouge on the deck access holes. The welder was observed in the overhead position removing the backing bar first then proceeding with the back gouge. At the end of this QA inspectors shift the welder was still in process of the CAC back gouge. The QC inspector for this location was Salvador Merino and was observed overseeing the welding operations. At the time of the observations no issues were noted by the QAI.
