DEPARTMENT OF TRANSPORTATION

Quality Assurance and Source Inspection

Contract #: 04-0120F4Cty: SF/ALA Rte: 80 PM: 13.2/13.9File #: 1.28**WELDING INSPECTION REPORT****Resident Engineer:** Casey, William**Address:** 333 Burma Road**City:** Oakland, CA 94607**Report No:** WIR-027465**Date Inspected:** 18-Apr-2012**Project Name:** SAS Superstructure**OSM Arrival Time:** 700**Prime Contractor:** American Bridge/Fluor Enterprises, a JV**OSM Departure Time:** 1730**Contractor:** American Bridge/Fluor Enterprises, a JV**Location:** Job Site

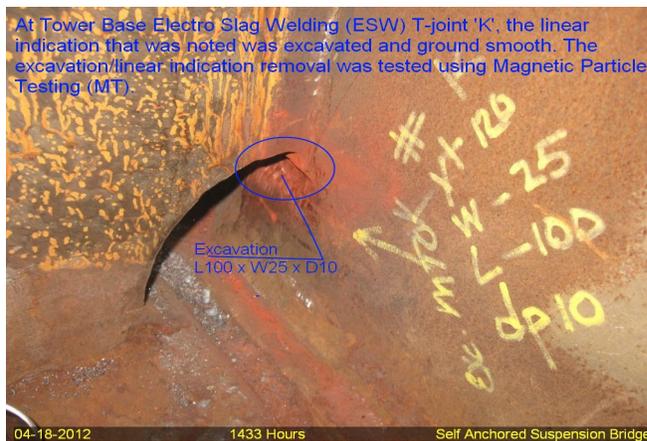
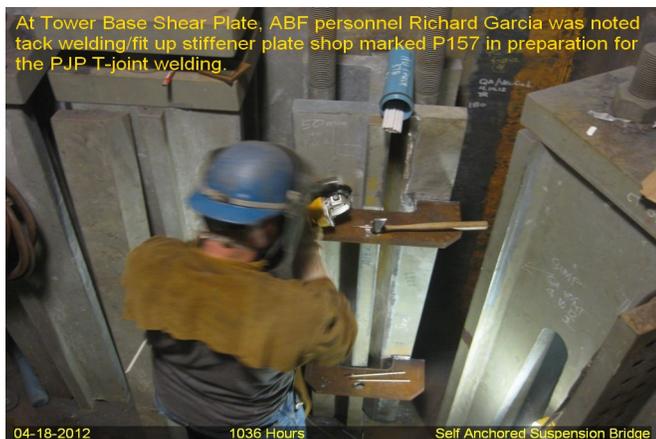
At Tower Base 13 meters diaphragm, weld joint number W108, QA randomly observed ABF certified welder James Zhen ID #6001 continuing to perform 1G (flat position) Submerged Arc Welding (SAW) on the Partial Joint Penetration (PJP) T- joint between the 45mm thick inner West diaphragm and 60mm tower skin plate. The welder was utilizing F7A6-EM12K-H8, 3.2mm electrode with corresponding Esab OK Flux 10.62 flux and implementing Caltrans approved Welding Procedure Specification (WPS) ABF-WPS-D15-4062-1. The joint being welded has a 45 degree bevel groove T- joint. The plates were preheated to more than 225 °F using Miller Proheat 35 Induction Heating System with one heater blanket located on top of each plate prior/during welding. ABF/QC Fred Von Hoff was noted monitoring the welding parameters of the welder with measured working current of 550 amperes, 32.5 volts with travel speed of 380 mm per minute and calculated heat input of 2.8 Kjoules/mm. QA noted the welding parameters, the workmanship and appearance of the completed fill satisfactory. At the end of the shift, SAW cover pass welding on PJP T-joint mentioned above was completed.

At Tower Base 13 meter South external diaphragm, this QA Inspector randomly observed ABF personnel Xiao Jian Wan continuing to perform 4F (overhead position) fillet production welding on the perimeter C10 channel to 45mm thick diaphragm plate fillet weld joint W134-2. The welder was noted welding 6mm fillet between one side of the channel top flange and diaphragm plate per detail 1 of the FW3 drawing. The welder was using the 3.2mm diameter E7018H4R electrode and implementing Caltrans approved Welding Procedure Specification (WPS)

At Tower Base 13 meter South external diaphragm, this QA Inspector randomly observed ABF personnel Luo Xiao Hua continuing to perform 4F (overhead position) fillet production welding on the perimeter C10 channel to 45mm thick diaphragm plate fillet weld joint W134-2. The welder was noted welding 6mm fillet between one side of the channel top flange and diaphragm plate per detail 1 of the FW3 drawing. The welder was using the 3.2mm diameter E7018H4R electrode and implementing Caltrans approved Welding Procedure Specification (WPS) ABF-WPS-D15-F1200A. This QA Inspector observed ABF personnel using propylene gas torch to preheat the plates being welded prior welding. This QA Inspector observed QC Inspector William Sherwood using a Fluke infra red temperature gauge to verify the preheat temperature of more than 150°F. This QA Inspector performed a verification of the welding parameters and observed 128 amperes on the 3.2 diameter electrode. The welding appeared to comply with Welding Procedure Specification (WPS) ABF-WPS-F1200A. At the end of the shift, SMAW fillet welding was still continuing and should remain tomorrow.

At Tower Base 9 meter outer West external diaphragm, this QA Inspector randomly observed ABF personnel Jin Pei Wang perform 4F (overhead position) fillet production welding on the 45mm thick stiffener plate shop marked P440-2. The stiffener plate is being welded on three sides; one on tower skin plate, the other side on West shear plate and the third one on the vertical stiffener plate. The welder was using Shielded Metal Arc Welding (SMAW) with 3.2mm diameter E7018H4R electrode implementing Caltrans approved Welding Procedure Specification (WPS) ABF-WPS-D15-F1200A. This QA Inspector observed ABF personnel using Miller Proheat 35 induction Heating System to preheat and maintain the temperature prior/during welding. This QA Inspector observed QC Inspector William Sherwood using a Fluke infra red temperature gauge to verify the preheat temperature of more than 225°F. This QA Inspector performed a verification of the welding parameters and observed 120 amperes. The welding appeared to comply with Welding Procedure Specification (WPS) ABF-WPS-D15-F1200A. At the end of the shift, the welder has completed the bottom 8mm fillet weld on three sides of the stiffener.

At Tower Base Electro Slag Welding (ESW) T-joint 'K', this QA performed visual test (VT) and Magnetic Particle Testing (MT) on the excavated linear indication that was detected after the cutting and grinding of the ESW sump starting plate. During VT it was noted that the excavation was ground to a boat shape with smooth surface. After the VT, this QA performed MT on the ground smooth boat shape excavation and noted no relevant indication during the test.
