Contract #: 04-0120F4Cty: SF/ALA Rte: 80 PM: 13.2/13.9File #: 1.28**WELDING INSPECTION REPORT****Resident Engineer:** Casey, William**Address:** 333 Burma Road**City:** Oakland, CA 94607**Report No:** WIR-027490**Date Inspected:** 23-Apr-2012**Project Name:** SAS Superstructure**OSM Arrival Time:** 700**Prime Contractor:** American Bridge/Fluor Enterprises, a JV**OSM Departure Time:** 1530**Contractor:** American Bridge/Fluor Enterprises, a JV**Location:** Skyway**CWI Name:** See below**CWI Present:** Yes No**Inspected CWI report:** Yes No N/A**Rod Oven in Use:** Yes No N/A**Electrode to specification:** Yes No N/A**Weld Procedures Followed:** Yes No N/A**Qualified Welders:** Yes No N/A**Verified Joint Fit-up:** Yes No N/A**Approved Drawings:** Yes No N/A**Approved WPS:** Yes No N/A**Delayed / Cancelled:** Yes No N/A**Bridge No:** 34-0006**Component:** Skyway**Summary of Items Observed:**

Skyway Guard Rail:

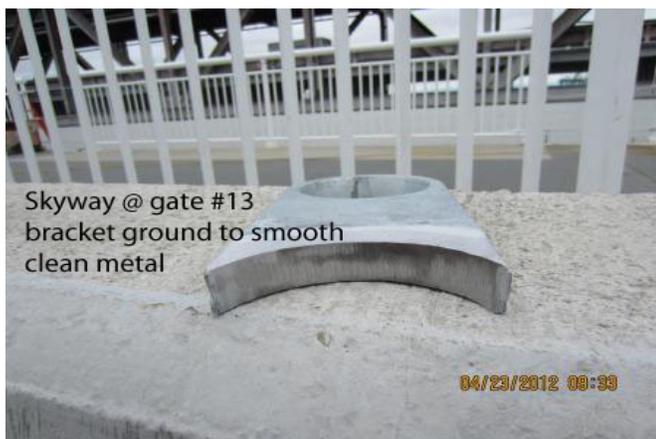
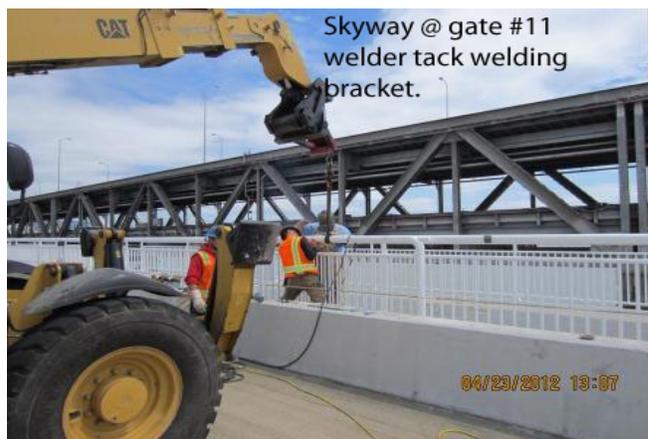
The QA Inspector at random intervals, observed ABF welder Jayson Collins (ID 8128) perform the Shielded Metal Arc Welding (SMAW) process in the 3G/4G vertical/overhead position on face "A" of the guard rail brackets at the East bound lane gate #13 as per change order #179. The welder was observed utilizing 3.2mm E7018-H4R electrodes obtained from a baking oven and drawing amperage of 123. QC Inspector was on hand to monitor the welding, parameters as they apply to ABF-WPS-D1.5-F1200A. On subsequent observations the welder was observed cleaning the work between passes by employing a small disc grinder, brushes and compressed air. Later in the shift the QA Inspector observed ABF personnel install the stainless steel track for the gate to run on. The QA Inspector noted the welding work at this location to be complete on this date.

observed utilizing 3.2mm E7018-H4R electrodes obtained from a baking oven and drawing amperage of 123. On subsequent observations the welder was observed cleaning the work between passes by employing a small disc grinder, brushes and compressed air. The QA Inspector observed all material preparations were performed prior to any welding being performed. Later in the shift the QA Inspector observed ABF personnel install the stainless steel track for the gate to run on. The QA Inspector noted the welding work at this location not to be complete on this date.

The QA Inspector at random intervals, observed ABF welder Jayson Collins (ID 8128) perform the Shielded Metal Arc Welding (SMAW) process in the 3G/4G vertical/overhead position on face "A" of the guard rail brackets at the East bound lane gate #11 as per WPS ABF-WPS-D1.5-F1200A and change order #179. The welder was observed utilizing 3.2mm E7018-H4R electrodes obtained from a baking oven and drawing amperage of 123. On subsequent observations the welder was observed cleaning the work between passes by employing a small disc grinder, brushes and compressed air. The QA Inspector observed all material preparations were performed prior to any welding being performed. The QA Inspector noted the welding work at this location not to be complete on this date.
