DEPARTMENT OF TRANSPORTATION

Contract #: 04-0120F4Cty: SF/ALA Rte: 80 PM: 13.2/13.9File #: 1.28**WELDING INSPECTION REPORT****Resident Engineer:** Casey, William**Address:** 333 Burma Road**City:** Oakland, CA 94607**Report No:** WIR-027493**Date Inspected:** 25-Apr-2012**Project Name:** SAS Superstructure**OSM Arrival Time:** 700**Prime Contractor:** American Bridge/Fluor Enterprises, a JV**OSM Departure Time:** 1530**Contractor:** American Bridge/Fluor Enterprises, a JV**Location:** Job Site

Bridge No: 34-0006**Summary of Items Observed:**

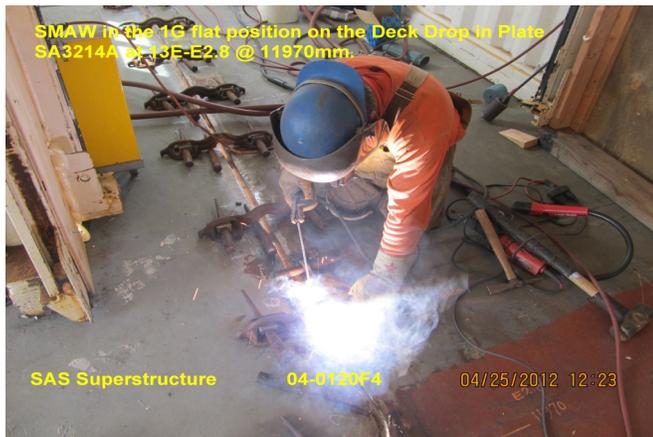
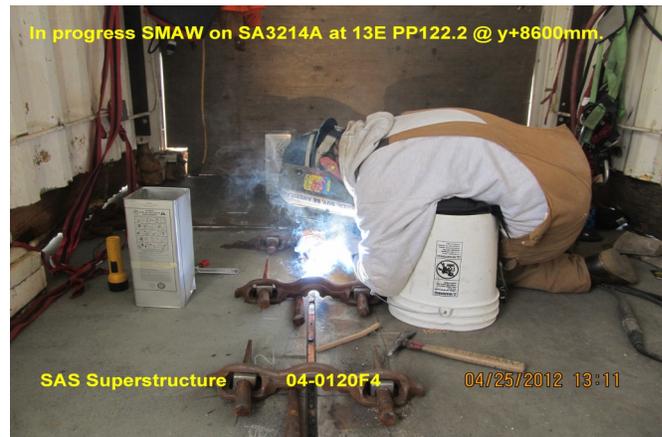
This QA Inspector observed F.W. Spencer welder Damian Llanos ID# (6645) performing SMAW in all positions on 4" schedule 80 pipe, located at 5E PP35.5 E5. This QA Inspector verified the fit up of the joints and found it to be satisfactory and randomly observed QC Inspector Steve Jensen monitoring the welding to ensure the welding parameters were in compliance pertaining to WPS-1-12-1 Revision 2 (1.12). The welder was observed utilizing 6010 electrodes in the root pass with the balance using 7018 electrodes and cleaning the weld after each pass utilizing a wire wheel on a small disc grinder. The QA inspector made subsequent observations throughout the shift to monitor quality and noted that the work appeared to be in general conformance with the contract documents.

This QA Inspector made random observations of ABF welding personnel performing SMAW on Deck Panel SA3214A East on the exterior of the OBG. This QA Inspector randomly observed ABF welder Mike Jimenez utilizing 3.2mm E7018-H4R electrodes in the 1G flat position at 13E PP 122.2 @ 8600mm. The welder was observed cleaning the start/stop edges of the work by employing a die grinder with a conical tipped bit. QC

Inspector William Sherwood was present to monitor the welding and the parameters as they pertained to ABF-WPS-D1.5-1040C-Revision 1. On a subsequent observation, the welder was observed continuing his work in the same manner and was noted that the work is in progress. This QA Inspector made random observations of ABF welder Salvador Sandoval (ID 2202) performing the SMAW process in the 1G flat position on a B-U2a Complete Joint Penetration (CJP) joint on 13E-E2.8 @ 11970mm. The welder was observed utilizing 3.2mm E7018-H4R electrodes drawing amperage of 119. Prior to welding, Mr. Sandoval was observed pre-heating the joint to 150°F and was verified by this QA Inspector utilizing a 150°F Tempilstik. QC Inspector William Sherwood was present to monitor the welding and the parameters as they pertained to ABF-WPS-D1.5-1040C-Revision 1. On a subsequent observation, the welder was observed cleaning the work utilizing a small disc grinder to grind and blend the weld for a smooth transition. It was noted that the work at this location was in progress. This QA Inspector randomly observed ABF welder Khit Lounechaney (ID 4985) performing SMAW in the 1G flat position located at 13E-E2.1 @ 2500mm. QC Inspector William Sherwood was present to monitor the welding and the parameters as they pertained to ABF-WPS-D1.5-1040C-Revision 1. The welder utilized 3.2mm E7018-H4R electrodes and this QA Inspector verified that they were obtained from a baking oven set at the correct temperature of 250°F. The welder was observed cleaning the work between passes and it was noted that the work at this location was in progress. This QA Inspector randomly observed ABF welder Edward Brown (ID 9331) performing the SMAW process in the 1G flat position on a B-U2a CJP joint located at 13E-E2.2 @ PP124.5. QC Inspector William Sherwood was present to monitor the welding and the parameters as they pertained to ABF-WPS-D1.5-1040C-Revision 1. The welder was observed cleaning the work between passes and utilized 3.2mm E7018-H4R electrodes and drew amperage of 123. The work at this location was noted as being in progress and this QA Inspector made subsequent observations throughout the shift to monitor quality and noted that the work at these locations is in progress and appeared to be in general conformance with the contract documents.
