Contract #: 04-0120F4Cty: SF/ALA Rte: 80 PM: 13.2/13.9File #: 1x.28**WELDING INSPECTION REPORT**

**Report No:** WIR-027497  
**Date Inspected:** 25-Apr-2012

**Project Name:** SAS Superstructure  
**Prime Contractor:** American Bridge/Fluor Enterprises, a JV  
**Contractor:** American Bridge/Fluor Enterprises, a JV

**Bridge No:** 34-0006**Component:** SAS OBG Components**Summary of Items Observed:**

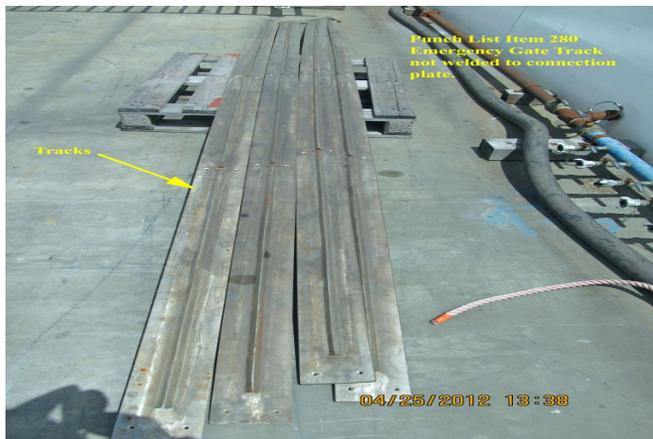
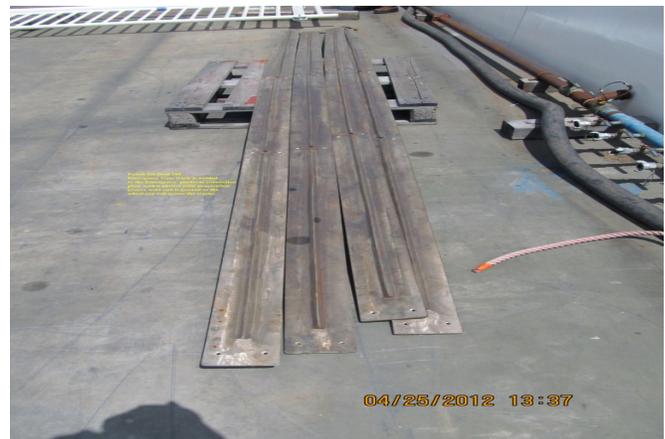
Punch List Item No. 280: General: Bike Path: Category: Outstanding: Location: BK005A-001

Description: The emergency gate track is not welded to emergency platform connection plate per Shop Drawing BKR-AN-5.

Status: Welding: complete / Paint: outstanding - Comment: The Contractor welded the piece mark numbers P-25 and P-26 as per the shop drawing which denoted a partial-joint penetration groove weld for the full length and were ground to fit the wheel. The Contractor has yet to perform the coating operation on the emergency gate tracks.
