Contract #: 04-0120F4Cty: SF/ALA Rte: 80 PM: 13.2/13.9File #: 1.28**WELDING INSPECTION REPORT****Resident Engineer:** Casey, William**Address:** 333 Burma Road**City:** Oakland, CA 94607**Report No:** WIR-027521**Date Inspected:** 30-Apr-2012**Project Name:** SAS Superstructure**OSM Arrival Time:** 1100**Prime Contractor:** American Bridge/Fluor Enterprises, a JV**OSM Departure Time:** 1730**Contractor:** American Bridge/Fluor Enterprises, a JV**Location:** Job site

Bridge No: 34-0006**Component:** OBG 13E**Summary of Items Observed:**

WELDING INSPECTION REPORT

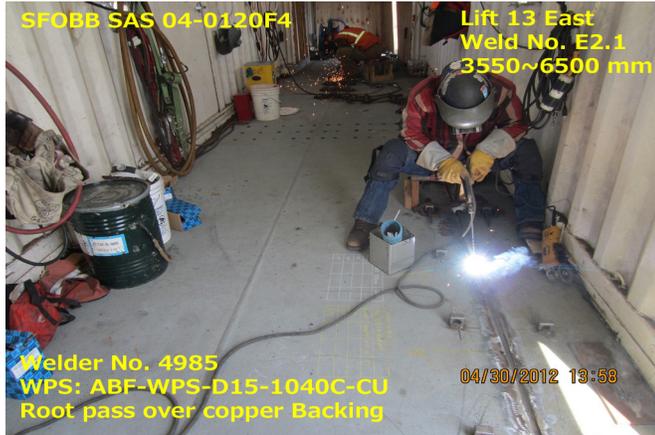
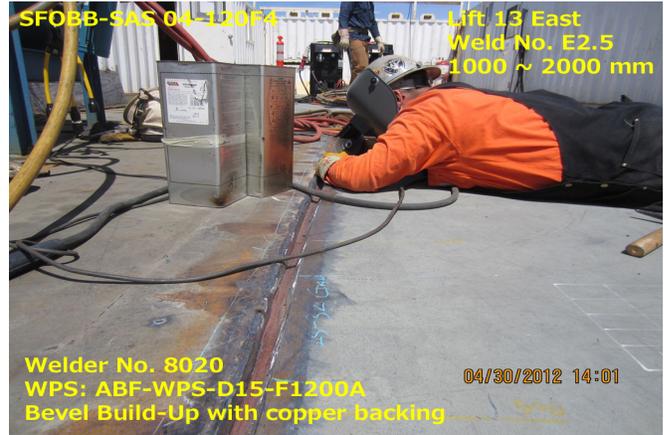
appeared to comply with the AWS Specification and AWS Classification. The QC inspection, testing and welding performed on this shift appeared to be in general compliance with the contract documents. At random intervals, the QAI verified the QC inspection, testing, welding parameters and the surface temperatures utilizing various inspection equipment and gages which included a Fluke 337 Clamp Meter and Tempilstik Temperature indicators. Unless noted otherwise, all work observed on this date appeared to be in general compliance with the contract documents at the time of observations.
