Contract #: 04-0120F4Cty: SF/ALA Rte: 80 PM: 13.2/13.9File #: 1.28**WELDING INSPECTION REPORT****Resident Engineer:** Casey, William**Address:** 333 Burma Road**City:** Oakland, CA 94607**Report No:** WIR-027578**Date Inspected:** 09-May-2012**Project Name:** SAS Superstructure**OSM Arrival Time:** 700**Prime Contractor:** American Bridge/Fluor Enterprises, a JV**OSM Departure Time:** 1730**Contractor:** American Bridge/Fluor Enterprises, a JV**Location:** Job Site

Bridge No: 34-0006**Component:** SAS Tower**Summary of Items Observed:**

WELDING INSPECTION REPORT

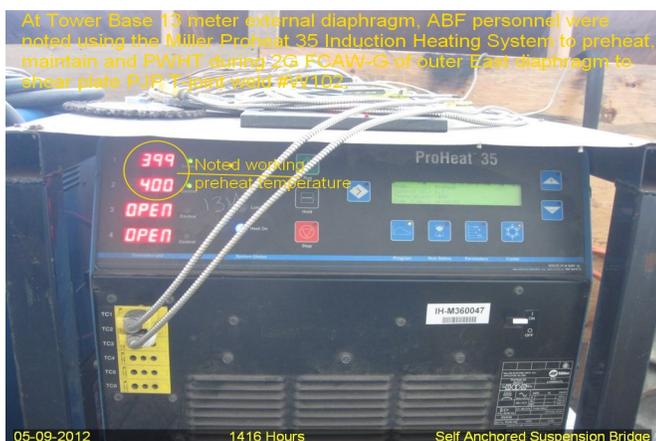
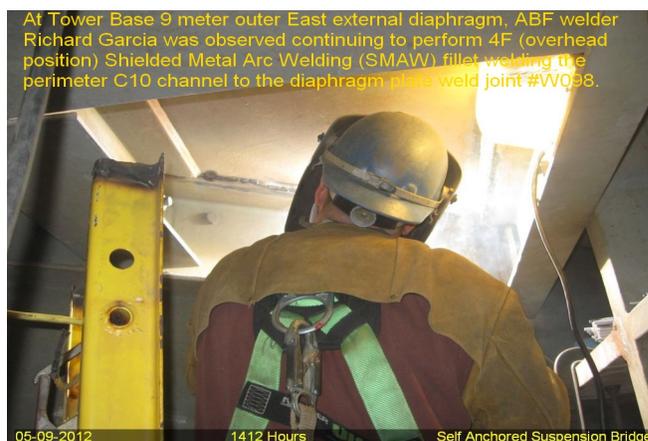
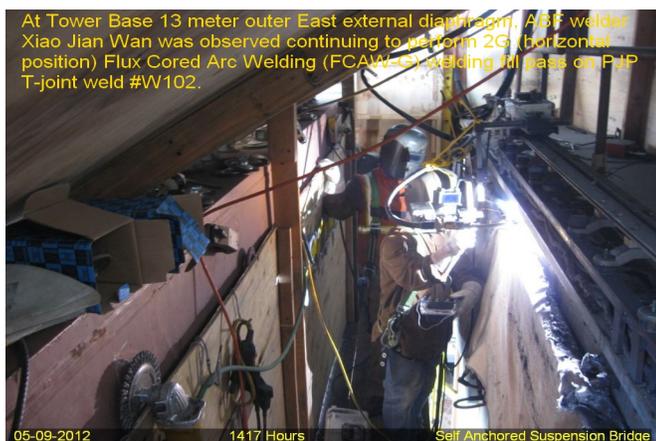
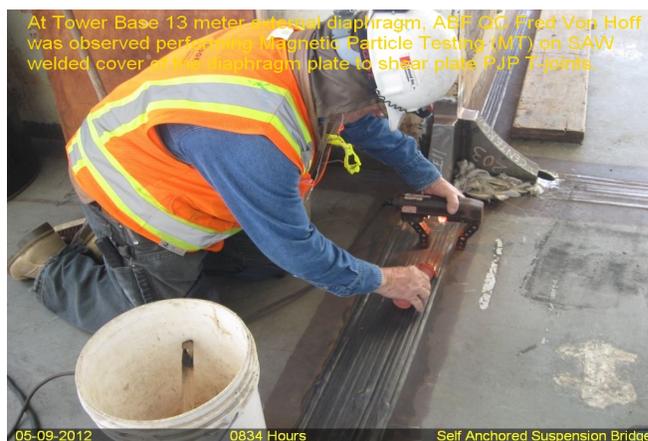
At Tower Base 13 meter outer East external diaphragm, QA randomly observed ABF/JV qualified welder Xiao Jian Wan continuing to perform Partial Joint Penetration (PJP) T-joint welding fill pass on 80mm thick shear plate to 45mm thick diaphragm plate weld joint #W102. The welder was observed welding in the 2G (horizontal) position utilizing a dual shield Flux Cored Arc Welding (FCAW-G) with E71T-1M, 1/16" diameter wire electrode and implementing Caltrans approved Welding Procedure Specification (WPS) ABF-WPS-D15-3160-1. The welder was using a track mounted welder holder assembly that was remotely controlled. The PJP T-joint was preheated to greater than 325 degrees Fahrenheit using Miller Proheat 35 Induction Heating System with the heater blankets located on top of the plate prior welding. During welding, ABF Quality Control (QC) Fred Von Hoff was noted monitoring the welding parameters of the welder. Measured welding parameters during welding were 240 amperes, 23.5 volts and 325mm travel speed. Calculated heat input was 1.04 Kjoules/mm which appears in compliance to the contract requirements. At the end of the shift, FCAW-G fill pass welding was still continuing and should remain tomorrow. The welder held the preheat using the same Miller Proheat 35 Heating System for three hours after welding as required.

At Tower Base 9 meter outer East external diaphragm, this QA Inspector randomly observed ABF personnel Richard Garcia continuing to perform 4F (overhead position) fillet production welding on the C10 channel to 45mm thick diaphragm plate fillet weld joint W098. The welder was noted welding 6mm fillet between one side

At Tower Base outer West shear plate, this QA randomly observed ABF welder Jin Pei Wang perform 2F/3F (horizontal/vertical) position tack welding temporary attachments to the 100/80mm plate transitioned shear plate. The welder was using SMAW with 3.2mm diameter E7018H4R electrode implementing Caltrans approved Welding Procedure Specification (WPS) ABF-WPS-D15-F1200A. The outer West shear plate was preheated to more than 225°F using propylene gas torch prior welding. The temporary attachments are being welded as an aid in erecting temporary platform for personnel access in welding the Partial Joint Penetration T-joint W110. During the shift, ABF QC Bernie Docena was noted monitoring the welder. The welder has completed six temporary attachments and erected their temporary working platform.

At Tower Base ED1-29 shear plate assembly, ABF QC Bernie Docena informed this QA that the 60mm thick bearing plate replacement that was brought to site was wrong. Upon cursory verification, the tapered side of the bearing stiffener was beveled to 45 degree while the straight portion of the plate which was to be beveled and welded to the bearing plate was noted flat (no bevel).
