Quality Assurance and Source Inspection

Contract #: 04-0120F4Cty: SF/ALA Rte: 80 PM: 13.2/13.9File #: 1.28**WELDING INSPECTION REPORT****Resident Engineer:** Casey, William**Address:** 333 Burma Road**City:** Oakland, CA 94607**Report No:** WIR-027623**Date Inspected:** 17-May-2012**Project Name:** SAS Superstructure**OSM Arrival Time:** 700**Prime Contractor:** American Bridge/Fluor Enterprises, a JV**OSM Departure Time:** 1730**Contractor:** American Bridge/Fluor Enterprises, a JV**Location:** Job Site

Bridge No: 34-0006**Summary of Items Observed:**

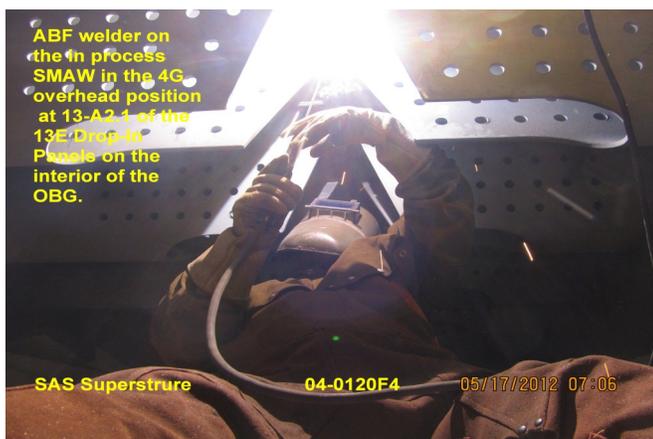
This QA Inspector observed ABF welders noted below performing 4G (overhead position) Shielded Metal Arc Welding (SMAW) on the Seismic Performance Critical Member (SPCM) Complete Joint Penetration (CJP) splice butt joint using 3.2mm E7018-H4R electrodes with amperage of 125. This welding was in progress for the duration of the shift. The welding consists of back fill passes at the 13E-A.1 location by Edward Brown (ID 9331) 13E-A2.1 by Salvador Sandoval (ID 2202) 13E-E2.3 by Khit Lounechaney (ID 4985) and 13E PP122.2 by Steven Davis (ID 7889). QC Inspector Sal Merino was observed monitoring the welding parameters for compliance to ABF-WPS-D1.5-1040C-CU Revision 0 and measuring inter-pass temperatures between passes. This QA Inspector verified that the electrodes were stored in electric rod ovens and appeared to be in accordance with AWS D1.5 Section 4.5.2 and exposure rates appeared to be in accordance with AWS D1.5 Table 4.7. During subsequent observations it was noted that the welders were using a power disc grinder and/or rotary die grinders at weld starts and stops as needed and were cleaning between weld passes with power wire wheel brushes. It was noted that the work on 13E-A2.1 and 13E-A.0 was completed on this date and appeared to be in general conformance with the contract specifications.
