DEPARTMENT OF TRANSPORTATION

Contract #: 04-0120F4Cty: SF/ALA Rte: 80 PM: 13.2/13.9File #: 99.28**WELDING INSPECTION REPORT****Resident Engineer:** Casey, William**Address:** 333 Burma Road**City:** Oakland, CA 94607**Report No:** WIR-027701**Date Inspected:** 31-May-2012**Project Name:** SAS Superstructure**OSM Arrival Time:** 700**Prime Contractor:** American Bridge/Fluor Enterprises, a JV**OSM Departure Time:** 1530**Contractor:** American Bridge Manufacturing**Location:** Reedsport, OR**CWI Name:** James Vanek**CWI Present:** Yes No**Inspected CWI report:** Yes No N/A**Rod Oven in Use:** Yes No N/A**Electrode to specification:** Yes No N/A**Weld Procedures Followed:** Yes No N/A**Qualified Welders:** Yes No N/A**Verified Joint Fit-up:** Yes No N/A**Approved Drawings:** Yes No N/A**Approved WPS:** Yes No N/A**Delayed / Cancelled:** Yes No N/A**Bridge No:** 34-0006**Component:** As Noted Below**Summary of Items Observed:**

WELDING INSPECTION REPORT

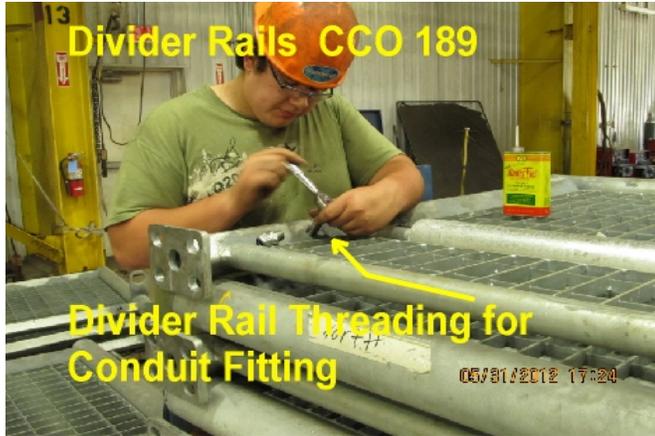
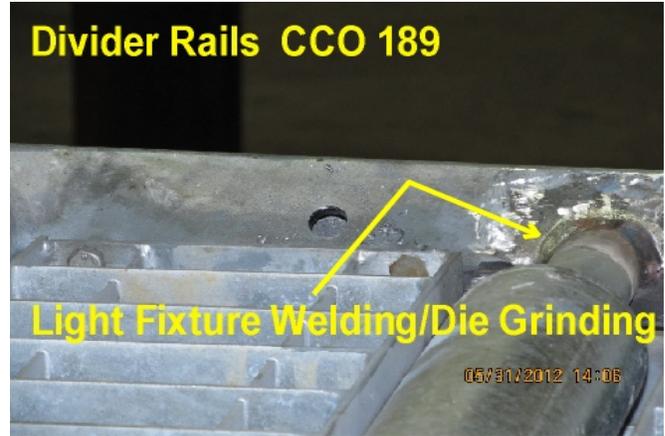
The QAI observed ABM personnel threading a 16mm hole on Tube Steel Uprights at drilled holes for electrical conduit fitting (Reference approved shop drawing Sheet 900SR6, Railing Detail No.3A, Section J-J for Bike path Divider Rails. The QAI noted there are approximately 50 pieces in process and appear to be in accordance with approved shop drawings.

The QAI observed ABM welder Tom Daily ID# 3 welding in the 2F position with Flux Cored Arc Welding with 100% CO2 Gas Shielding (FCAW-GS) utilizing 1.4mm E71T-1C wire electrode. The QAI noted that the light fixture pipe assembly was being welded to the Tube Steel Uprights at drilled holes (Reference approved shop drawing Sheet 899R3, Railing Detail No.2, Detail U and 900R6, Railing Detail No.3, Detail F) for Bike path Divider Rails at Expansion Joints. The QAI checked welding parameters (237 DC Amps and 28.6 DC Volts) and appear to be in compliance with Welding Procedure Specifications (WPS) ABM-SAS-06. Quality Control Inspector (QCI) James Vanek was observed monitoring the welding parameters. During subsequent observations it was noted that the welder was using a power die grinder to profile the weld at weld to a smooth finish, and was cleaning between weld passes with power wire wheel brushes. Welding was in process to the end of the shift. The QAI noted that the workmanship herein appears to be in accordance with the project plans and specifications.
