Contract #: 04-0120F4Cty: SF/ALA Rte: 80 PM: 13.2/13.9File #: 1.28**WELDING INSPECTION REPORT****Resident Engineer:** Casey, William**Address:** 333 Burma Road**City:** Oakland, CA 94607**Report No:** WIR-027771**Date Inspected:** 16-Jun-2012**Project Name:** SAS Superstructure**OSM Arrival Time:** 700**Prime Contractor:** American Bridge/Fluor Enterprises, a JV**OSM Departure Time:** 1530**Contractor:** American Bridge/Fluor Enterprises, a JV**Location:** Job Site**CWI Name:** William Sherwood**CWI Present:** Yes No**Inspected CWI report:** Yes No N/A**Rod Oven in Use:** Yes No N/A**Electrode to specification:** Yes No N/A**Weld Procedures Followed:** Yes No N/A**Qualified Welders:** Yes No N/A**Verified Joint Fit-up:** Yes No N/A**Approved Drawings:** Yes No N/A**Approved WPS:** Yes No N/A**Delayed / Cancelled:** Yes No N/A**Bridge No:** 34-0006**Component:** SAS Tower**Summary of Items Observed:**

WELDING INSPECTION REPORT

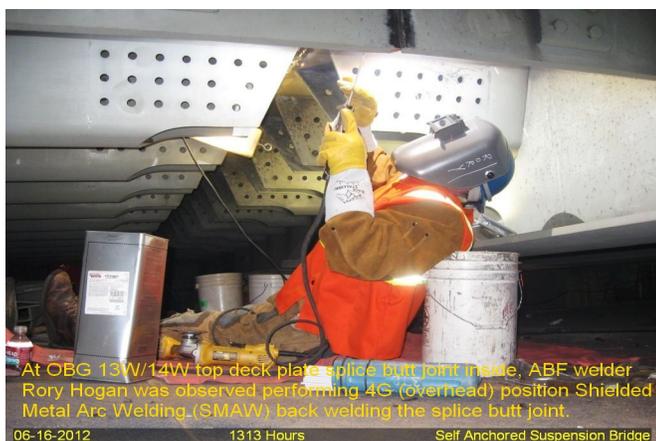
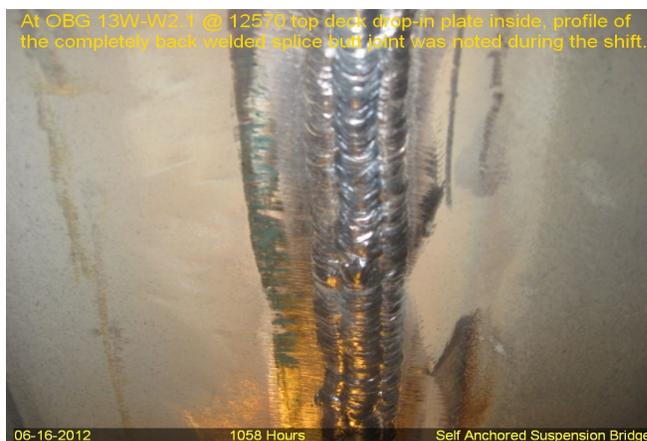
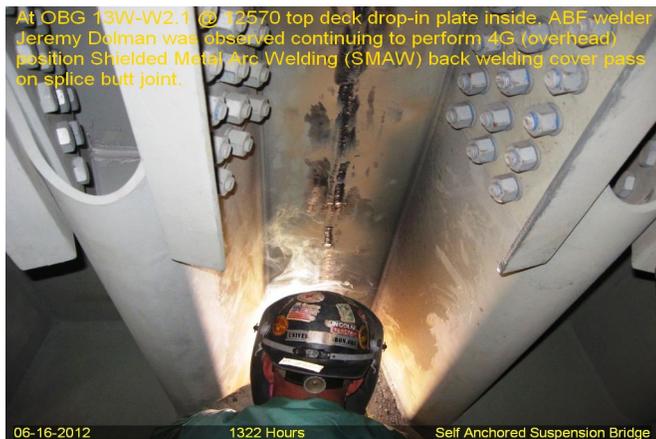
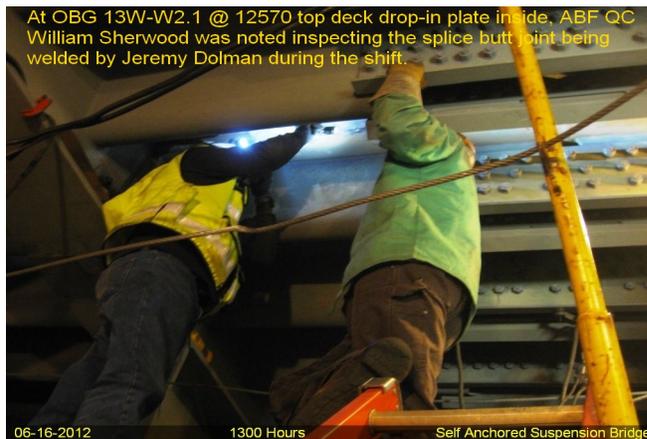
At OBG 13W-W2.8 @ 12570 approximately between Y=5000mm to Y=6000mm top deck drop-in plate inside, QA randomly observed ABF certified welder Jeremy Dolman continuing to perform 4G (overhead position) Shielded Metal Arc Welding (SMAW) back welding cover pass on the CJP SPCM splice butt joint. The welder was utilizing 3.2mm diameter E7018H4R electrode implementing Caltrans approved Welding Procedure Specification (WPS) ABF-WPS-D15-1040C-CU. The joint being welded had a single V-groove butt joint with copper plate backing bar that was originally welded from the top using a combination of SMAW and Submerged Arc Welding (SAW) then removed the copper backing plate using carbon air arc gouging and ground smooth. The plates were preheated to more than 150 degree Fahrenheit using Miller Proheat 35 Induction Heating System prior welding. Welding parameters were monitored by ABF/QC William Sherwood. QA noted the working welding parameters of 126 amperes on the 3.2mm diameter E7018H4R electrode. The workmanship and appearance of the completed cover pass deemed satisfactory. During the shift, cover pass back welding on area mentioned above was partially completed and the welder has slowly moved to farther Y location of the same joint wherein he continued the overhead SMAW back welding until the end of the shift.

At OBG 13W/14W top deck splice butt joint inside approximately between Y=2500mm to Y=4000mm, QA randomly observed ABF certified welder Rory Hogan perform 4G (overhead position) Shielded Metal Arc Welding (SMAW) back welding cover pass on the CJP SPCM splice butt joint. The welder was utilizing 3.2mm

diameter E7018H4R electrode implementing Caltrans approved Welding Procedure Specification (WPS) ABF-WPS-D15-1040C-CU. The joint being welded had a single V-groove butt joint with copper plate backing bar that was originally welded from the top using a combination of SMAW and Submerged Arc Welding (SAW) then removed the copper backing plate using carbon air arc gouging and ground smooth. The plates were preheated to more than 150 degree Fahrenheit using Miller Proheat 35 Induction Heating System prior welding. Welding parameters were monitored by ABF/QC William Sherwood. QA noted the working welding parameters of 128 amperes on the 3.2mm diameter E7018H4R electrode. The workmanship and appearance of the completed cover pass deemed satisfactory. During the shift, cover pass back welding on area mentioned above was partially completed.

All other related welding activities at the OBG include flush grinding of SMAW back welded splice butt joint at weld location 13W-W2.1 @10100 and 13W-PP121.2 wherein the latter was still in progress at the end of the shift.
