Contract #: 04-0120F4Cty: SF/ALA Rte: 80 PM: 13.2/13.9File #: 1.28**WELDING INSPECTION REPORT**

Report No: WIR-027814
Date Inspected: 22-Jun-2012

Project Name: SAS Superstructure
Prime Contractor: American Bridge/Fluor Enterprises, a JV
Contractor: American Bridge/Fluor Enterprises, a JV

OBG 12W

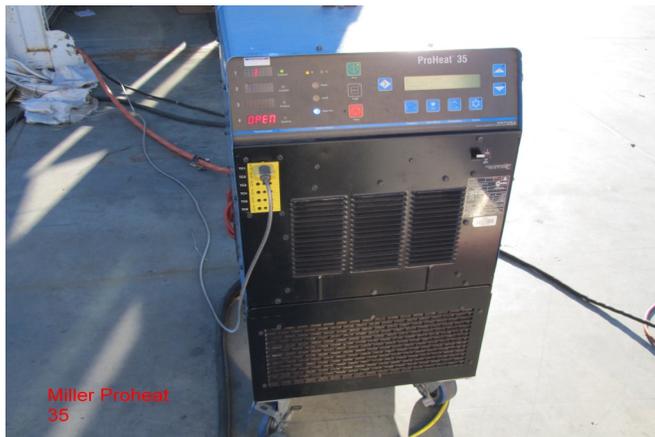
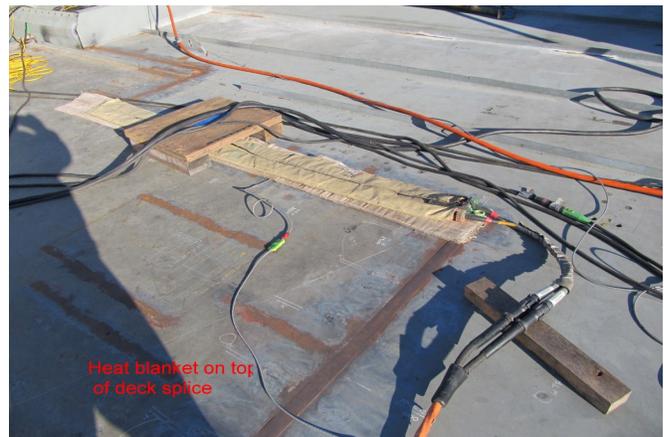
This QAI observed the welding of the back gouged back of weld 13W-14W-W2.1 by Welder Mike Jiminez in the 4G position utilizing the Shield Metal Arc Welding (SMAW) Process. E7018 consumable electrode was being used to the QC recorded QAI randomly verified parameters of Welding Procedure Specification ABF-WPS-D15-1040C-CV. The welder was using a stringer technique to fill in the back-gouge. A power wire brush and manual chipping hammer was being used to clean between passes. Welding is 75% complete on the above-mentioned weld.

QAI observed the welding of the back gouged back of weld 13W-14W-W2.3 by Welder Tran Chau (ID# 3139) utilizing the Shield Metal Arc Welding (SMAW) Process. E7018 consumable electrode was being used to the QC recorded QAI randomly verified parameters of Welding Procedure Specification ABF-WPS-D15-1040C-CV. The welder was using a stringer technique to fill in the back-gouge. A power wire brush and manual chipping hammer was being used to clean between passes. Welding is 75% complete on the above-mentioned weld.
