**DEPARTMENT OF TRANSPORTATION**

Contract #: 04-0120F4Cty: SF/ALA Rte: 80 PM: 13.2/13.9File #: 1.28**WELDING INSPECTION REPORT****Resident Engineer:** Casey, William**Address:** 333 Burma Road**City:** Oakland, CA 94607**Report No:** WIR-027863**Date Inspected:** 29-Jun-2012**Project Name:** SAS Superstructure**OSM Arrival Time:** 700**Prime Contractor:** American Bridge/Fluor Enterprises, a JV**OSM Departure Time:** 1930**Contractor:** American Bridge/Fluor Enterprises, a JV**Location:** jobsite

# WELDING INSPECTION REPORT

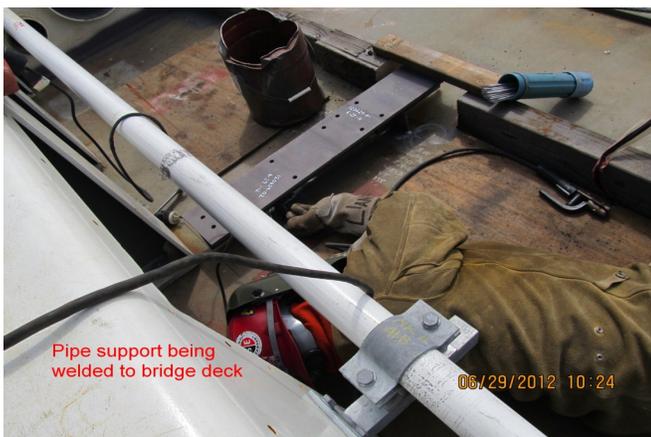
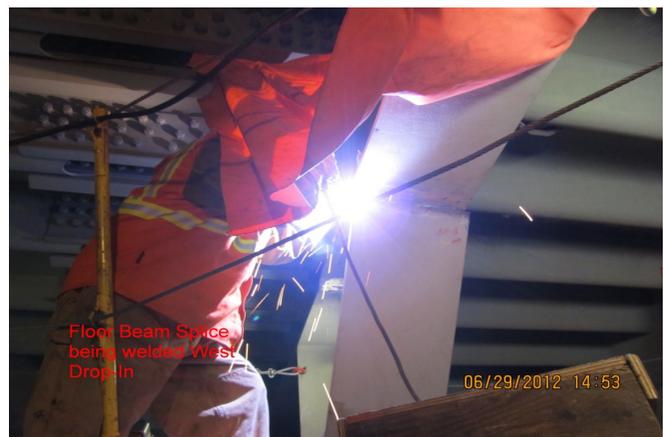
This QAI witnessed the welding of Floor Beam Splice PP123-W2.1-BF1 by welder Eddie Brown (ID#9331)utilizing the Shield Metal Arc Welding Process in the 1G/4G position using E7018 consumable electrodes to the QC recorded QA verified parameters of Welding Procedure Specification ABF-WPS-D15-1030-1. Welder Brown was depositing weld metal using the stringer technique post weld cleaning was accomplished using a chipping hammer and power wire brush.

This QAI performed a Visual Weld Inspection at the conclusion of welding operations, the Inspection revealed no weld defects. After the weld has cooled to ambient conditions for 48 hours, it will be tested using the Magnetic Particle Testing method, followed by Ultrasonic Testing to check for internal defects.
