Contract #: 04-0120F4Cty: SF/ALA Rte: 80 PM: 13.2/13.9File #: 1.28**WELDING INSPECTION REPORT**

Report No: WIR-027935
Date Inspected: 06-Jul-2012

Project Name: SAS Superstructure **OSM Arrival Time:** 700
Prime Contractor: American Bridge/Fluor Enterprises, a JV **OSM Departure Time:** 1830
Contractor: American Bridge/Fluor Enterprises, a JV **Location:** jobsite

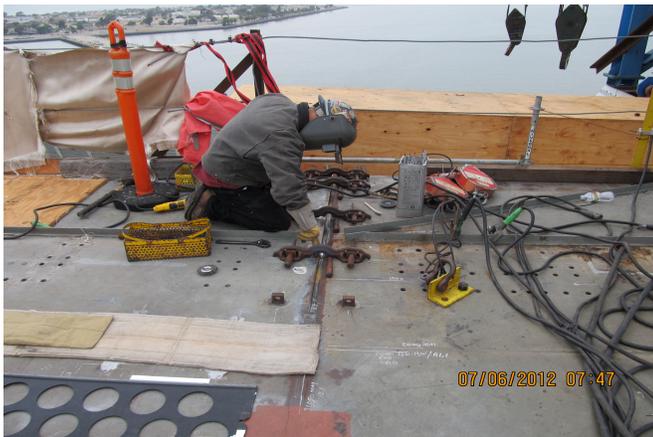
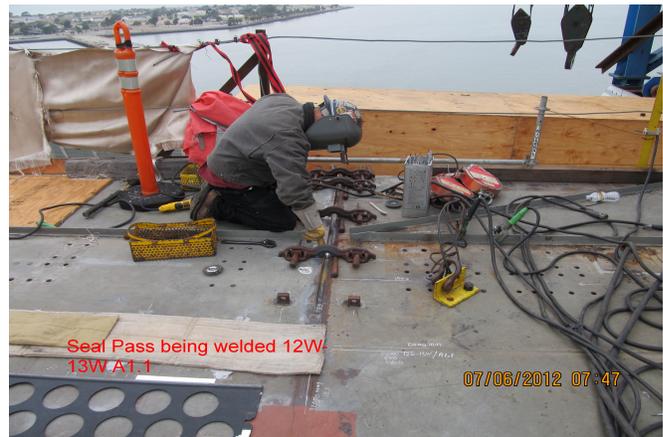
This QAI observed Welder Tran Chau using a rosebud torch to preheat floor beam splice PP124-W2.8-BW-1 to a QC recorded, QA verified temperature of 150F. Preheat temperature was measured using a Tempil Stick. This QAI noted QC Tony Sherwood recording preheat temperature whenever there was a stop in work.

QAI witnessed the welding of floor beam PP124-W2.8-BW-1 by welder Tran Chau utilizing the Shield Metal Arc Welding Process in the 3G position using E7018 consumable electrodes. The QC recorded and this QAI verified that the weld metal was being deposited to the parameters of Welding Procedure Specification ABF-WPS-D15-1100. Welder Chau was observed using the stringer method and good workmanship practices in regard to interpass cleaning.

This QAI observed Welder Steve Davis (ID#7889) using a rosebud torch to preheat floor beam splice PP122.5-W2.1-BF-1 to a QC recorded, QA verified temperature of 150F. Preheat temperature was measured using a Tempil Stick. This QAI noted QC Tony Sherwood recording preheat temperature whenever there was a stop in work.

QAI witnessed the welding of Stiffener PP122.5-W2.1-BF-1 by welder Steve Davis utilizing the Shield Metal Arc Welding Process in the 3G position using E7018 consumable electrodes. The QC recorded and this QAI verified that the weld metal was being deposited to the parameters of Welding Procedure Specification ABF-WPS-D15-1100. Welder Davis was observed using the stringer method and good workmanship practices in regard to interpass cleaning.
