Contract #: 04-0120F4Cty: SF/ALA Rte: 80 PM: 13.2/13.9File #: 1.28**WELDING INSPECTION REPORT**

Report No: WIR-028027
Date Inspected: 20-Jul-2012

Project Name: SAS Superstructure
Prime Contractor: American Bridge/Fluor Enterprises, a JV
Contractor: American Bridge/Fluor Enterprises, a JV

CWI Name:	William Sherwood	CWI Present:	Yes	No	
Inspected CWI report:	Yes No N/A	Rod Oven in Use:	Yes	No	N/A
Electrode to specification:	Yes No N/A	Weld Procedures Followed:	Yes	No	N/A
Qualified Welders:	Yes No N/A	Verified Joint Fit-up:	Yes	No	N/A
Approved Drawings:	Yes No N/A	Approved WPS:	Yes	No	N/A
		Delayed / Cancelled:	Yes	No	N/A
Bridge No:	34-0006	Component:	SAS Tower

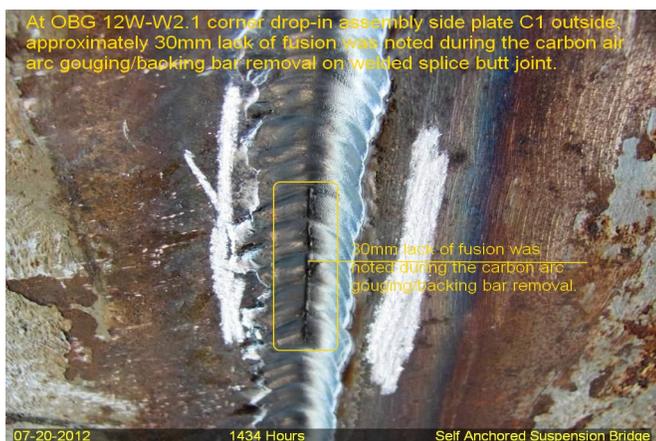
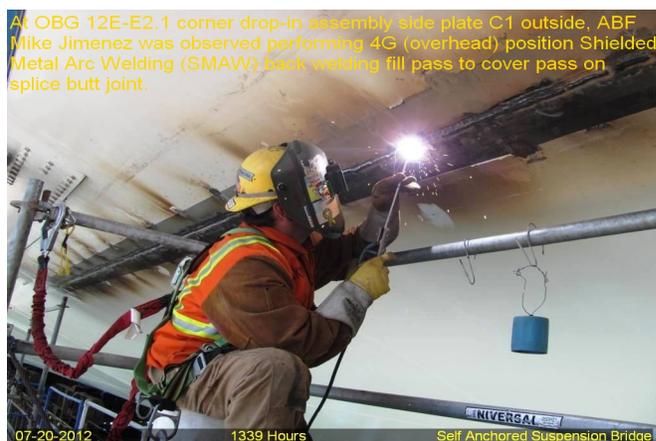
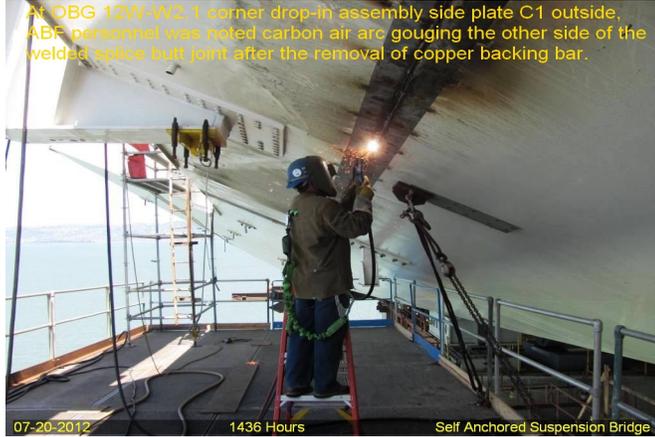
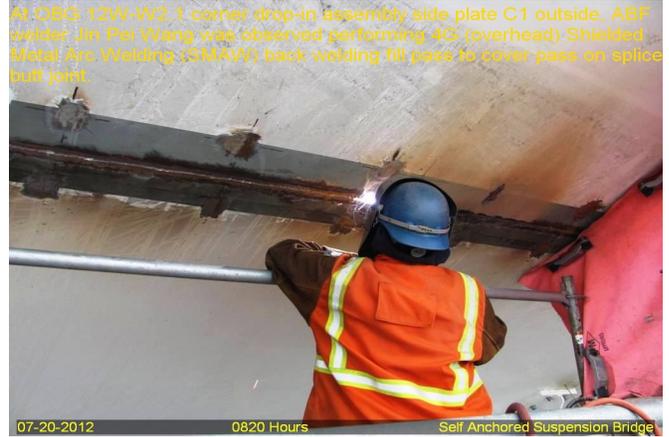
At OBG 12W-W2.1 corner drop-in side plate 'C1' outside, QA randomly observed ABF/JV qualified welder Jin Pei Wang continuing to perform CJP groove (splice) back welding fill pass to cover pass on the splice butt joint from Y=11,000mm to Y=15,000mm. The welder was observed perform manual welding in the 4G (overhead) position utilizing a Shielded Metal Arc Welding (SMAW) with 3.2mm diameter E7018H4R electrode and implementing Caltrans approved Welding Procedure Specification (WPS) ABF-WPS-D15-1040C-Cu. The joint being welded has a single V-groove butt joint with copper backing bar that has been removed back gouged and ground. During welding, ABF Quality Control (QC) William Sherwood was noted monitoring the welding parameters of the welder with measured working current of 123 amperes. At the end of the shift, cover pass welding at location mentioned above was still continuing and should remain tomorrow.

At OBG 12E/13E LS1 longitudinal stiffener inside, QA randomly observed ABF welder Todd Jackson perform 3G (vertical) Shielded Metal Arc Welding (SMAW) complete joint penetration (CJP) welding fill pass on the stiffener splice butt joint. The stiffener plates being welded are made of high strength plate material HPS 485W and has a thickness of 30mm. The joint has a double 'V' joint preparation that is being welded from one side and after the completion from one side to be back gouged; Non Destructive Testing (NDT) tested using Magnetic Particle Testing (MT) and back welded to the other side. The welder was noted using E9018H4R with 1/8" diameter electrode implementing Caltrans approved welding procedure specification (WPS) ABF-WPS-D1.

At OBG 12E-E2.1 corner drop-in side plate 'C1' outside, QA randomly observed ABF/JV qualified welder Mike Jimenez continuing to perform CJP groove (splice) back welding fill pass to cover pass on the splice butt joint from $Y=6,000\text{mm}$ to $Y=8,000\text{mm}$. The welder was observed perform manual welding in the 4G (overhead) position utilizing a Shielded Metal Arc Welding (SMAW) with 4.0mm diameter E7018H4R electrode and implementing Caltrans approved Welding Procedure Specification (WPS) ABF-WPS-D15-1040C-Cu. The joint being welded has a single V-groove butt joint with copper backing bar that has been removed back gouged and ground. During welding, ABF Quality Control (QC) William Sherwood was noted monitoring the welding parameters of the welder with measured working current of 180 amperes. At the end of the shift, cover pass welding at location mentioned above was still continuing and should remain tomorrow.

Other welding related activities noted during the shift include backing bar removal using carbon air gouging at 12E-E2.1 location $Y=20,000\text{mm}$ to $Y=23,000\text{mm}$ and 12W-W2.1 location $Y=20,000\text{mm}$ to $23,000\text{mm}$ of corner drop-in assembly top deck plates and side plate at 12W-W2.1-C1 from $Y=23,000\text{mm}$ to $Y=26,000\text{mm}$. All three back gouging/carbon arcing at respective locations were still continuing at the end of the shift and should remain tomorrow.
