DEPARTMENT OF TRANSPORTATION

Contract #: 04-0120F4Cty: SF/ALA Rte: 80 PM: 13.2/13.9File #: 1.28**WELDING INSPECTION REPORT****Resident Engineer:** Casey, William**Address:** 333 Burma Road**City:** Oakland, CA 94607**Report No:** WIR-028038**Date Inspected:** 25-Jul-2012**Project Name:** SAS Superstructure**OSM Arrival Time:** 900**Prime Contractor:** American Bridge/Fluor Enterprises, a JV**OSM Departure Time:** 1930**Contractor:** American Bridge/Fluor Enterprises, a JV**Location:** Job Site

Bridge No: 34-0006**Component:** SAS Tower**Summary of Items Observed:**

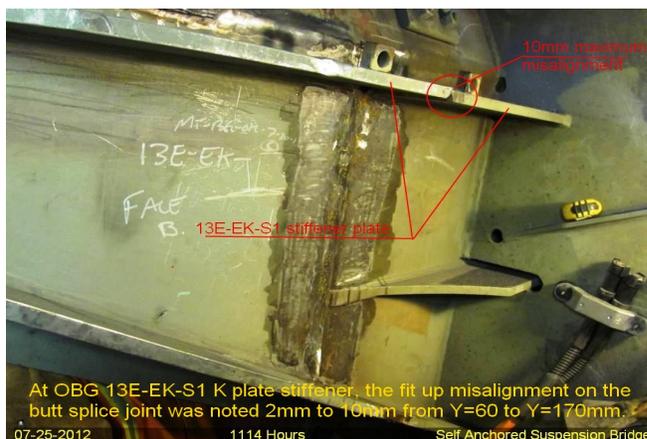
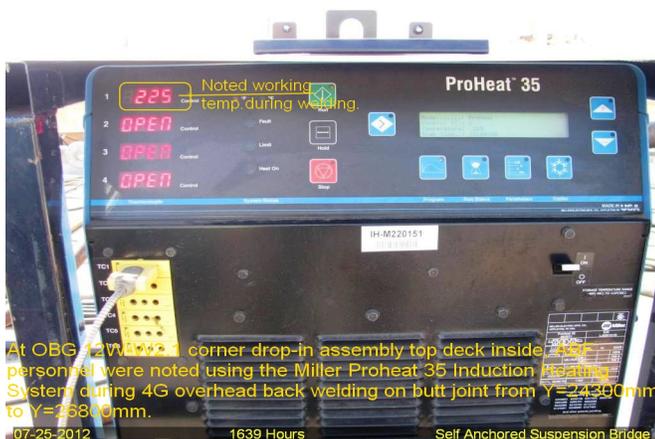
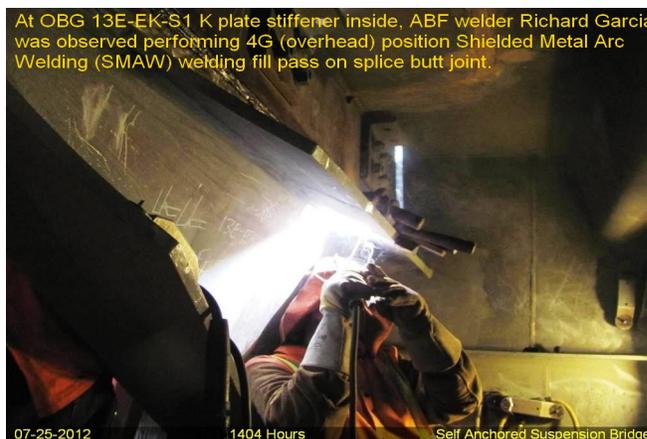
At OBG 13E-EK-S1 K plate stiffener # 1 inside, QA randomly observed ABF/JV qualified welder Richard Garcia perform fit up on the 22mm thick X 170mm wide stiffener splice butt joint. During fit up, the web where the abutting stiffeners are welded has already an offset and so the stiffener to be welded has already a built in offset which was measured 10mm. According to ABF QC Bonifacio Daquinag, he sent an e-mail with corresponding fit up report to ABF QC Manager Jim Bowers regarding this issue dated July 10, 2012. Mr. Bowers and Caltrans SMR Bajhat Dagher went and assess the situation but according to QC they never received an official response to that e-mail and fit up report. Due to the out of tolerance offset on the stiffener butt joint mentioned above, an Incident Report was generated.

After the completion of the fit up wherein an offset of 2mm to 10mm was measured from Y=60 to Y=170mm, the welder was noted perform 4G (overhead) position Shielded Metal Arc Welding (SMAW) welding root pass to fill pass on K plate stiffener S1 splice butt joint. The welder was using 3.2mm diameter E7018H4R electrode and implementing Caltrans approved Welding Procedure Specification (WPS) ABF-WPS-D15-1040A Rev. 1. The joint being welded has a single V-groove butt joint without backing bar. During the shift, ABF QC Salvador Merino was noted monitoring the welder with measured working current of 127 amperes on the 3.2mm electrode. At the end of the shift, fill pass SMAW welding was still continuing and should remain tomorrow.

At OBG 2W-PP13-W5 deck access hole outside, QA randomly observed ABF/JV qualified welder Roby Smith perform cover pass welding on the Complete Joint Penetration (CJP) butt joint. The welder was observed manually welding in the 1G (flat) position utilizing a Shielded Metal Arc Welding (SMAW) with 1/8" diameter E7018H4R electrode and implementing Caltrans approved Welding Procedure Specification (WPS)

At OBG 12W-W2.1 corner drop-in assembly top deck plate inside, QA randomly observed ABF/JV qualified welder James Zhen perform back welding on butt joint location Y=21800mm to Y=24300mm. The welder was noted welding in the 4G (overhead) position utilizing a dual shield Flux Cored Arc Welding (FCAW-G) with E71T-1M, 1/16" diameter wire electrode and implementing Caltrans approved Welding Procedure Specification (WPS) ABF-WPS-D15-3110-4. The welder was using a track mounted welder holder assembly that is remotely controlled. The joint being welded has the steel backing bar removed and gouged using carbon air arc gouging and was ground smooth. The backing bar removal was also tested using Magnetic Particle Testing (MT). The butt joint was preheated to greater than 200 degree Fahrenheit using Miller Proheat 35 Induction Heating System with the heater blanket on top of the weld joint. During welding, ABF Quality Control (QC) Steve Jensen was noted monitoring the welding parameters of the welder. The parameters measured during welding were 262 amperes, 22.5 volts with travel speed of 180 mm per minute travel speed which are deemed acceptable to contract specifications. At the end of the shift, fill pass to cover pass was still continuing and should remain tomorrow.

At OBG 12W-W2.1 corner drop-in side plate 'C1' outside, QA randomly observed ABF/JV qualified welder Jin Pei Wang continuing to perform CJP groove (splice) back welding fill pass to cover pass on the splice butt joint from Y=25,000mm to Y=28,000mm. The welder was observed perform manual welding in the 4G (overhead) position utilizing a Shielded Metal Arc Welding (SMAW) with 3.2mm diameter E7018H4R electrode and implementing Caltrans approved Welding Procedure Specification (WPS) ABF-WPS-D15-1040C-Cu. The joint being welded has a single V-groove butt joint with copper backing bar that has been removed, back gouged and ground. During welding, ABF Quality Control (QC) William Sherwood was noted monitoring the welding parameters of the welder with measured working current of 128 amperes. At the end of the shift, cover pass welding at location mentioned above was still continuing and should remain tomorrow.
