DEPARTMENT OF TRANSPORTATION

Quality Assurance and Source Inspection

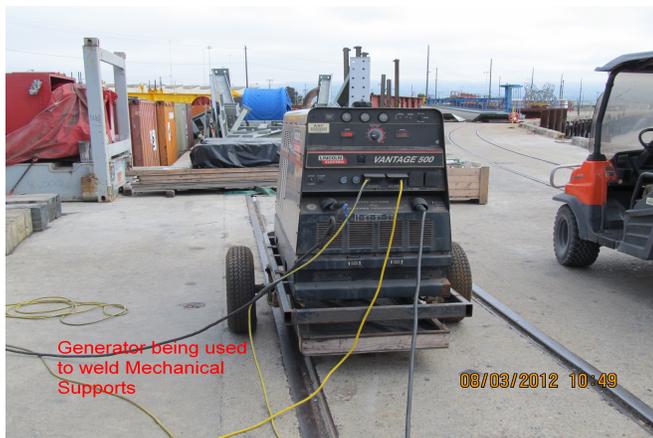
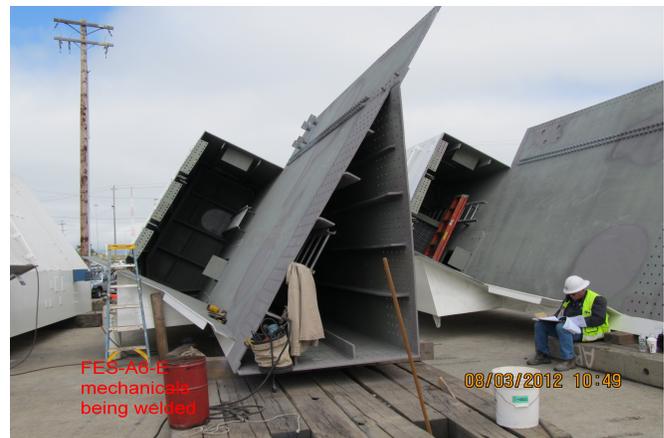
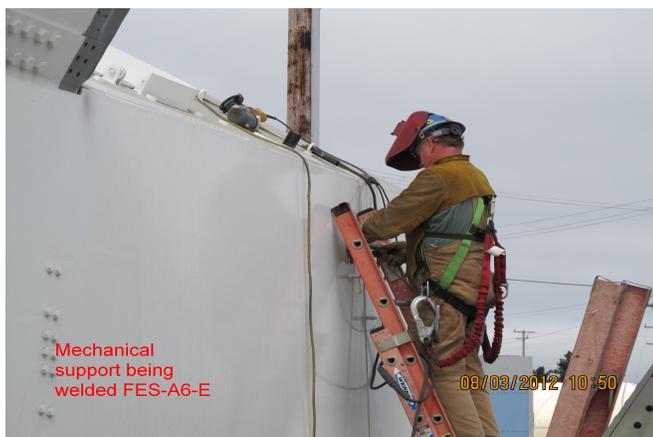
comprising assembly ESD1-TL6-2. The fitting and tacking was being performed by qualified welder Kevin Kananen utilizing the Shield Metal Arc Welding Process to the parameters set forth in approved Welding Procedure Specification ABF-WPS-D15-F1200-A. Tacking parameters were recorded at standard intervals by QC Technician Fred Michels and verified at random intervals throughout the shift by this QAI.

QAI observed the welding of PPE pipe supports in FES-A6-1N one of the four subassemblies comprising assembly ESD1-TL6-2. The welding was being performed by qualified welder Kevin Kananen utilizing the Shield Metal Arc Welding Process to the parameters set forth in approved Welding Procedure Specification ABF-WPS-D15-F1200-A. Welding parameters were recorded at standard intervals by QC Technician Fred Michels and verified at random intervals throughout the shift by this QAI.
