Contract #: 04-0120F4Cty: SF/ALA Rte: 80 PM: 13.2/13.9File #: 1.28**WELDING INSPECTION REPORT**

Report No: WIR-028154
Date Inspected: 12-Aug-2012

Project Name: SAS Superstructure
Prime Contractor: American Bridge/Fluor Enterprises, a JV
Contractor: American Bridge/Fluor Enterprises, a JV

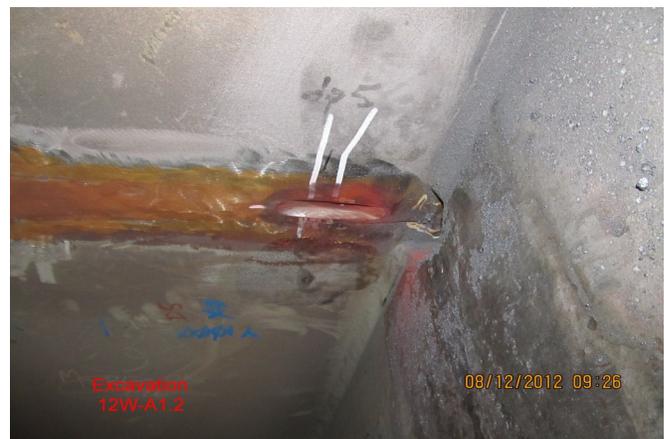
Due to the contractor choosing to weld prior to getting engineer approval for the poor fit up an Incident Report was issued on the above-mentioned welded splice. At the time of this report the joint exhibited a 3mm to 5mm offset with a maximum root opening of 20mm.

The QA inspector periodically observed the in process Shield Metal Arc Welding being performed by ABF welding personnel Jim Quan Huang (9340) on 13W/14W Plate G vertical splice. The welder spent the shift depositing the root passes and fill passes with approximately 20% being completed at the end of the shift. QC inspector Fred Michels was noted to be present in order to monitor the progress and ensure the welding was within the established Welding Procedure Specification (WPS) noted as ABF-WPS-D15-1040-C and supporting Procedure Qualification Records (PQR). Prior to initiating the welding at this location the QC inspector observed

the preheat temperature using a Raytek non-contact Thermometer was sufficient and compliant to the above-mentioned WPS. Using a Tempil Stick (temperature indicating crayon) the preheat and interpass temperature was then verified by this QA inspector to be greater than 150F and the parameters using a Fluke brand Tong style meter was verified to be 174 amps. See digital photo included in the body of this report for general information.

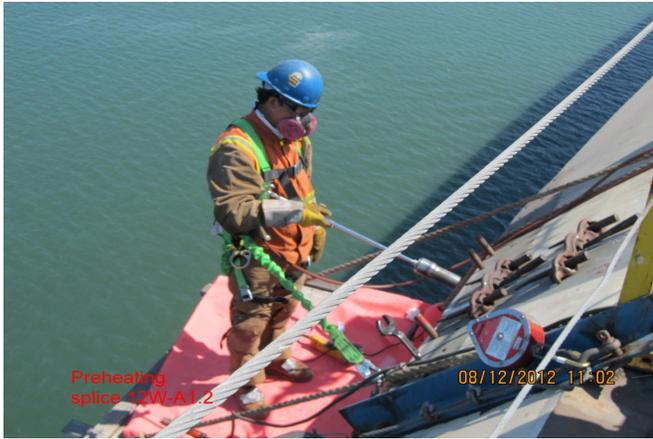
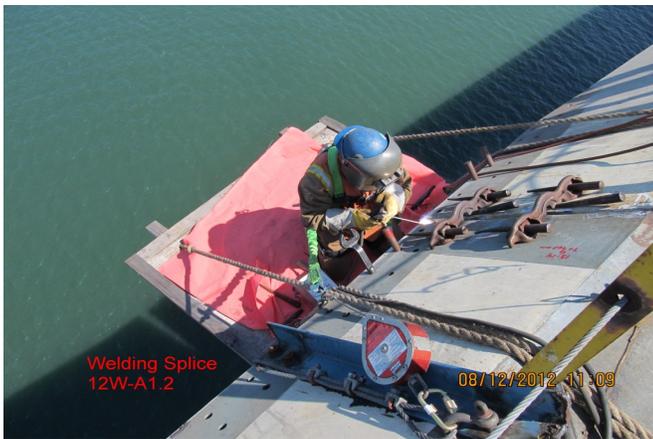
Weld Repairs 12W-A1.2

The QA inspector periodically observed the start and in process Shield Metal Arc Welding being performed by ABF welding personnel Roby Smith on the following repairs to Deck Splice 12W-A1.2:

Y= 470mm-580mm, L=150mm, W=40mm, D=11mm

Y=1000mm-1023mm, L=23mm, W=20mm, D=7mm

The welder spent the shift depositing the root passes and fill passes with approximately 60% being completed at the end of the shift. QC inspector Chris Concha was noted to be present in order to monitor the progress and ensure the welding was within the established Welding Procedure Specification (WPS) noted as ABF-WPS-D15-1110-A and supporting Procedure Qualification Records (PQR). Prior to initiating the welding at this location the QC inspector observed the preheat temperature using a Raytek non-contact Thermometer was sufficient and compliant to the above-mentioned WPS. Using a Tempil Stick (temperature indicating crayon) the preheat and interpass temperature was then verified by this QA inspector to be greater than 250F and the parameters using a Fluke brand Tong style meter was verified to be 170 amps. The work progressed throughout the shift and appeared to be in general conformance with the contract documents. See digital photo included in the body of this report for general information.
