Contract #: 04-0120F4Cty: SF/ALA Rte: 80 PM: 13.2/13.9File #: 1.28**WELDING INSPECTION REPORT****Resident Engineer:** Casey, William**Address:** 333 Burma Road**City:** Oakland, CA 94607**Report No:** WIR-028189**Date Inspected:** 14-Aug-2012**Project Name:** SAS Superstructure**OSM Arrival Time:** 700**Prime Contractor:** American Bridge/Fluor Enterprises, a JV**OSM Departure Time:** 1930**Contractor:** American Bridge/Fluor Enterprises, a JV**Location:** S.A.S. Job site**CWI Name:** Listed below**CWI Present:** Yes No**Inspected CWI report:** Yes No N/A**Rod Oven in Use:** Yes No N/A**Electrode to specification:** Yes No N/A**Weld Procedures Followed:** Yes No N/A**Qualified Welders:** Yes No N/A**Verified Joint Fit-up:** Yes No N/A**Approved Drawings:** Yes No N/A**Approved WPS:** Yes No N/A**Delayed / Cancelled:** Yes No N/A**Bridge No:** 34-0006**Component:** S.A.S. Structure**Summary of Items Observed:**

WELDING INSPECTION REPORT

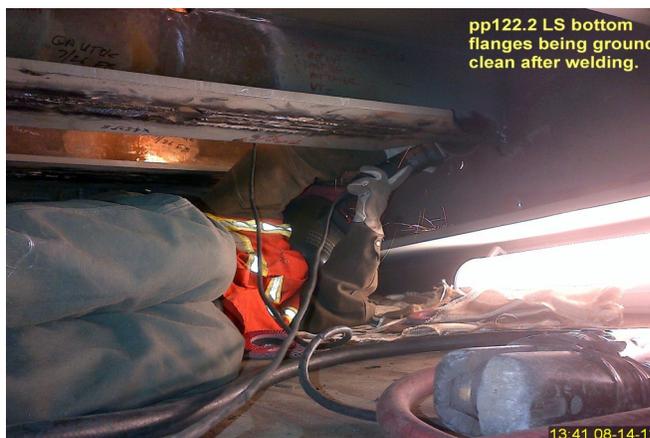
The QAI observed additional welding of longitudinal stiffener flanges at 13W/14W field splice, stiffener #3 and #2. The QAI observed welder Xiao Jian Wan, ID 9677, making 4G PJP stiffener welds. The QAI noted that the QCI William Sherwood is also monitoring this welding. Through-out the work shift, the QAI made random observations of the welding. During these observations, the preheat, interpass temperature and welding current was verified. The QAI noted that the welding observed was within the ranges listed on the WPS. This work was in progress at the end of the shift. See the attached photo.
