DEPARTMENT OF TRANSPORTATION

Quality Assurance and Source Inspection

Contract #: 04-0120F4Cty: SF/ALA Rte: 80 PM: 13.2/13.9File #: 1.28**WELDING INSPECTION REPORT****Resident Engineer:** Casey, William**Address:** 333 Burma Road**City:** Oakland, CA 94607**Report No:** WIR-028306**Date Inspected:** 31-Aug-2012**Project Name:** SAS Superstructure**OSM Arrival Time:** 700**Prime Contractor:** American Bridge/Fluor Enterprises, a JV**OSM Departure Time:** 1530**Contractor:** American Bridge/Fluor Enterprises, a JV**Location:** Job Site**CWI Name:** Barry Drake**CWI Present:** Yes No**Inspected CWI report:** Yes No N/A**Rod Oven in Use:** Yes No N/A**Electrode to specification:** Yes No N/A**Weld Procedures Followed:** Yes No N/A**Qualified Welders:** Yes No N/A**Verified Joint Fit-up:** Yes No N/A**Approved Drawings:** Yes No N/A**Approved WPS:** Yes No N/A**Delayed / Cancelled:** Yes No N/A**Bridge No:** 34-0006**Component:** SAS OBG**Summary of Items Observed:**

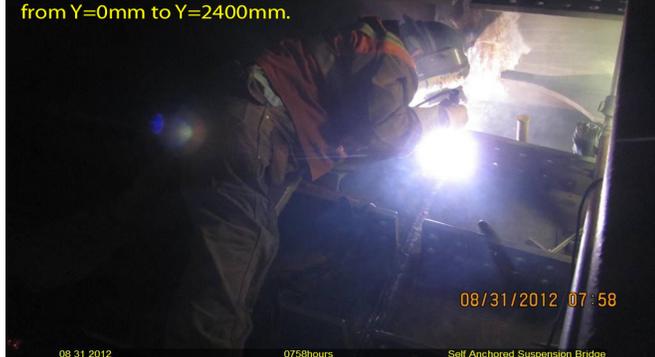
At OBG 12W/13W side plate C1.1 inside, ABF welder Mike Jimenez was observed performing 3G (overhead) position Shielded Metal Arc Welding (SMAW) welding repair on welded splice butt joint from Y=0mm to Y=2400mm.

At OBG 12W/13W side plate C1.1 inside, QA randomly observed ABF/JV qualified welder Mike Jimenez continuing to perform CJP groove welding repair on a Seismic Performance Critical Member (SPCM) welded splice butt joint from Y=0mm to Y=2400mm per Caltrans approved Request for Weld Repair (RWR) # 201208-093. ABF personnel were noted using the Miller Proheat 35 Induction Heating System to preheat and maintain the required temperature of 325°F during welding. ABF welder Mike Jimenez was observed performing 3G (vertical) position utilizing Shielded Metal Arc Welding (SMAW) welding repair on welded splice butt joint. The welder was noted using 4.0mm E7018H4R electrode implementing Caltrans approved welding procedure ABF-WPS-D15-1004 Repair. ABF QC Barry Drake was also noted monitoring the welder with measured working current of 180 amperes. With the absence of ABF welder Rick Clayborn, Mike Jimenez continued 3G SMAW repair welding by himself till the end of shift wherein he was not able to complete the repair. The welder held the preheat of 450°F for one hour after welding as required. Repair welding will continue.

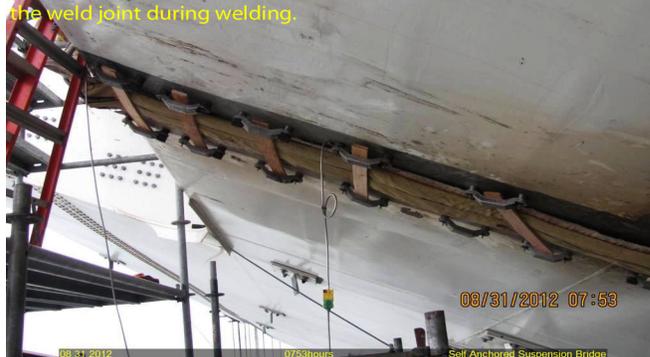
At OBG 12W/13W side plate C1.1 outside, ABF personnel were noted using the Miller Proheat 35 Induction Heating System to preheat, maintain and PWHT with the heater blanket put in place outside the weld joint during welding.

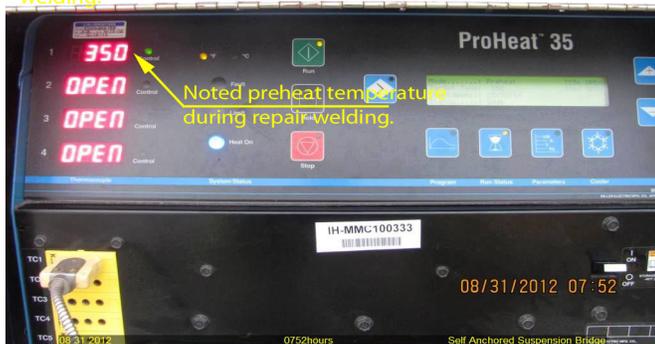
At OBG 12W/13W side plate C1.1 inside, ABF personnel were noted using Miller Proheat 35 Induction Heating System to preheat, maintain and Post Weld Heat Treatment (PWHT) the repair during welding.
