**DEPARTMENT OF TRANSPORTATION**

Contract #: 04-0120F4Cty: SF/ALA Rte: 80 PM: 13.2/13.9File #: 1.28**WELDING INSPECTION REPORT****Resident Engineer:** Casey, William**Address:** 333 Burma Road**City:** Oakland, CA 94607**Report No:** WIR-028456**Date Inspected:** 20-Sep-2012**Project Name:** SAS Superstructure**OSM Arrival Time:** 700**Prime Contractor:** American Bridge/Fluor Enterprises, a JV**OSM Departure Time:** 1930**Contractor:** American Bridge/Fluor Enterprises, a JV**Location:** Job Site

**Summary of Items Observed:**

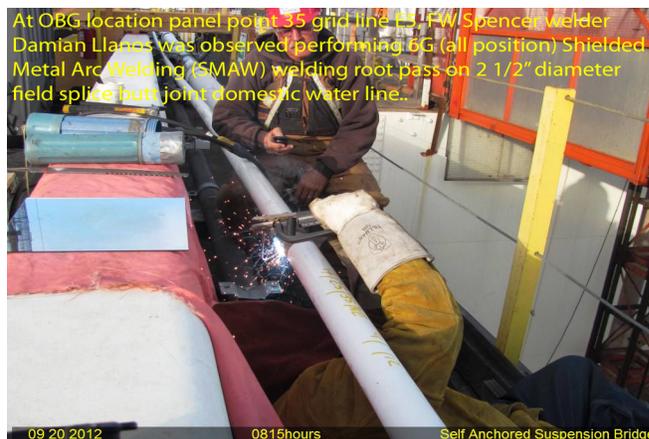
At OBG 6E location Panel Point PP31 to PP35 grid line E5, this QA randomly observed FW Spencer qualified welder Damian Llanos continuing to perform Complete Joint Penetration (CJP) 6G (all position) Shielded Metal Arc Welding (SMAW) welding root pass to cover pass on the field splice butt joint of 2.5" and 4" domestic water and compressed air lines respectively. The system lines being welded are field weld joints along the grid line of E5 of the OBG. The welder was noted welding the root pass with 3/32" diameter E6010 electrode and followed by fill pass to cover pass using 3/32" diameter E7018H4R electrode implementing Caltrans approved procedure FW Spencer WPS 1-12-1. The welder was noted preheating and removing the moisture of the joint using a portable propane gas torch prior welding. During welding, ABF QC Steve Jensen was noted monitoring the parameters of the welder. At the end of the shift, the welder has completed the welding of the splice butt joints at the following;

1. Domestic Water 2 1/2" 31 Northeast 15/2.5/31/NE
2. Compressed Air 4" 35 Northeast 17/4/35/NE

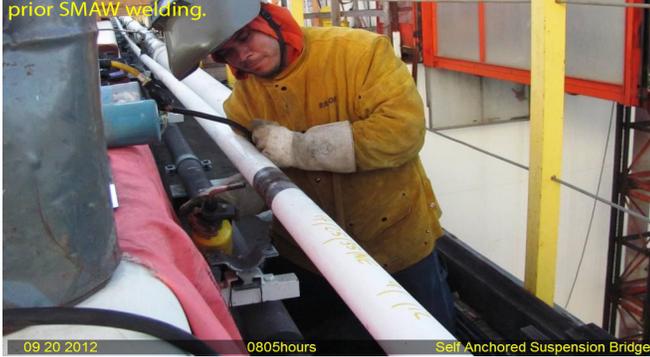
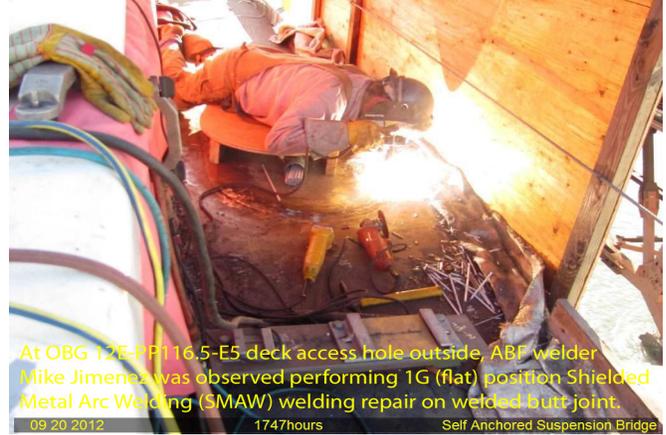
At OBG location panel point 25 grid line C5, FW Spencer welder Damian Dlanos was noted preheating the 2 1/2" diameter domestic water line (DW) splice butt joint using portable propylene gas torch prior SMAW welding.
