DEPARTMENT OF TRANSPORTATION

Contract #: 04-0120F4Cty: SF/ALA Rte: 80 PM: 13.2/13.9File #: 1.28**WELDING INSPECTION REPORT****Resident Engineer:** Casey, William**Address:** 333 Burma Road**City:** Oakland, CA 94607**Report No:** WIR-028697**Date Inspected:** 01-Nov-2012**Project Name:** SAS Superstructure**OSM Arrival Time:** 700**Prime Contractor:** American Bridge/Fluor Enterprises, a JV**OSM Departure Time:** 1730**Contractor:** American Bridge/Fluor Enterprises, a JV**Location:** Job Site

WELDING INSPECTION REPORT

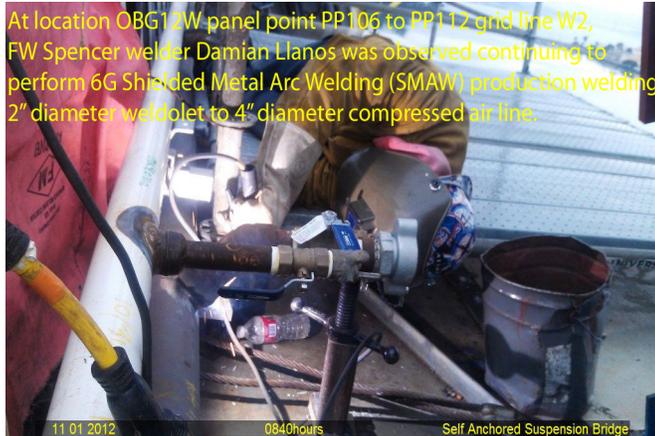
At location OBG12W panel point PP106 to PP112 grid line W2, FW Spencer welder Damian Llanos was observed continuing to perform 6G Shielded Metal Arc Welding (SMAW) production welding 2" diameter weldolet to 4" diameter compressed air line.

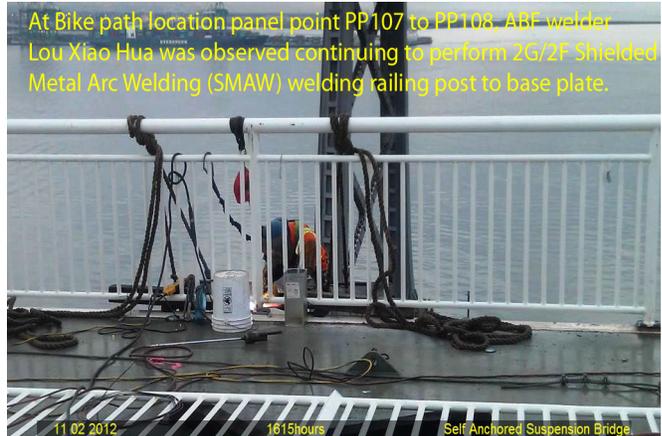
At Bike path location panel point PP107 to PP108, ABF welder Lou Xiao Hua was observed continuing to perform 2G/2F Shielded Metal Arc Welding (SMAW) welding railing post to base plate.

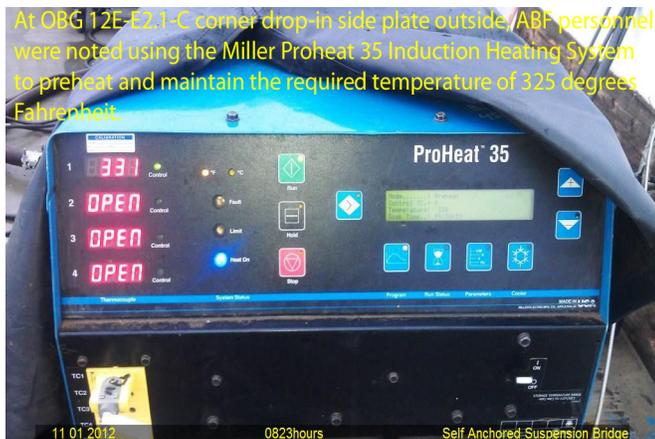
At OBG 12E-E2.1-C corner drop-in side plate outside, ABF personnel were noted using the Miller Proheat 35 Induction Heating System to preheat and maintain the required temperature of 325 degrees Fahrenheit.

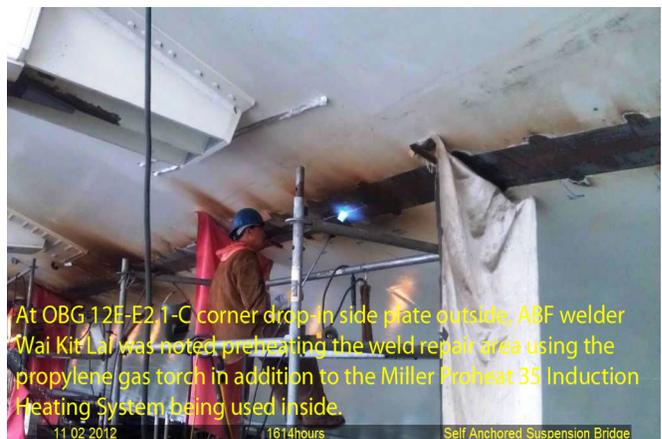
At OBG 12E-E2.1-C corner drop-in side plate outside, ABF welder Wai Kit Lai was noted preheating the weld repair area using the propylene gas torch in addition to the Miller Proheat 35 Induction Heating System being used inside.
