Contract #: 04-0120F4Cty: SF/ALA Rte: 80 PM: 13.2/13.9File #: 74.28**WELDING INSPECTION REPORT****Resident Engineer:** Casey, William**Address:** 333 Burma Road**City:** Oakland, CA 94607**Report No:** WIR-028727**Date Inspected:** 09-Nov-2012**Project Name:** SAS Superstructure**OSM Arrival Time:** 530**Prime Contractor:** American Bridge/Fluor Enterprises, a JV**OSM Departure Time:** 1600**Contractor:** Goodwin Steel, UK**Location:** Stoke-On-Trent, UK**CWI Name:****CWI Present:**

Bridge No: 34-0006**Component:** Type B16 Supplemental Cable Bands after pro**Summary of Items Observed:**

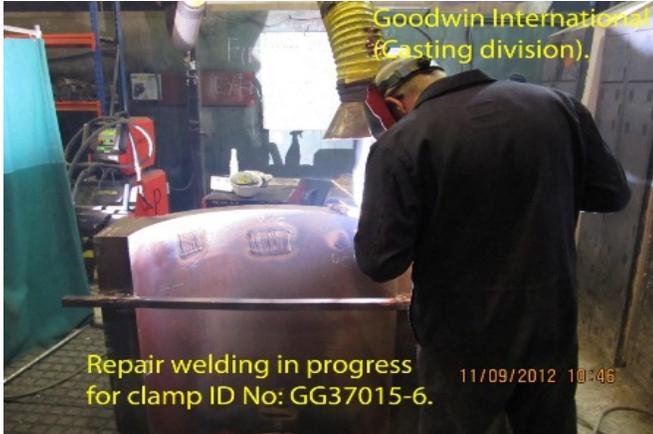
Repair welding is in progress for Clamp ID No: GG37015-6. Welder was identified as Mr. Witold Kaminski and the welding process was identified as Shielded Metal Arc Welding (SMAW). Welding was observed to be done in 1G position. Welding was done as per welding procedure specification (WPS): WPS04-0120F4A Issue-5.

This QA Inspector observed that the pre-heating and interpass temperature was maintained as per WPS requirement; while the welding was in progress. Also proper interpass cleaning followed by interpass visual inspection was done before depositing the following run. See attached photo for details.
