**DEPARTMENT OF TRANSPORTATION**

Contract #: 04-0120F4Cty: SF/ALA Rte: 80 PM: 13.2/13.9File #: 1.28**WELDING INSPECTION REPORT****Resident Engineer:** Casey, William**Address:** 333 Burma Road**City:** Oakland, CA 94607**Report No:** WIR-028852**Date Inspected:** 11-Dec-2012**Project Name:** SAS Superstructure**OSM Arrival Time:** 700**Prime Contractor:** American Bridge/Fluor Enterprises, a JV**OSM Departure Time:** 1730**Contractor:** American Bridge/Fluor Enterprises, a JV**Location:** Job Site**CWI Name:** Jesse Cayabyab**CWI Present:** Yes No**Inspected CWI report:** Yes No N/A**Rod Oven in Use:** Yes No N/A**Electrode to specification:** Yes No N/A**Weld Procedures Followed:** Yes No N/A**Qualified Welders:** Yes No N/A**Verified Joint Fit-up:** Yes No N/A**Approved Drawings:** Yes No N/A**Approved WPS:** Yes No N/A**Delayed / Cancelled:** Yes No N/A**Bridge No:** 34-0006**Component:** SAS Tower**Summary of Items Observed:**

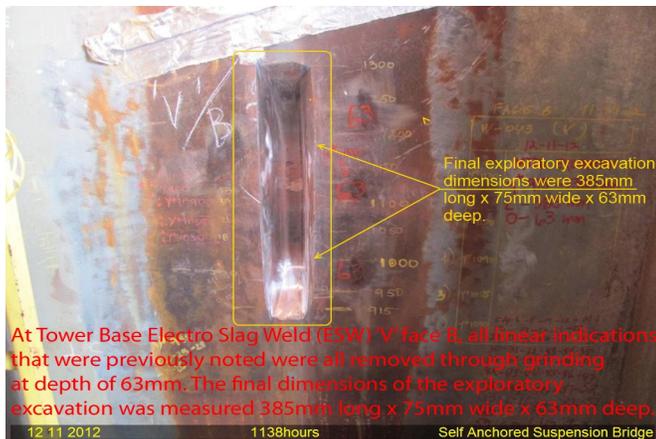
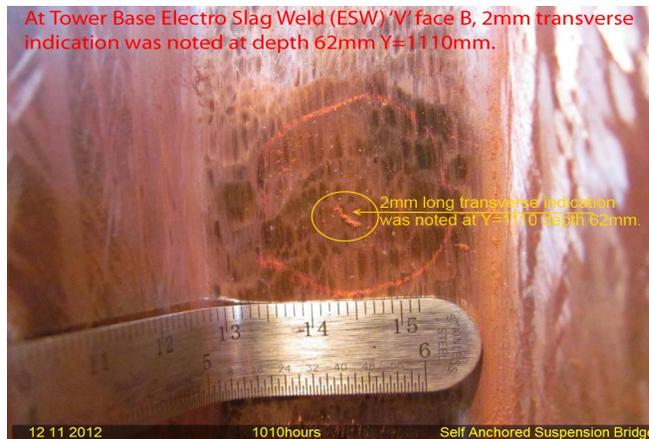
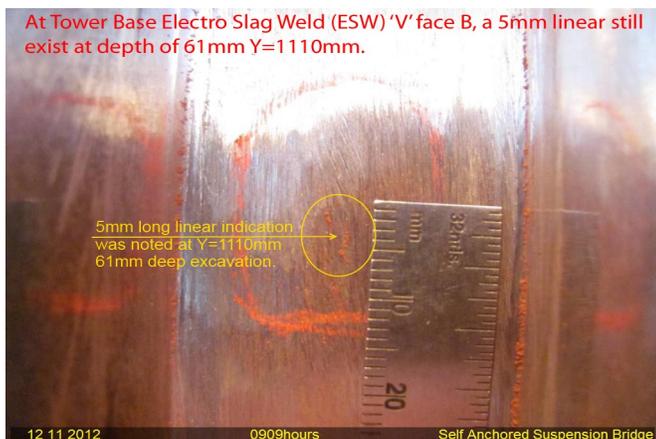
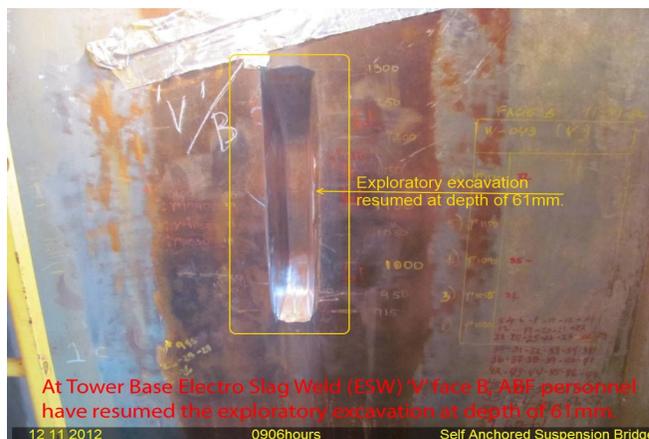
At Tower Base Electro Slag Weld (ESW) 'V' weld joint #W-043 face B, ABF personnel was observed continuing to perform exploratory excavation on welded ESW at various Y locations; Y=1030mm, Y=1055mm, Y=1090mm, Y=1100mm and Y=1130mm due to UT detected defects. The ABF personnel have resumed the exploratory excavation from 60mm deep where they left off Monday. The personnel were noted using only the disc grinder in every 1mm increments of excavation. ABF QC Jesse Cayabyab was observed performing Magnetic Particle Testing (MT) on the following various depths with various indications noted mentioned below. This QA also performed the same test and noted same result. During the shift, the ABF personnel continued the excavation in 1mm increments using the same method of test and verification up to 63mm with indications as noted below. The shift was completed up to this depth of excavation.

1. 61mm in depth -5mm linear indication noted @y=1110mm, X=0.
2. 62mm in depth -2mm transverse indication noted @y=1110mm, X=0.
3. 63mm in depth -no significant indication noted. All previously noted indications have been removed.

The exploratory excavations at this location have stopped with final excavation profile of 385mm long x 75mm wide x 75mm deep. ABF QC and other personnel were told that the next exploratory excavation will be at ESW 'T'.
