**DEPARTMENT OF TRANSPORTATION**

Contract #: 04-0120F4Cty: SF/ALA Rte: 80 PM: 13.2/13.9File #: 1.28**WELDING INSPECTION REPORT****Resident Engineer:** Casey, William**Address:** 333 Burma Road**City:** Oakland, CA 94607**Report No:** WIR-029052**Date Inspected:** 30-Jan-2013**Project Name:** SAS Superstructure**OSM Arrival Time:** 700**Prime Contractor:** American Bridge/Fluor Enterprises, a JV**OSM Departure Time:** 1530**Contractor:** American Bridge/Fluor Enterprises, a JV**Location:** USA Hoist, Crest Hill, IL

**Bridge No:** 34-0006**Component:** SAS Tower Elevator**Summary of Items Observed:**

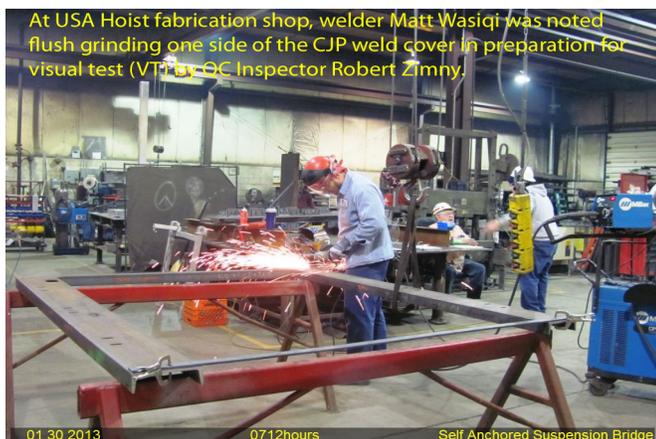
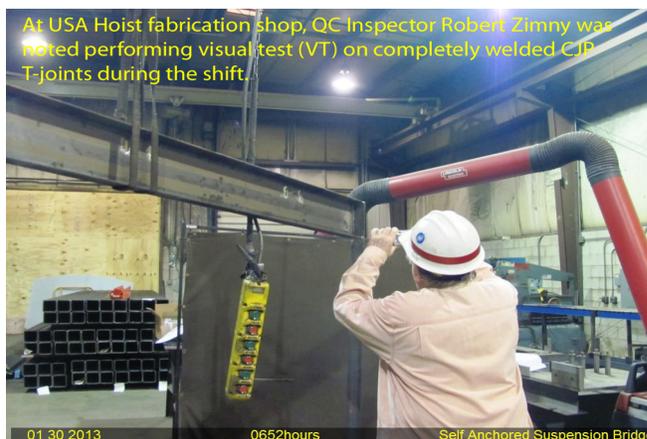
Today at USA Hoist fabrication shop, this QA met with Mr. Robert Zimny the Quality Control Inspector. Mr. Zimny was noted performing after the fact visual test (VT) on welded CJP T-joints between the C channels C200 x 20.5/C180 x 18.2 to angular 6.4 x 6.4 x 9.5 intended for elevator door enclosure frames stops 1 thru 6. But prior to the VT of the welded T-joints by Mr. Zimny, USA Hoist welder Matt Wasiqi performed flush grinding on one side of the joint then wire brushed the other side to all six door enclosure frames. Mr. Wasiqi flush ground one door enclosure frame at a time and let QAI Robert Zimny perform the VT of the joints as he finishes grinding. QAI Robert Zimny occasionally requested this QA to perform the VT verification on welded joints after finishing his VT. This was done to all six door enclosure frames. During the shift, QAI Robert Zimny also randomly performed Penetrant Testing (PT) on the flush ground surface of the welded joints which he found them acceptable. This QA found all six door enclosure frames for stops 1 thru 6 deemed visually acceptable to the requirements of the project.

At USA Hoist fabrication shop, Mr. Genaro Ulloa was noted cutting to size formed channel 3/16" x 3 5/8" x 4". Mr. Genaro Ulloa was noted using the Marvel Vertical Band Saw in cutting the formed channel to the required length. During the shift, Mr. Ulloa has completed cutting four (4) pieces of formed channel 3/16" x 3 5/8" x 4" x 70 5/8" long with mark part number of 916001 that are intended for side bottom door channel and four pieces of formed channel 3/16" x 3 5/8" x 4" x 38 3/4" long with mark part number of 916005 that are intended for bottom

At the same shop, Mr. Matt Wasiqi was also noted cutting to size channel C4 x 5.4. Mr. Wasiqi was noted using the Marvel Vertical Band Saw in cutting the channel to the required length. During the shift, Mr. Wasiqi has completed cutting two (2) pieces of channel C4 x 5.4 x 54 1/2" long with mark part number 916006 that are intended for top and bottom channel and one (1) piece of channel C4 x 5.4 x 22 5/16" long with mark part number 916023 that is intended for top panel side angle brace of the elevator cab frame.

This QA received mill certification from Tim Moran of USA Hoist. After a review of the material and the supporting documentation the QA Inspector signed the mill certification report for the following material: Two pieces C channel 4 x 5.4 ASTM A36/A36M-08, from Nucor Corporation with heat #DL-12105738. After reviewing this provided documentation, this QA performed random visual identification of this material listed above to ensure it was acceptable for use. This QA observed the heat number on the MTR appeared to match the heat number tagged to the material. This QA observed the documentation and visual verification of the material appeared to be in general compliance with the approved project drawings listed material for the Cab Frame. This QA signed on the MTR "OK-TO-CUT" and assigned a Caltrans lot number B231-001-13 for tracking purposes. Material was properly staged inside the shop facility and heat number was transferred to the individual pieces using a marker.
