Contract #: 04-0120F4Cty: SF/ALA Rte: 80 PM: 13.2/13.9File #: 99.28**WELDING INSPECTION REPORT****Resident Engineer:** Casey, William**Address:** 333 Burma Road**City:** Oakland, CA 94607**Report No:** WIR-029149**Date Inspected:** 15-Feb-2013**Project Name:** SAS Superstructure**OSM Arrival Time:** 700**Prime Contractor:** American Bridge/Fluor Enterprises, a JV**OSM Departure Time:** 1530**Contractor:** USA Hoist**Location:** USA Hoist, Crest Hill, IL

Bridge No: 34-0006**Component:** SAS Tower Elevator**Summary of Items Observed:**

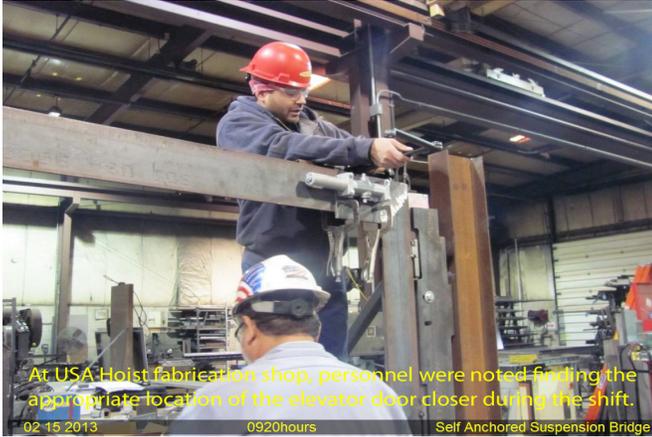
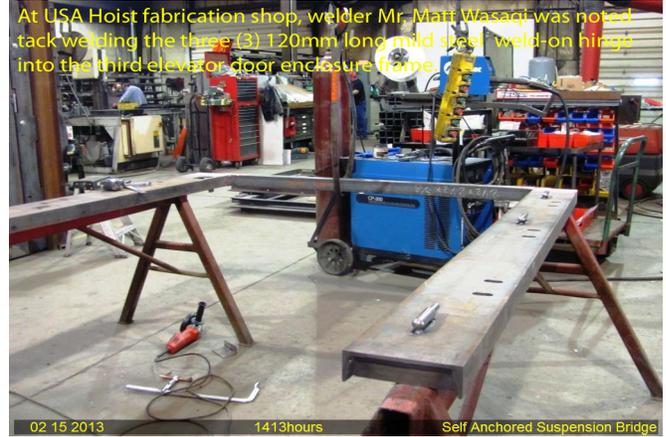
At USA Hoist fabrication shop, welding foreman Genaro Ulloa together with another welder Matt Wasaqi were noted trial fitting the Norton Parallel Rigid Arm Door Closer door assembly for elevator door stops 1, 4 and 5. Since the second door assembly for door stops 1, 4 & 5 was completed, USA Hoist personnel did not disassemble the door assembly but instead worked on the same assembly and located the appropriate location for the door closer. The personnel were noted trial fitting the door closer on many locations before they finally found one. According to Mr. Genaro Ulloa, he will show this tentative location of the door closer to Mr. Bob Overbeek and then if he is satisfied he will take the measurements and make a template for all six (6) elevator door closer. Mr. Bob Overbeek was not able to check the trial fit up of the door closer today.

While waiting for Mr. Bob Overbeek, USA Hoist welder Matt Wasaqi performed tack welding of the three (3) 120mm long mild steel weld-on hinge on the third door assembly for elevator door stops 1, 4 & 5. The welder was noted using the gas shielded Flux Cored Arc Welding (FCAW-G) during the tack welding. After tack welding the three weld-on hinges, Mr. Genaro took the measurements from the tack welded hinges and transferred them to the door frame. The shift was completed after transferring the hinge measurements.
