**DEPARTMENT OF TRANSPORTATION**

Contract #: 04-0120F4Cty: SF/ALA Rte: 80 PM: 13.2/13.9File #: 1.28**WELDING INSPECTION REPORT****Resident Engineer:** Casey, William**Address:** 333 Burma Road**City:** Oakland, CA 94607**Report No:** WIR-029156**Date Inspected:** 15-Feb-2013**Project Name:** SAS Superstructure**OSM Arrival Time:** 700**Prime Contractor:** American Bridge/Fluor Enterprises, a JV**OSM Departure Time:** 1730**Contractor:** American Bridge/Fluor Enterprises, a JV**Location:** Job Site**CWI Name:** As noted below**CWI Present:** Yes No**Inspected CWI report:** Yes No N/A**Rod Oven in Use:** Yes No N/A**Electrode to specification:** Yes No N/A**Weld Procedures Followed:** Yes No N/A**Qualified Welders:** Yes No N/A**Verified Joint Fit-up:** Yes No N/A**Approved Drawings:** Yes No N/A**Approved WPS:** Yes No N/A**Delayed / Cancelled:** Yes No N/A**Bridge No:** 34-0006**Component:** SAS OBG**Summary of Items Observed:**

# WELDING INSPECTION REPORT

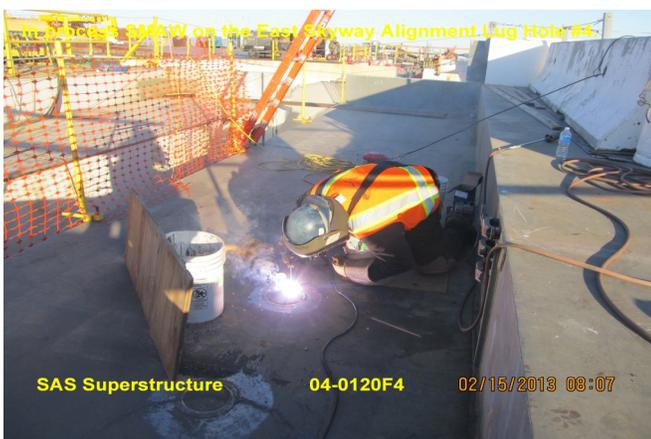
ABF welder Wai Kit Lai #2953 was observed Carbon Arc Gouging (CAG) from the root side of the weld on ALH East #1. The welder was observed grinding past the root to clean shiny metal. QC Inspector Salvador Merino performed a Magnetic Particle (MT) inspection of the back gouge to ensure soundness of the metal. Upon approval the welder began performing the SMAW process in the 4G overhead position drawing 132 Amps in conformance with ABF-WPS-D1.5-1110A-CU. This QA Inspector made subsequent observations throughout the shift to monitor quality and noted that the work was in progress and appeared to be in general conformance with the contract documents.
