Contract #: 04-0120F4Cty: SF/ALA Rte: 80 PM: 13.2/13.9File #: 1.28**WELDING INSPECTION REPORT****Resident Engineer:** Casey, William**Address:** 333 Burma Road**City:** Oakland, CA 94607**Report No:** WIR-029197**Date Inspected:** 01-Mar-2013**Project Name:** SAS Superstructure**OSM Arrival Time:** 700**Prime Contractor:** American Bridge/Fluor Enterprises, a JV**OSM Departure Time:** 1530**Contractor:** American Bridge/Fluor Enterprises, a JV**Location:** Job Site**CWI Name:** Fred Michels**CWI Present:** Yes No**Inspected CWI report:** Yes No N/A**Rod Oven in Use:** Yes No N/A**Electrode to specification:** Yes No N/A**Weld Procedures Followed:** Yes No N/A**Qualified Welders:** Yes No N/A**Verified Joint Fit-up:** Yes No N/A**Approved Drawings:** Yes No N/A**Approved WPS:** Yes No N/A**Delayed / Cancelled:** Yes No N/A**Bridge No:** 34-0006**Component:** SAS OBG**Summary of Items Observed:**

WELDING INSPECTION REPORT

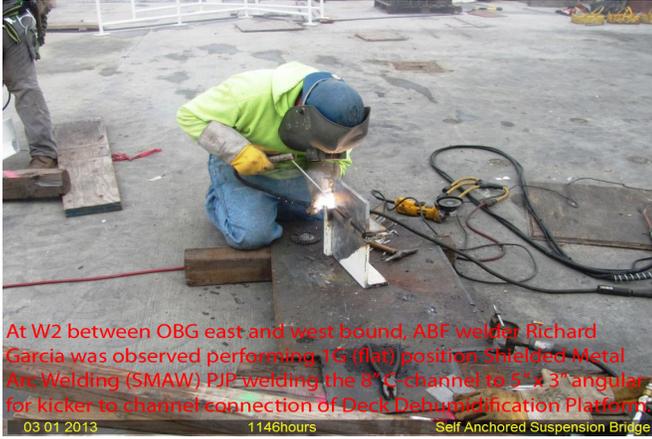
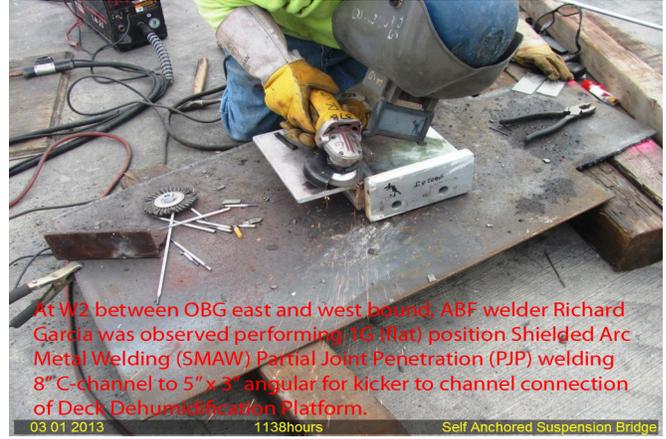
At the W2 Bent Cap, located at west end between the east and west bound OBG, this QA randomly observed ABF/JV qualified welder Richard Garcia perform the Partial Joint Penetration (PJP) welding of the 8" C-channel to a 3" x 5" angle brace connection. The welder was observed using 1/8" diameter E7018H4R electrode. The Dehumidification Platform is being assembled and installed per the Request for Information (RFI) #001249R02 and ZPMC drawing OBG E3050. During welding, ABF QC Fred Michels was noted monitoring the welding parameters of the welder which measured 142 amperes. Prior to welding, the welder was noted beveling one side of the joint to 45 degree to a depth of preparation of 8mm deep by 10 inches long. After beveling all four (4) connections marked SA6028F, SA6028G, SA6028H and SA6028J using the disc grinder, the welder started the PJP welding. The welder was noted performing welding and at the same time with the help of other ABF personnel, they were assembling the platform. At the end of the shift, two of the PJP connections were completed.
