**DEPARTMENT OF TRANSPORTATION**

Contract #: 04-0120F4Cty: SF/ALA Rte: 80 PM: 13.2/13.9File #: 1.28**WELDING INSPECTION REPORT****Resident Engineer:** Casey, William**Address:** 333 Burma Road**City:** Oakland, CA 94607**Report No:** WIR-029200**Date Inspected:** 02-Mar-2013**Project Name:** SAS Superstructure**OSM Arrival Time:** 700**Prime Contractor:** American Bridge/Fluor Enterprises, a JV**OSM Departure Time:** 1530**Contractor:** American Bridge/Fluor Enterprises, a JV**Location:** Job Site

# WELDING INSPECTION REPORT

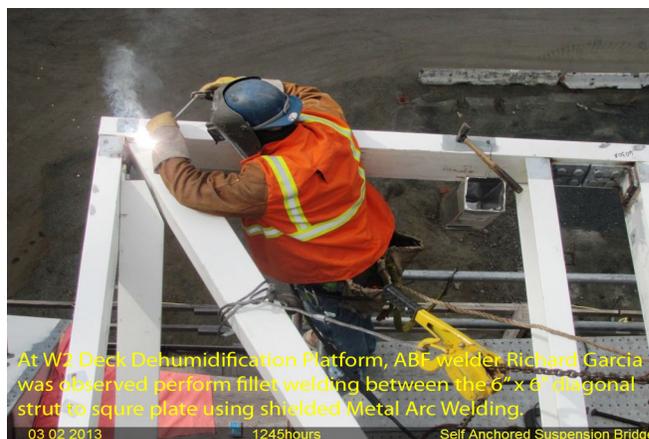
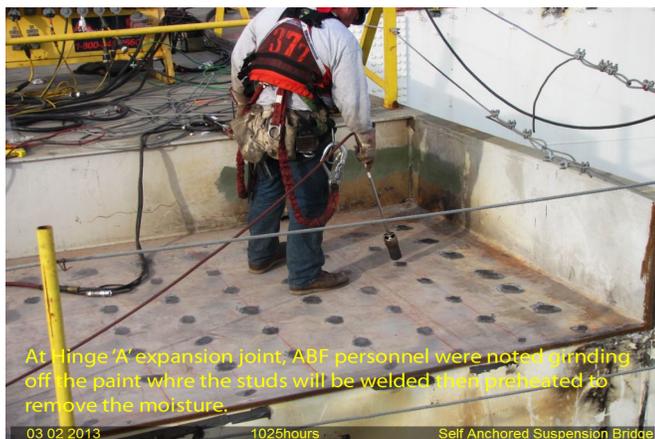
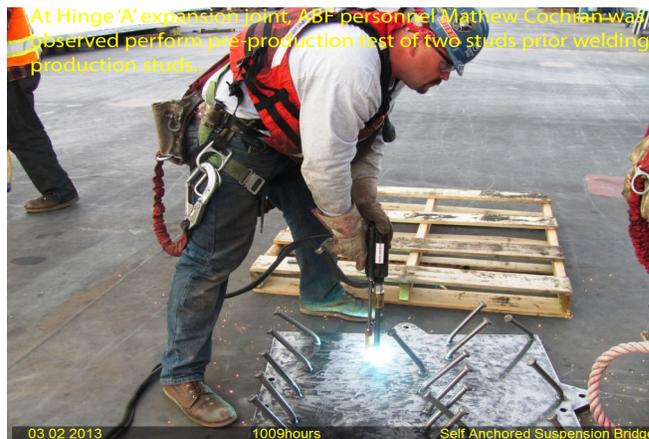
At Hinge 'A' expansion joint of OBG to skyway, QA randomly observed ABF welder Mathew Cochran perform flat stud welding on 3/4" diameter x 8 3/16" long stud to the top and side of the expansion joint deck implementing procedure ABF-WPS-D1.5-5063. Two studs (2) were welded and utilized to perform a pre-production test and bent to 30 degrees. After welding, ABF QC Bernie Docena inspected the diameter of the welds for 360 degree flash all around and noted the 360 degree flash. This QA also performed visual verification on the flash of the stud welds and noted same results. The welder then bent tested the test studs to 30 degree using a 10 pounds sledge hammer and noted acceptable results. The welder started the production stud welding at the conclusion of the test. During the shift, the same welder performed horizontal test stud welding two 3/4" diameter x 8 3/16" long stud and then performed the preproduction test. The test result was noted as acceptable. The same welder performed horizontal stud welding on the side of the expansion deck implementing procedure ABF-WPS-D1.5-5062. At the end of the shift, more than 90 studs were welded at flat position and more than 40 studs were welded at horizontal.

At 12E grid line E1 panel point PP112, PP114, this QA Inspector randomly observed ABF welding personnel Mike Jimenez perform 2F (horizontal) position fillet welding the cable suspender bracket bottom shim. The welder was noted using Shielded Metal Arc Welding (SMAW) with 1/8" diameter E7018H4R implementing procedure ABF-WPS-D1.5-F1200A. During welding, ABF QC Bonifacio Daquinag was on site to monitor the workmanship and welding parameters. Prior welding, the welder has preheated the suspender bracket to more than 150°F using

At Dehumidification Platform located at the W2 Bent Cap, between the east and west bound OBG, QA randomly observed ABF/JV qualified welder Richard Garcia perform fillet welding between the 6" x 6" diagonal angle strut to 125mm x 12.5mm square plate per detail 1 and 3 of drawing OBG E3050. The welder was observed using 1/8" diameter E7018H4R electrode. The Dehumidification Platform is being assembled and installed per the Request for Information (RFI) #001249R02 and the ZPMC drawing OBG E3050. During welding, ABF QC Fred Michels was noted monitoring the welding parameters of the welder with measured working current of 140 amperes on a 1/8" diameter E7018 electrode.

At the request of Quality Control Field Supervisor, Bonifacio Daquinag, QA has randomly verified the QC VT/MT on fillet weld of one 466mm x 466mm doubler plate marked X3878R to the bottom of the OBG at 13W-PP124-W3 and removal of temporary welded lifting lug attachments at tower cable shroud east and west. The QA verification was performed to verify that the welding and the VT/MT inspection performed by the QC inspector meet the requirements of the contract documents. At the conclusion of the QA verification it appeared that the welds and the QC inspection complied with the contract documents.
