Contract #: 04-0120F4Cty: SF/ALA Rte: 80 PM: 13.2/13.9File #: 1.28**WELDING INSPECTION REPORT****Resident Engineer:** Casey, William**Address:** 333 Burma Road**City:** Oakland, CA 94607**Report No:** WIR-029421**Date Inspected:** 16-Apr-2013**Project Name:** SAS Superstructure**OSM Arrival Time:** 700**Prime Contractor:** American Bridge/Fluor Enterprises, a JV**OSM Departure Time:** 1730**Contractor:** American Bridge/Fluor Enterprises, a JV**Location:** Job Site**CWI Name:** See below.**CWI Present:** Yes No**Inspected CWI report:** Yes No N/A**Rod Oven in Use:** Yes No N/A**Electrode to specification:** Yes No N/A**Weld Procedures Followed:** Yes No N/A**Qualified Welders:** Yes No N/A**Verified Joint Fit-up:** Yes No N/A**Approved Drawings:** Yes No N/A**Approved WPS:** Yes No N/A**Delayed / Cancelled:** Yes No N/A**Bridge No:** 34-0006**Component:** OBG**Summary of Items Observed:**

WELDING INSPECTION REPORT

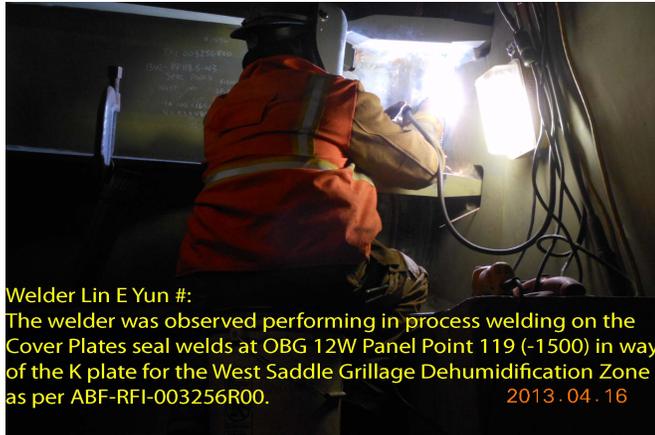
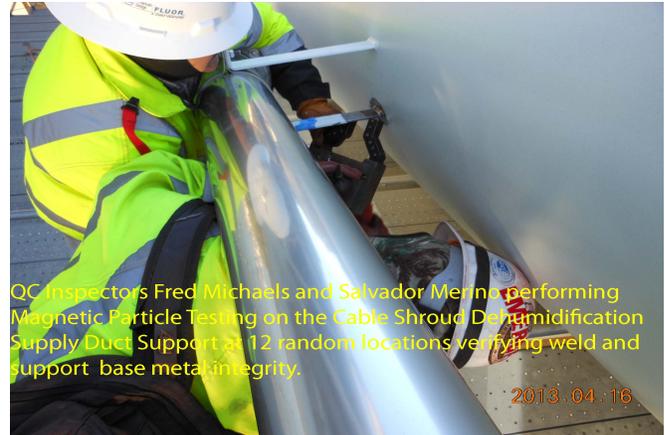
The welder was observed performing in process welding on the Cover Plates seal welds at OBG 12W Panel Point 119 (-1500) in way of the K plate for the West Saddle Grillage Dehumidification Zone as per ABF-RFI-003256R00. The welder was observed pre heating the "K" plates to 300 degrees Fahrenheit prior to welding. The welding was performed utilizing the Welding Procedure Specification (WPS) ABF-WPS-D15-F1200A Rev.2 for Shield Metal Arc Welding (SMAW). The welding parameters were verified by QC Inspector Salvador Merino throughout the day and appeared to be in compliance with the WPS noted above.

Cable Shroud Dehumidification Supply Duct Support.

- 12 Random Locations East to West OBG (MPT Accept).
