Contract #: 04-0120F4Cty: SF/ALA Rte: 80 PM: 13.2/13.9File #: 99.28**WELDING INSPECTION REPORT****Resident Engineer:** Casey, William**Address:** 333 Burma Road**City:** Oakland, CA 94607**Report No:** WIR-029682**Date Inspected:** 14-Jun-2013**Project Name:** SAS Superstructure**OSM Arrival Time:** 700**Prime Contractor:** American Bridge/Fluor Enterprises, a JV**OSM Departure Time:** 1530**Contractor:** USA Hoist**Location:** Crest Hill, IL

Bridge No: 34-0006**Component:** SAS Tower Elevator**Summary of Items Observed:**

WELDING INSPECTION REPORT

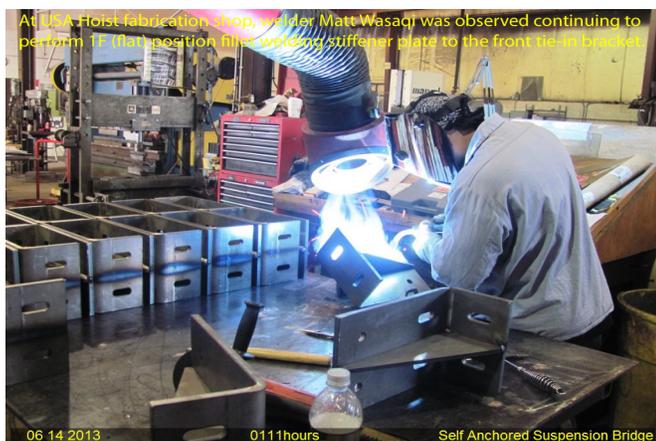
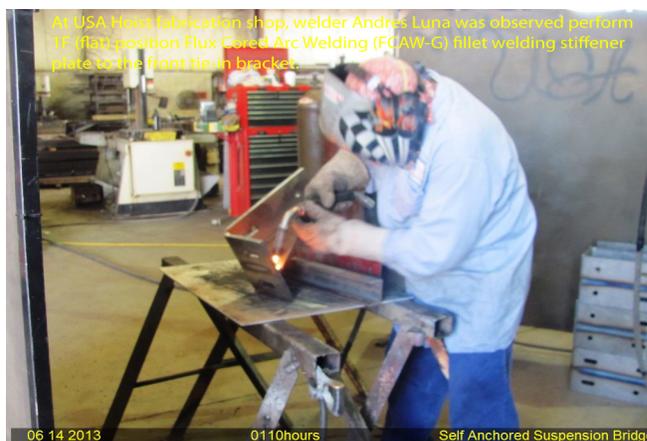
Today at USA Hoist assembly shop, this QA randomly observed USA Hoist qualified welder Jose Dominguez continuing to perform fit up and tack welding the 13 1/2" long x 5 1/2" wide x 3/8" thick triangular shape stiffener plate to 14" x 6" x 1/2" thick 90° bent plate front tie-in bracket per USA Hoist shop drawing #914204-14. The welder was noted tack welding the stiffener plate using gas shielded FCAW-G with 1.1mm E71T-1C Familiarc DW-50 wire electrode implementing USA Hoist Welding Procedure Specification FCAW 3210. The shielding gas being used was noted a combination of 75% Argon and 25% CO2 with flow rate of 35 CFH. During the shift, fit up/tack welding of the above mentioned bracket was still continuing and should remain tomorrow.

At the same assembly shop, another USA Hoist qualified welder Matt Wasiqi was observed continuing to perform fillet welding the same front tie-in brackets for the tower elevator as the other welder was performing fit up and tack welding. The welder was noted using the same process and implementing the same welding procedure specification. The welder was noted using gas shielded FCAW-G with 1.1mm E71T-1C Familiarc DW-50 wire electrode implementing USA Hoist Welding Procedure Specification FCAW 3210. The shielding gas being used was noted a combination of 75% Argon and 25% CO2 with flow rate of 38 CFH. During the shift, the working welding parameters were measured 29 volts and 230 amperes which deemed in compliance to the project requirements. This QA randomly checked the workmanship and measured the required 1/4" fillet on all sides of the stiffener which it was found in compliance to the requirement. With the number of brackets to be welded, fillet

Another USA Hoist qualified welder Andres Luna was observed perform fillet welding the same front tie-in brackets for the tower elevator as mentioned above. The welder was noted using the same process and implementing the same welding procedure specification. The welder was noted using gas shielded FCAW-G with 1.1mm E71T-1C Familiarc DW-50 wire electrode implementing USA Hoist Welding Procedure Specification FCAW 3210. The shielding gas being used was noted a combination of 75% Argon and 25% CO2 with flow rate of 40 CFH. During the shift, the working welding parameters were measured 26 volts and 200 amperes which deemed in compliance to the project requirements. This QA randomly checked the workmanship and measured the required ¼” fillet on all sides of the stiffener which it was found in compliance to the requirement. With the two welders welding side by side on the front tie-in brackets, approximately 40 pieces were completed as of to date.
