Contract #: 04-0120F4Cty: SF/ALA Rte: 80 PM: 13.2/13.9File #: 1.28**WELDING INSPECTION REPORT**

Report No: WIR-029776
Date Inspected: 11-Jun-2013

Project Name: SAS Superstructure
Prime Contractor: American Bridge/Fluor Enterprises, a JV
Contractor:

CWI Name:	Wayne Van Dewark	CWI Present:	Yes	No
Inspected CWI report:	Yes No N/A	Rod Oven in Use:	Yes	No N/A
Electrode to specification:	Yes No N/A	Weld Procedures Followed:	Yes	No N/A
Qualified Welders:	Yes No N/A	Verified Joint Fit-up:	Yes	No N/A
Approved Drawings:	Yes No N/A	Approved WPS:	Yes	No N/A
		Delayed / Cancelled:	Yes	No N/A
Bridge No:	34-0006	Component:	E2 Shear Key Anchorage

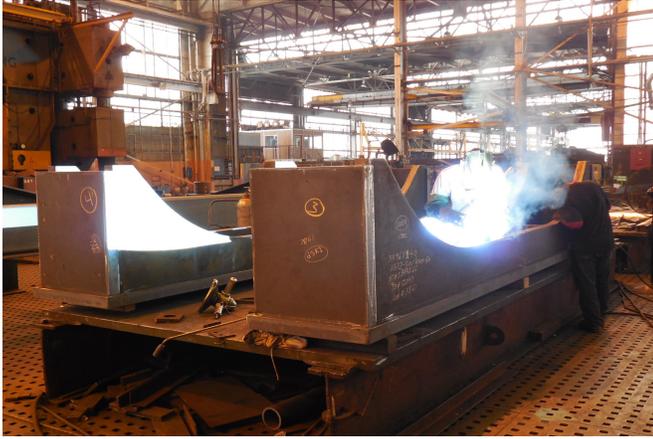
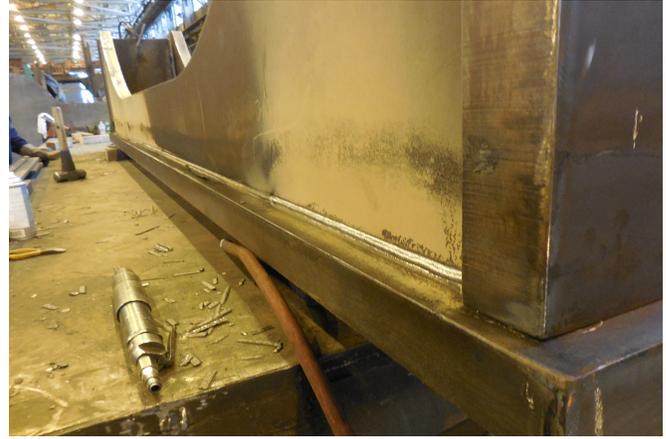
Pieces cut from 3" flat plate to fabricate fixtures that will hold the saddle pieces during fabrication. Cut pieces were fit-up and tack welded. Welding is in process per Drawing No. 7861-SK1. QA Inspector observed the following QC operations.

- QC performed fit-up and alignment verification of assembled components utilizing a square and straight edge.
- Preheat was performed by rosebud touch and verified with temperature stick.
- Welding was performed by approved welders. Fillet welds installed are 3/8" typical.

Fabrication and welding remains in progress.
