Contract #: 04-0120F4Cty: SF/ALA Rte: 80 PM: 13.2/13.9File #: 1.28**WELDING INSPECTION REPORT**

Report No: WIR-029849
Date Inspected: 23-Jul-2013

Project Name: SAS Superstructure
Prime Contractor: American Bridge/Fluor Enterprises, a JV
Contractor: American Bridge/Fluor Enterprises, a JV

CWI Name:	Jesus Cayabyab, Bernie Docena	CWI Present:	Yes	No
Inspected CWI report:	Yes No N/A	Rod Oven in Use:	Yes	No N/A
Electrode to specification:	Yes No N/A	Weld Procedures Followed:	Yes	No N/A
Qualified Welders:	Yes No N/A	Verified Joint Fit-up:	Yes	No N/A
Approved Drawings:	Yes No N/A	Approved WPS:	Yes	No N/A
		Delayed / Cancelled:	Yes	No N/A
Bridge No:	34-0006	Component:	SAS Tower

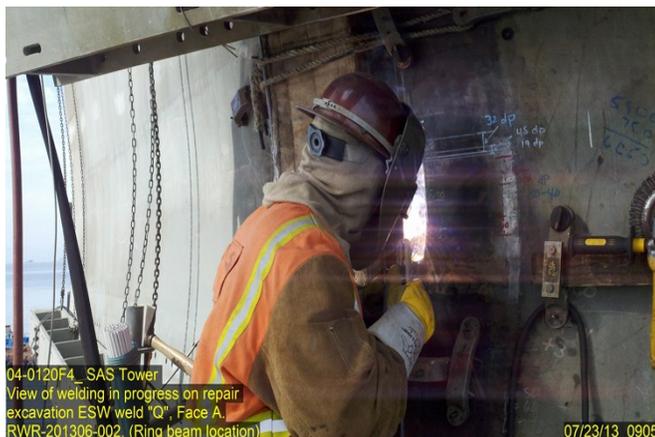
The QA Inspector observed, at random intervals, ABF/JV welder Kit Lai (WID-2953) performing weld repairs of the investigative repair excavation on Electroslag Weld (ESW) "F", at face B locations noted as:

The welder was observed preheating the weld to over 300° Fahrenheit prior to welding using the Miller ProHeat 35 with heat induction blankets. The welder was using 4.0mm diameter electrode (E7018-MH4-R) per ABF Welding Procedure Specification (WPS) ABF-WPS-D15-1000-Repair Rev.3 for Shield Metal Arc Welding (SMAW). The welding parameters were verified by QC Inspector Bernie Docena throughout the day and appeared to be in compliance with the WPS noted above. ABF Field Engineer Eric Blue and ABF QC Engineer Chris Chew stated that RWR# for the investigative excavations are pending and that CT METS are aware of the in process work.
