DEPARTMENT OF TRANSPORTATION

Quality Assurance and Source Inspection

Contract #: 04-0120F4Cty: SF/ALA Rte: 80 PM: 13.2/13.9File #: 99.28**WELDING INSPECTION REPORT****Resident Engineer:** Casey, William**Address:** 333 Burma Road**City:** Oakland, CA 94607**Report No:** WIR-029939**Date Inspected:** 22-Aug-2013**Project Name:** SAS Superstructure**OSM Arrival Time:** 600**Prime Contractor:** American Bridge/Fluor Enterprises, a JV**OSM Departure Time:** 1530**Contractor:** Steward Machine Co.**Location:** Birmingham AL**CWI Name:** Fred Hudson**CWI Present:** Yes No**Inspected CWI report:** Yes No N/A**Rod Oven in Use:** Yes No N/A**Electrode to specification:** Yes No N/A**Weld Procedures Followed:** Yes No N/A**Qualified Welders:** Yes No N/A**Verified Joint Fit-up:** Yes No N/A**Approved Drawings:** Yes No N/A**Approved WPS:** Yes No N/A**Delayed / Cancelled:** Yes No N/A**Bridge No:** 34-0006**Component:** E2 Shear Key Anchorages**Summary of Items Observed:**

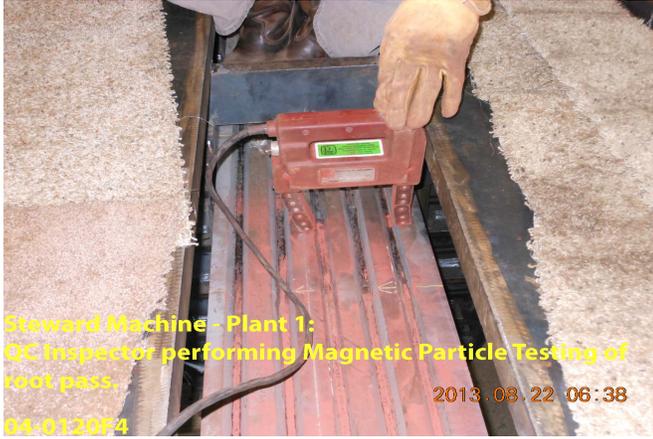
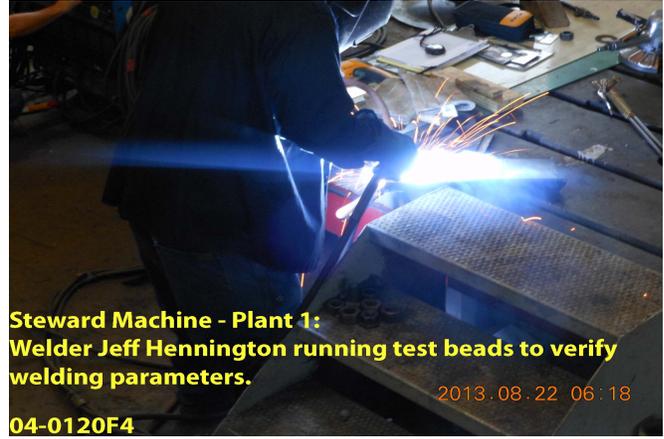
The welder was observed welding the S10B Upper Saddle Assembly (Plates a2 thru d1) utilizing Welding Procedure Specification (WPS) P2-W126-B Flux Core Arc Welding-Gas Shielded (FCAW-G) in the 1G position. Welding parameters were adjusted and monitored by Certified Welding Inspector (CWI) Fred Hudson who was onsite with the WPS as required by contract documents. The welding parameters were measured to be 278Amps, 29Volts with E70T-1 Class 1/16" diameter wire with a pre heat of over 70 degrees Fahrenheit. The welder was observed welding the assembly root pass as sequenced earlier by the shop supervisor.

Welding parameters were adjusted and monitored by Certified Welding Inspector (CWI) Fred Hudson who was onsite with the WPS as required by contract documents. The welding parameters were measured to be 280Amps, 28Volts with E70T-1 Class 1/16" diameter wire with a pre heat of over 70 degrees Fahrenheit. The welder was observed welding the assembly root pass as sequenced earlier by the shop supervisor.

Assembly S10B as welded by welders #73 and #476 above includes plates S10B-d1, S10B-c1, S10B-b1, S10B-a1, S10B-b2, S10B-a2.
