Quality Assurance and Source Inspection

Contract #: 04-0120F4Cty: SF/ALA Rte: 80 PM: 13.2/13.9File #: 99.28**WELDING INSPECTION REPORT****Resident Engineer:** Casey, William**Address:** 333 Burma Road**City:** Oakland, CA 94607**Report No:** WIR-029979**Date Inspected:** 06-Sep-2013**Project Name:** SAS Superstructure**OSM Arrival Time:** 830**Prime Contractor:** American Bridge/Fluor Enterprises, a JV**OSM Departure Time:** 1700**Contractor:** Steward Machine Co.**Location:** Birmingham, AL**CWI Name:** Fred Hudson**CWI Present:** Yes No**Inspected CWI report:** Yes No N/A**Rod Oven in Use:** Yes No N/A**Electrode to specification:** Yes No N/A**Weld Procedures Followed:** Yes No N/A**Qualified Welders:** Yes No N/A**Verified Joint Fit-up:** Yes No N/A**Approved Drawings:** Yes No N/A**Approved WPS:** Yes No N/A**Delayed / Cancelled:** Yes No N/A**Bridge No:** 34-0006**Component:** E2 Shear Key Anchorages**Summary of Items Observed:**

WELDING INSPECTION REPORT

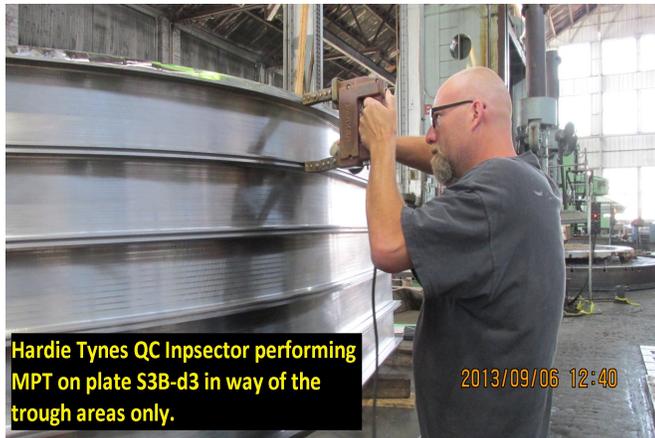
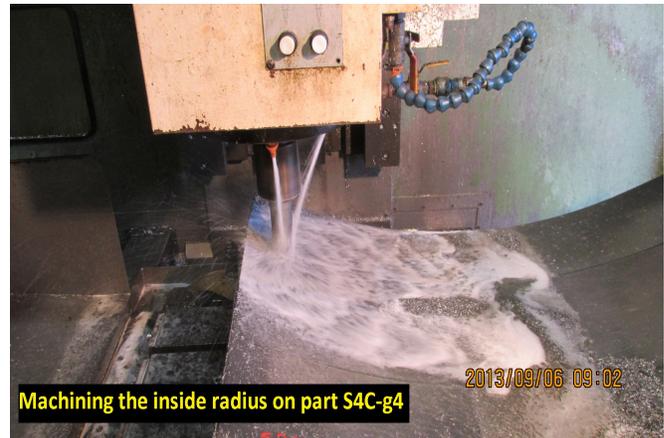
This QAI noted the welding of the above mentioned plates in the welding jig. The welding was done by qualified Jeffery Hennington (476) and Benjamin Rhodes (481). The welding was done to the approved welding procedure (WPS) P2-W126-B. All welding done at the time of this inspector's arrival was monitored by Certified Welding Inspector (CWI) Fred Hudson. The welders welded the root pass on the non-shear key side after which this QAI witnessed the QC Inspector Cory Cardwell perform 100% Magnetic Partical Testing (MPT) followed by this QAI's 10% verification on the root pass. The part was flipped and the root was welded on the shear key side after

which this QAI witnessed the QC Inspector perform 100% MPT followed by this QAI's 10% verification on the root pass. All MPT was found to be acceptable per the contract specifications at the time of inspection. Welding was completed at 1630.
