DEPARTMENT OF TRANSPORTATION

Contract #: 04-0120F4Cty: SF/ALA Rte: 80 PM: 13.2/13.9File #: 99.28**WELDING INSPECTION REPORT****Resident Engineer:** Casey, William**Address:** 333 Burma Road**City:** Oakland, CA 94607**Report No:** WIR-029988**Date Inspected:** 10-Sep-2013**Project Name:** SAS Superstructure**OSM Arrival Time:** 800**Prime Contractor:** American Bridge/Fluor Enterprises, a JV**OSM Departure Time:** 1830**Contractor:** Steward Machine Co.**Location:** Birmingham, AL

| Bridge No: | 34-0006 | | | Component: | E2 Shear Key Anchorages | | |

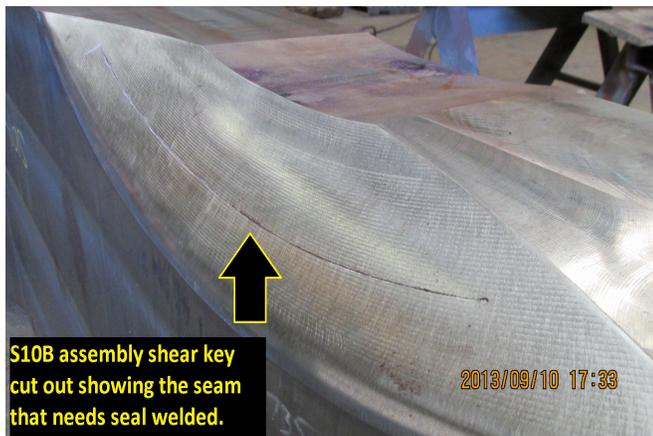
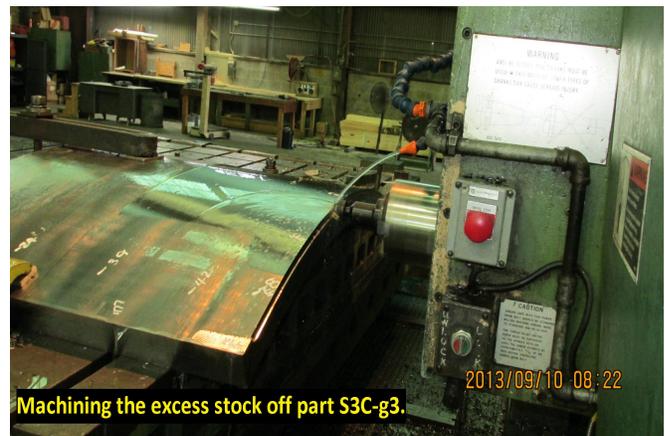
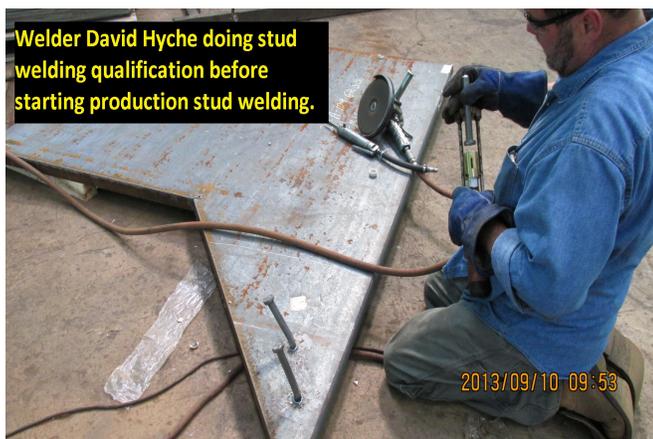
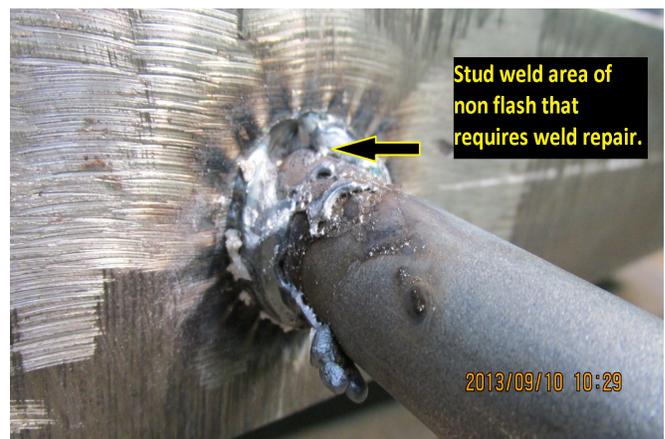
It was noted by this QAI that the shear key cut out for the S10B assembly was machined past the weld of the c1 plate to the d1 plate. This QAI and the onsite SMR were told that this would be seal welded in the morning. When this QAI asked Mr. Whitney Debardeleben if there was a WPS for this welding Mr. Whitney Debardeleben said yes. When this QAI asked QC Manager Prince Debardeleben III for a copy of the seal weld WPS. QC Manager Prince Debardeleben III informed this QAI that they didn't have one and that Zach with American Bridge said to just weld it. This information was relayed to the lead QAI Fritz Belford so he was aware of this possible issue during his shift in the morning.

This QAI noted the stud welding of the S3B-e3, S4B-e4, S3C-e3, S4C-e4 and p3 (x8) plates. The stud welding was done by welder David Hych (37). This QAI and QC Inspector CWI Darrell Nix witnessed welder (37) perform the qualification for welding the studs per section 7 in the AWS D1.5 2002 code. The stud welding was done with Steward Machine's approved stud welding WPS. During the visual inspection of the stud welds it was noted that three of the welds did not meet the codes 360 flash requirement. Onsite SMR Courtney Goldstein was informed of this issue. SMR Aaron Prchlik was consulted and it was relayed thru the onsite SMR to QC Inspector Darrell Nix that Steward Machine needed to bend the three studs to the required 15 and if they passed then Steward Machine needed to weld repair to achieve the 360 requirement. This QAI later learned thru the onsite SMR that Steward Machine was informed by Zach with American Bridge to cut the three studs off. The onsite SMR contacted SMR Aaron Prchlik again and was told that the studs where not to be cut off. This QAI contacted QC Inspector Darrell Nix to see if they had started and was informed that one had already been cut off. This QAI informed Mr Nix that he may want to hold off on the remaining two as he should be getting a call from his boss to not cut the studs off. All of this information was relayed to the lead QAI Fritz Belford so he was aware of this possible issue during his shift in the morning.
