Quality Assurance and Source Inspection

Contract #: 04-0120F4Cty: SF/ALA Rte: 80 PM: 13.2/13.9File #: 99.28**WELDING INSPECTION REPORT****Resident Engineer:** Casey, William**Address:** 333 Burma Road**City:** Oakland, CA 94607**Report No:** WIR-029997**Date Inspected:** 11-Sep-2013**Project Name:** SAS Superstructure**OSM Arrival Time:** 700**Prime Contractor:** American Bridge/Fluor Enterprises, a JV**OSM Departure Time:** 1530**Contractor:** Steward Machine Co.**Location:** Birmingham, AL**CWI Name:** Fred Hudson (#01061501)**CWI Present:** Yes No**Inspected CWI report:** Yes No N/A**Rod Oven in Use:** Yes No N/A**Electrode to specification:** Yes No N/A**Weld Procedures Followed:** Yes No N/A**Qualified Welders:** Yes No N/A**Verified Joint Fit-up:** Yes No N/A**Approved Drawings:** Yes No N/A**Approved WPS:** Yes No N/A**Delayed / Cancelled:** Yes No N/A**Bridge No:** 34-0006**Component:** E2 Shear Key Anchorages**Summary of Items Observed:**

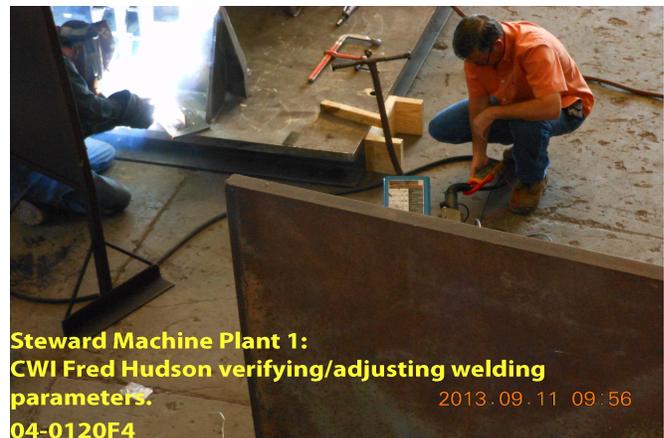
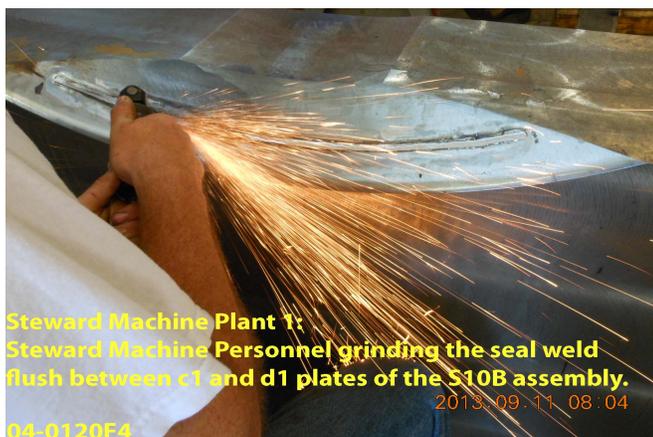
The welder was observed welding the S10C Upper Saddle Assembly East and West ends root pass for plates a2 and b1 utilizing Welding Procedure Specification (WPS) P2-W126-B for Flux Core Arc Welding-Gas Shielded (FCAW-G) in the 1G position. The welding parameters were observed adjusted and monitored by Certified Welding Inspector (CWI) Fred Hudson who was onsite with the WPS as required by contract documents. The welding parameters were measured to be 30volts/290amps using 1/16" Class E70T-1 filler and 100% CO2 at 40cfm. After welding each root pass the welder was then observed continue with welding to fill the weld groove as required. Assembly of the S10C as noted above includes plates S10C-d1, S10C-c1, S10C-b1, S10C-a1, S10C-b2 & S10C-a2.

The welder was observed welding the S4B Lower Saddle Assembly South and North side root pass utilizing Welding Procedure Specification (WPS) P2-W126-B for Flux Core Arc Welding-Gas Shielded (FCAW-G) in the 1G position. The welding parameters were observed adjusted and monitored by Certified Welding Inspector (CWI) Fred Hudson who was onsite with the WPS as required by contract documents. The welding parameters were measured to be 30volts/295amps using 1/16" Class E70T-1 filler and 100% CO2 at 40cfm. After welding both root passes the welder was then observed continue with welding to fill the weld groove as required. The welding of the root pass and cover were performed sequentially as plotted by the shop supervisor. Assembly of the S4B as noted above includes plates S4B-f4, S4B-g4, S4B-d4, S4B-c4, S4B-h4, S4B-b4, & S4B-a4.

East End Root Pass VT & MPT Acceptable. (See TL-6028 for detailed information).

West End Root Pass VT & MPT Acceptable. (See TL-6028 for detailed information).

South Side Root Pass VT & MPT Acceptable. (See TL-6028 for detailed information).
