**DEPARTMENT OF TRANSPORTATION**

Contract #: 04-0120F4Cty: SF/ALA Rte: 80 PM: 13.2/13.9File #: 78.28**WELDING INSPECTION REPORT****Resident Engineer:** Casey, William**Address:** 333 Burma Road**City:** Oakland, CA 94607**Report No:** WIR-030046**Date Inspected:** 20-Sep-2013**Project Name:** SAS Superstructure**OSM Arrival Time:** 1300**Prime Contractor:** American Bridge/Fluor Enterprises, a JV**OSM Departure Time:** 2130**Contractor:** Steward Machine Co.**Location:** Birmingham, AL**CWI Name:** Jimmy Brewer**CWI Present:** Yes No**Inspected CWI report:** Yes No N/A**Rod Oven in Use:** Yes No N/A**Electrode to specification:** Yes No N/A**Weld Procedures Followed:** Yes No N/A**Qualified Welders:** Yes No N/A**Verified Joint Fit-up:** Yes No N/A**Approved Drawings:** Yes No N/A**Approved WPS:** Yes No N/A**Delayed / Cancelled:** Yes No N/A**Bridge No:** 34-0006**Component:** E2 Shear Key Anchorages**Summary of Items Observed:**

# WELDING INSPECTION REPORT

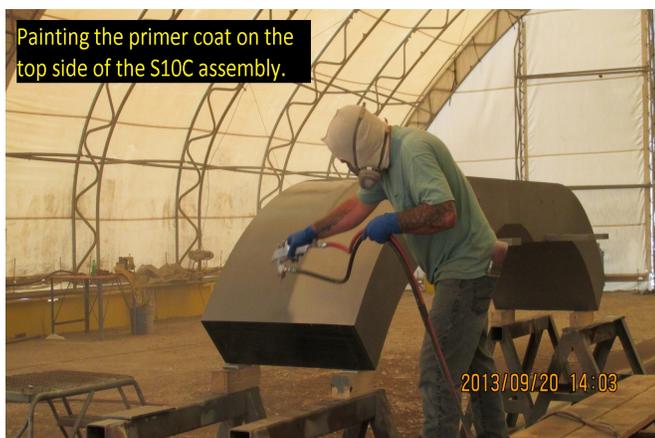
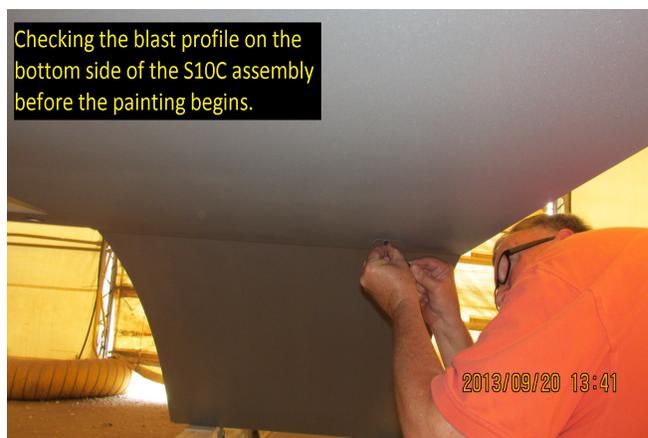
The above mentioned assembly was moved to the paint area where it was blasted to the required profile and then painted. The blast profile was checked using extra coarse profile tape and was found to be between the required 1.57 to 3.38 mills. After the blast profile was checked and found to be acceptable the S10C assembly was painted with the primer coat.
