DEPARTMENT OF TRANSPORTATION

Quality Assurance and Source Inspection

Contract #: 04-0120F4Cty: SF/ALA Rte: 80 PM: 13.2/13.9File #: 78.28**WELDING INSPECTION REPORT****Resident Engineer:** Casey, William**Address:** 333 Burma Road**City:** Oakland, CA 94607**Report No:** WIR-030047**Date Inspected:** 16-Sep-2013**Project Name:** SAS Superstructure**OSM Arrival Time:** 700**Prime Contractor:** American Bridge/Fluor Enterprises, a JV**OSM Departure Time:** 1530**Contractor:** Steward Machine Co.**Location:** Birmingham, AL

CWI Name:	Fred Hudson (Cert. #01061501)			CWI Present:	Yes	No	
Inspected CWI report:	Yes	No	N/A	Rod Oven in Use:	Yes	No	N/A
Electrode to specification:	Yes	No	N/A	Weld Procedures Followed:	Yes	No	N/A
Qualified Welders:	Yes	No	N/A	Verified Joint Fit-up:	Yes	No	N/A
Approved Drawings:	Yes	No	N/A	Approved WPS:	Yes	No	N/A
				Delayed / Cancelled:	Yes	No	N/A
Bridge No:	34-0006			Component:	E2 Shear Key Anchorages

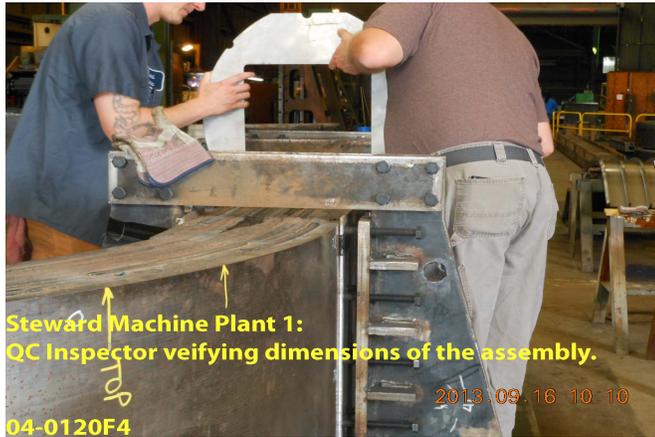
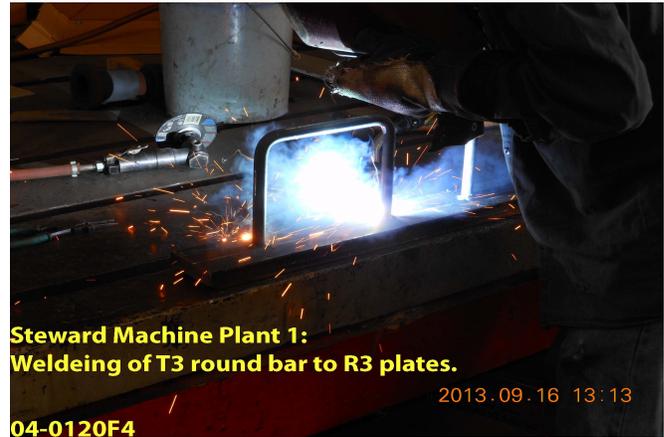
The welder was observed tack welding and fillet welding the T3 round bars to the R3 plates utilizing Welding Procedure Specification (WPS) P2-W101-B for Flux Core Arc Welding-Gas Shielded (FCAW-G) in the 1G position. The welding parameters were observed adjusted and monitored by Certified Welding Inspector (CWI) Fred Hudson (Cert. #01061501) who was onsite with the WPS as required by contract documents. The welding parameters were measured to be 28volts/260amps using 1/16" Class E70T-1 filler and 100% CO2 at 40cfm.
