**DEPARTMENT OF TRANSPORTATION**

Contract #: 04-0120F4Cty: SF/ALA Rte: 80 PM: 13.2/13.9File #: 78.28**WELDING INSPECTION REPORT****Resident Engineer:** Casey, William**Address:** 333 Burma Road**City:** Oakland, CA 94607**Report No:** WIR-030048**Date Inspected:** 17-Sep-2013**Project Name:** SAS Superstructure**OSM Arrival Time:** 600**Prime Contractor:** American Bridge/Fluor Enterprises, a JV**OSM Departure Time:** 1430**Contractor:** Steward Machine Co.**Location:** Birmingham, AL**CWI Name:** Fred Hudson & Darrell Nix**CWI Present:** Yes No**Inspected CWI report:** Yes No N/A**Rod Oven in Use:** Yes No N/A**Electrode to specification:** Yes No N/A**Weld Procedures Followed:** Yes No N/A**Qualified Welders:** Yes No N/A**Verified Joint Fit-up:** Yes No N/A**Approved Drawings:** Yes No N/A**Approved WPS:** Yes No N/A**Delayed / Cancelled:** Yes No N/A**Bridge No:** 34-0006**Component:** E2 Shear Key Anchorages**Summary of Items Observed:**

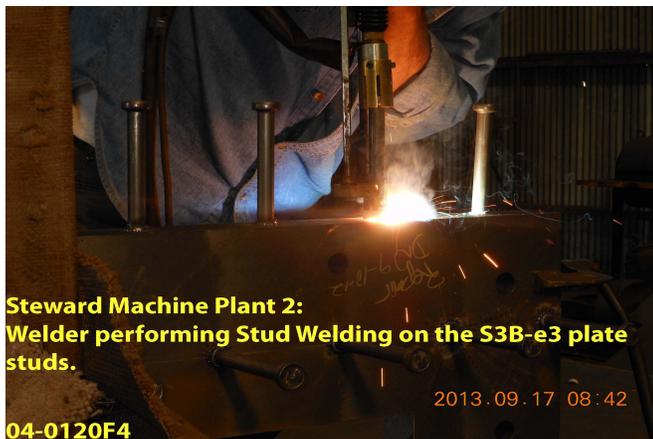
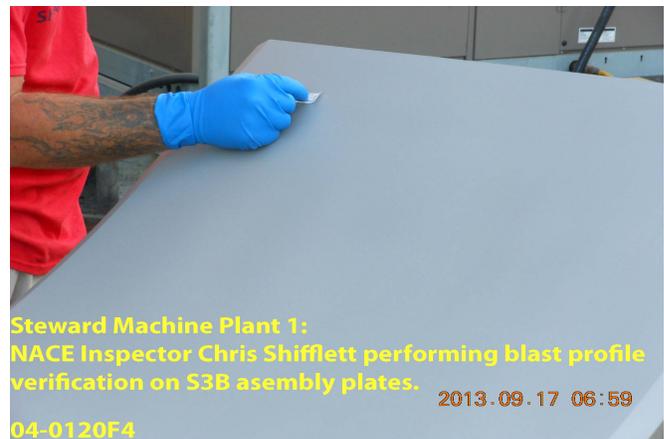
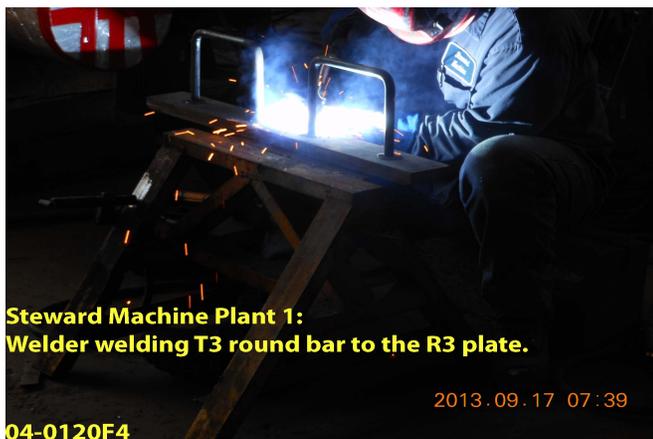
The completed and accepted work observed at this location appeared to be in compliance with the contract specifications.
