Contract #: 04-0120F4Cty: SF/ALA Rte: 80 PM: 13.2/13.9File #: 78.28**WELDING INSPECTION REPORT****Resident Engineer:** Casey, William**Address:** 333 Burma Road**City:** Oakland, CA 94607**Report No:** WIR-030049**Date Inspected:** 18-Sep-2013**Project Name:** SAS Superstructure**OSM Arrival Time:** 700**Prime Contractor:** American Bridge/Fluor Enterprises, a JV**OSM Departure Time:** 1530**Contractor:** Steward Machine Co.**Location:** Birmingham, AL**CWI Name:** Fred Hudson (Cert. #01061501)**CWI Present:** Yes No**Inspected CWI report:** Yes No N/A**Rod Oven in Use:** Yes No N/A**Electrode to specification:** Yes No N/A**Weld Procedures Followed:** Yes No N/A**Qualified Welders:** Yes No N/A**Verified Joint Fit-up:** Yes No N/A**Approved Drawings:** Yes No N/A**Approved WPS:** Yes No N/A**Delayed / Cancelled:** Yes No N/A**Bridge No:** 34-0006**Component:** E2 Shear Key Anchorages**Summary of Items Observed:**

## WELDING INSPECTION REPORT

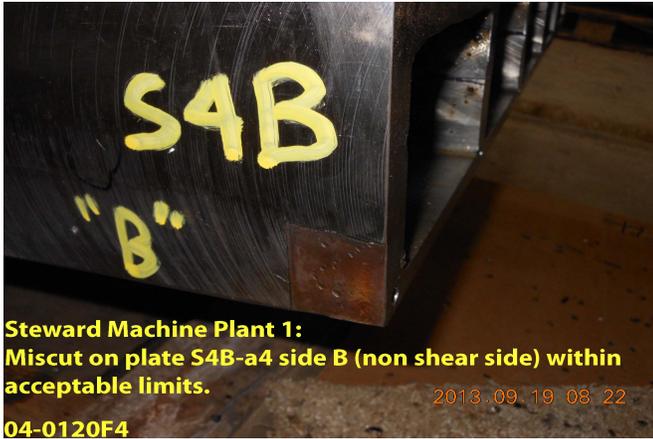
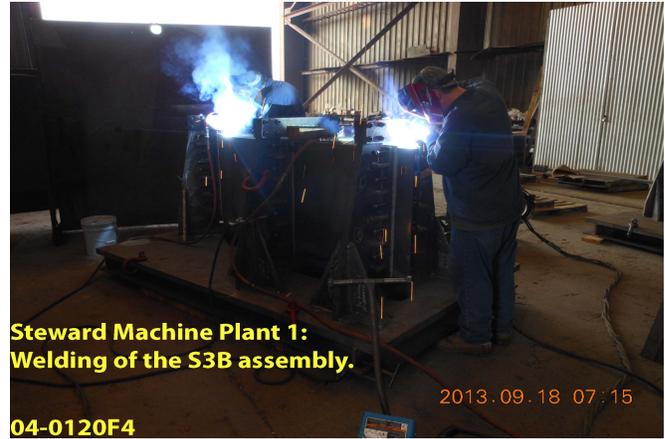
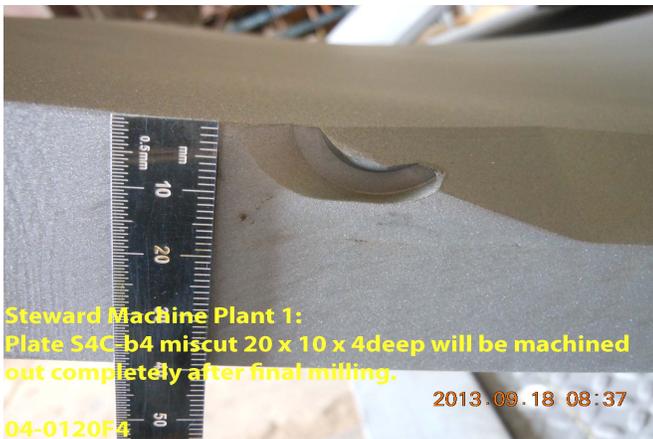
The QC Inspector relayed to the QA Inspector that the S4B Assembly had an area where the machining had milled too deep into the parent material of plate S4B-a4. After careful measurements were taken the QA concurs with the QC findings that the milled area is within acceptable limits of the plate dimensions. The area is in way of the S4B-a4 plate and measure 30 x 30 x 0.8mm deep on the non shear side at the East End upper corner . The overall width of the assembly when measured from the depth of the miscut area was 811.5 mm out of a required 812mm and is within acceptable limits. Assembly width overall is 812.5mm. Hardie Tynes will be filing a non conformance material report (NCRM) for the milling performed on the S3C-h3 plate. See attached for photo for detailed information
