DEPARTMENT OF TRANSPORTATION

Quality Assurance and Source Inspection

Contract #: 04-0120F4Cty: SF/ALA Rte: 80 PM: 13.2/13.9File #: 78.28**WELDING INSPECTION REPORT****Resident Engineer:** Casey, William**Address:** 333 Burma Road**City:** Oakland, CA 94607**Report No:** WIR-030051**Date Inspected:** 20-Sep-2013**Project Name:** SAS Superstructure**OSM Arrival Time:** 700**Prime Contractor:** American Bridge/Fluor Enterprises, a JV**OSM Departure Time:** 1430**Contractor:** Steward Machine Co.**Location:** Birmingham, AL**CWI Name:** Fred Hudson**CWI Present:** Yes No**Inspected CWI report:** Yes No N/A**Rod Oven in Use:** Yes No N/A**Electrode to specification:** Yes No N/A**Weld Procedures Followed:** Yes No N/A**Qualified Welders:** Yes No N/A**Verified Joint Fit-up:** Yes No N/A**Approved Drawings:** Yes No N/A**Approved WPS:** Yes No N/A**Delayed / Cancelled:** Yes No N/A**Bridge No:** 34-0006**Component:** E2 Shear Key Anchorages**Summary of Items Observed:**

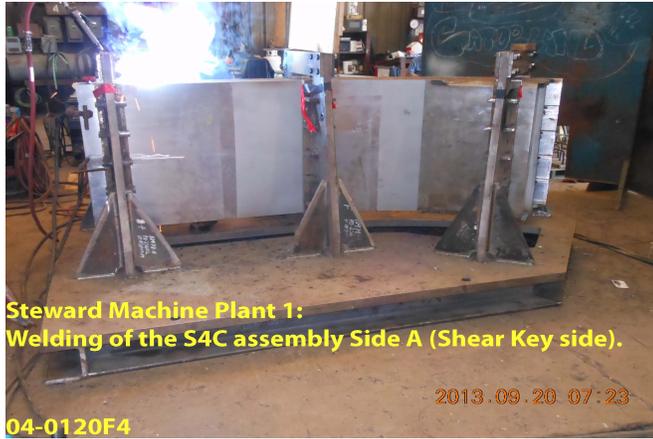
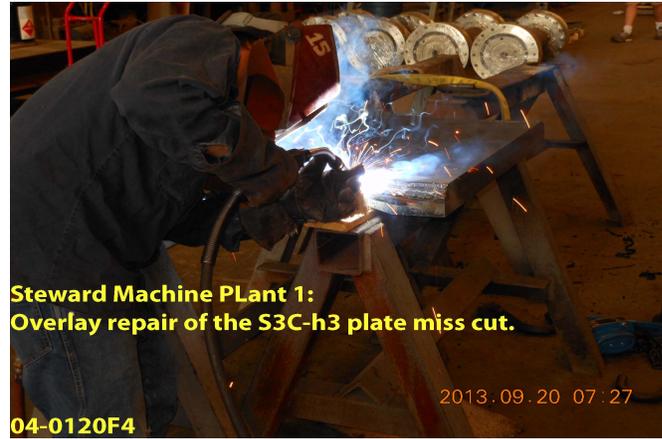
The welders were observed welding the S4C assembly utilizing Welding Procedure Specification (WPS) P2-W126-B for Flux Core Arc Welding-Gas Shielded (FCAW-G) in the 1G position. The welding parameters were observed adjusted and monitored by Certified Welding Inspector (CWI) Fred Hudson (Cert. #01061501) who was onsite with the WPS as required by contract documents. The welding parameters were measured to be 30volts/300amps using 1/16" Class E70T-1 filler and 100% CO2 at 40cfm. Assembly S4C as noted above includes plates S4C-f4, S4C -g4, S4C -d4, S4C -c4, S4C -h4, S4C -b4 & S4C -a4.

Welder Ben Rhodes (#481) was also observed welding the S3C-h3 plate "buttering" or overlaying the miss cut in way of the plate's inside curve weld bevel. The welder utilized unapproved Welding Procedure Specification (WPS) P2-OVERLAY-R2 for Flux Core Arc Welding-Gas Shielded (FCAW-G) in the flat position. The welding

Shop personnel were observed attempting to fit the S4B-e4 plate in place for welding. Multiple attempts were made at grinding the plate to fit but with no success.
