**DEPARTMENT OF TRANSPORTATION**

Contract #: 04-0120F4Cty: SF/ALA Rte: 80 PM: 13.2/13.9File #: 78.28**WELDING INSPECTION REPORT****Resident Engineer:** Casey, William**Address:** 333 Burma Road**City:** Oakland, CA 94607**Report No:** WIR-030053**Date Inspected:** 21-Sep-2013**Project Name:** SAS Superstructure**OSM Arrival Time:** 1400**Prime Contractor:** American Bridge/Fluor Enterprises, a JV**OSM Departure Time:** 2230**Contractor:** Steward Machine Co.**Location:** Birmingham, AL**CWI Name:** Jimmy Brewer**CWI Present:** Yes No**Inspected CWI report:** Yes No N/A**Rod Oven in Use:** Yes No N/A**Electrode to specification:** Yes No N/A**Weld Procedures Followed:** Yes No N/A**Qualified Welders:** Yes No N/A**Verified Joint Fit-up:** Yes No N/A**Approved Drawings:** Yes No N/A**Approved WPS:** Yes No N/A**Delayed / Cancelled:** Yes No N/A**Bridge No:** 34-0006**Component:** E2 Shear Key Anchorages**Summary of Items Observed:**

## WELDING INSPECTION REPORT

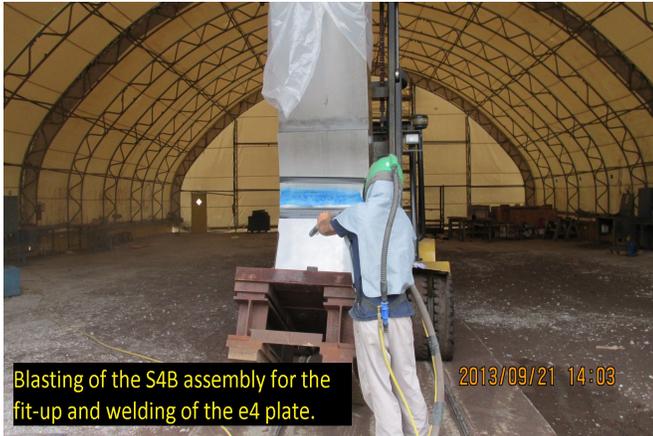
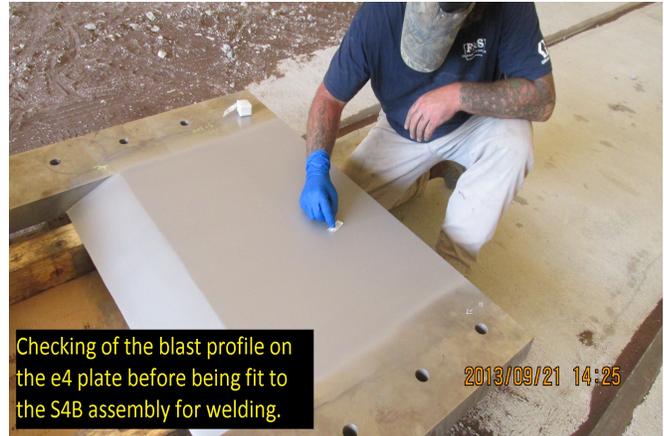
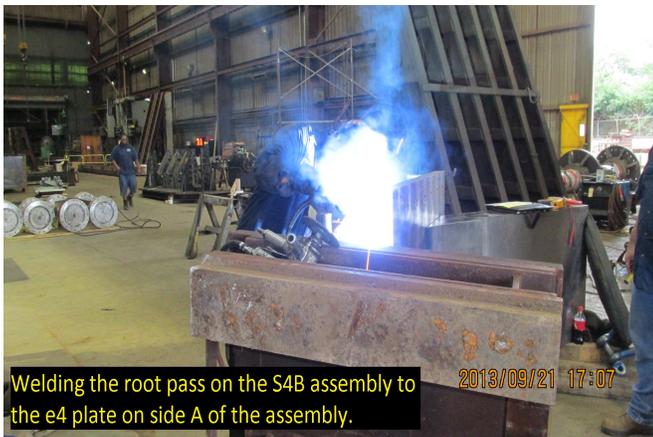
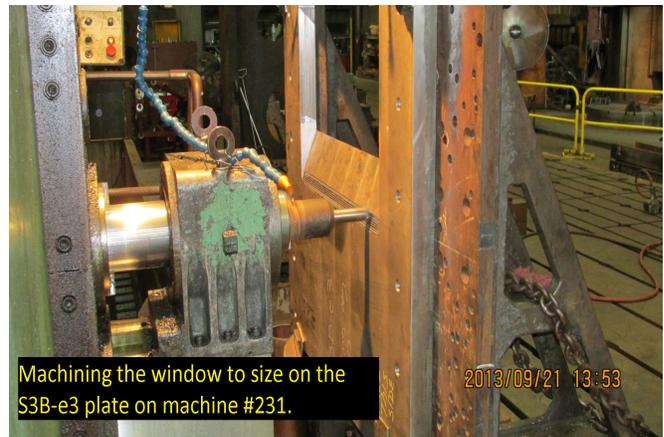
This QAI noted the above mentioned assembly in the welding jig ready for machining.

This QAI noted the above mentioned assembly being blasted along with the S4B-e4 plate. After the blast profile was checked and found to be acceptable the parts were fit together and the root pass for the S4B assembly side B to the e4 plate was welded. The welding was done by qualified welder Jeffery Hennington (476). The welding was done to the approved welding procedure (WPS) P2-W128-B. All welding done was monitored by Certified Welding Inspector (CWI) Jimmy Brewer. After the welder completed the root pass this QAI witnessed the QC Inspector MPT the root pass on side B. After the QC Inspector was done with his MPT inspection this QAI performed the required MPT verification on the root pass. After the MPT was found to be acceptable the S4B assembly was flipped to side A and the root pass welded on that side. After the welder completed the root pass this QAI witnessed the QC Inspector MPT the root pass on side A. After the QC Inspector was done with his MPT inspection this QAI performed the required MPT verification on the root pass.

- Visual Testing (VT) & Magnetic Particle Testing (MPT) Accept. (See TL-6028 for detailed information.)
