Contract #: 04-0120F4Cty: SF/ALA Rte: 80 PM: 13.2/13.9File #: 78.28**WELDING INSPECTION REPORT**

Report No: WIR-030055
Date Inspected: 23-Sep-2013

Project Name: SAS Superstructure **OSM Arrival Time:** 700
Prime Contractor: American Bridge/Fluor Enterprises, a JV **OSM Departure Time:** 1530
Contractor: Steward Machine Co. **Location:** Birmingham, AL

CWI Name:	Fred Hudson (Cert. #01061501)	CWI Present:	Yes	No
Inspected CWI report:	Yes No N/A	Rod Oven in Use:	Yes	No N/A
Electrode to specification:	Yes No N/A	Weld Procedures Followed:	Yes	No N/A
Qualified Welders:	Yes No N/A	Verified Joint Fit-up:	Yes	No N/A
Approved Drawings:	Yes No N/A	Approved WPS:	Yes	No N/A
		Delayed / Cancelled:	Yes	No N/A
Bridge No:	34-0006	Component:	E2 Shear Key Anchorages

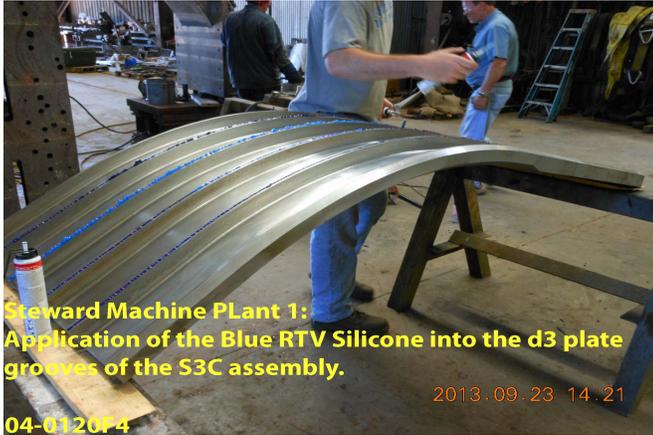
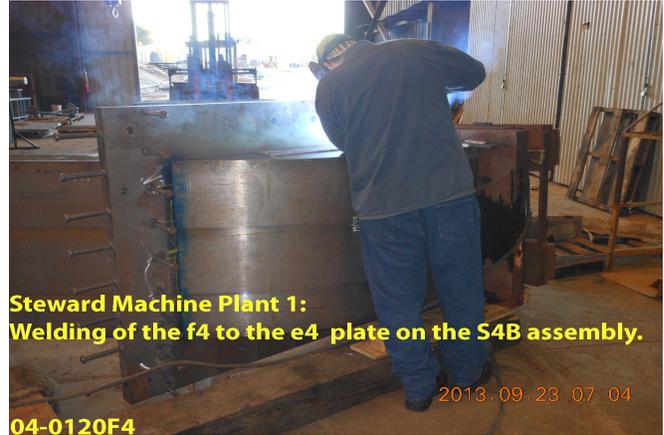
- VT/MPT Cover pass of e4 plate to f4 acceptable. (See TL-6028 for more information.)

- T3 round bar to R3 plate fillet welds VT/MT acceptable. (See TL-6028 for more information.)

The QC Inspector was observed performing 100% Magnetic Particle Testing (MPT) and accepting of items noted above prior to QA Inspector's verification MPT.
