**DEPARTMENT OF TRANSPORTATION**

Contract #: 04-0120F4Cty: SF/ALA Rte: 80 PM: 13.2/13.9File #: 99.28**WELDING INSPECTION REPORT****Resident Engineer:** Casey, William**Address:** 333 Burma Road**City:** Oakland, CA 94607**Report No:** WIR-030058**Date Inspected:** 19-Sep-2013**Project Name:** SAS Superstructure**OSM Arrival Time:** 700**Prime Contractor:** American Bridge/Fluor Enterprises, a JV**OSM Departure Time:** 1730**Contractor:** American Bridge/Fluor Enterprises, a JV**Location:** Job Site**CWI Name:** Scott Kortum, Tony Sherwood**CWI Present:** Yes No**Inspected CWI report:** Yes No N/A**Rod Oven in Use:** Yes No N/A**Electrode to specification:** Yes No N/A**Weld Procedures Followed:** Yes No N/A**Qualified Welders:** Yes No N/A**Verified Joint Fit-up:** Yes No N/A**Approved Drawings:** Yes No N/A**Approved WPS:** Yes No N/A**Delayed / Cancelled:** Yes No N/A**Bridge No:** 34-0006**Component:** SAS Tower**Summary of Items Observed:**

# WELDING INSPECTION REPORT

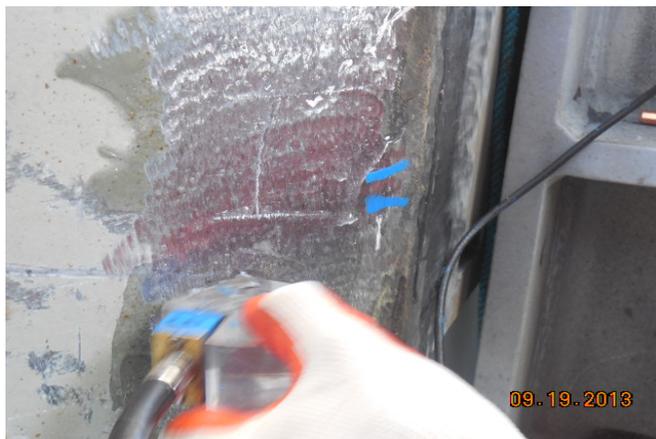
Weld crowns were ground to a smooth contour. Upon cooling to ambient temperature QC Inspector performed VT, MT and UT on web and flange, all test results are in general compliance.

QC UT of ring beam flange and web welds.

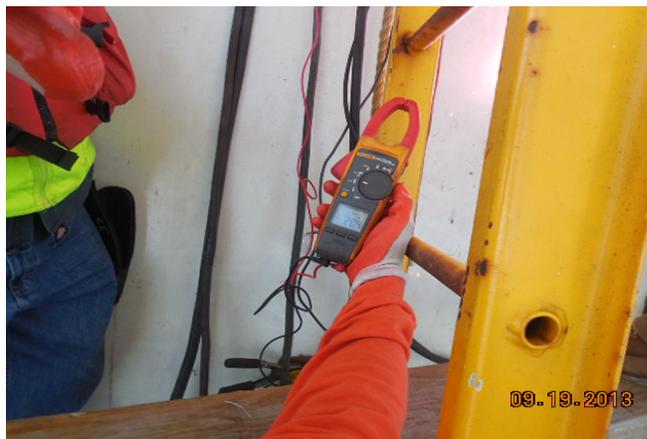
- The weld joint fit-up and alignment was checked with a straight edge and bridge cam gauge.
- Preheat was performed by rosebud torch and verified with temperature stick (200°F).
- Welding was performed by approved welder (Rick Clayborn)
- QC check results for Rick Clayborn (20 volts / 260 amps).
- The weld procedure and joint details referenced (FWT23 & FWT24) are for a CJP weld.
- Electrodes utilized are FCAW NR-232, .072", except at the web back gouge SMAW E7018 MR 1/8" was used.
- Weld passes were de-slugged by grinder and wire wheel.

QC electrical parameter check at ring beam welds.
