Contract #: 04-0120F4Cty: SF/ALA Rte: 80 PM: 13.2/13.9File #: 78.28**WELDING INSPECTION REPORT****Resident Engineer:** Casey, William**Address:** 333 Burma Road**City:** Oakland, CA 94607**Report No:** WIR-030074**Date Inspected:** 24-Sep-2013**Project Name:** SAS Superstructure**OSM Arrival Time:** 700**Prime Contractor:** American Bridge/Fluor Enterprises, a JV**OSM Departure Time:** 1530**Contractor:** Steward Machine Co.**Location:** Birmingham, AL

Bridge No: 34-0006**Component:** E2 Shear Key Anchorages**Summary of Items Observed:**

WELDING INSPECTION REPORT

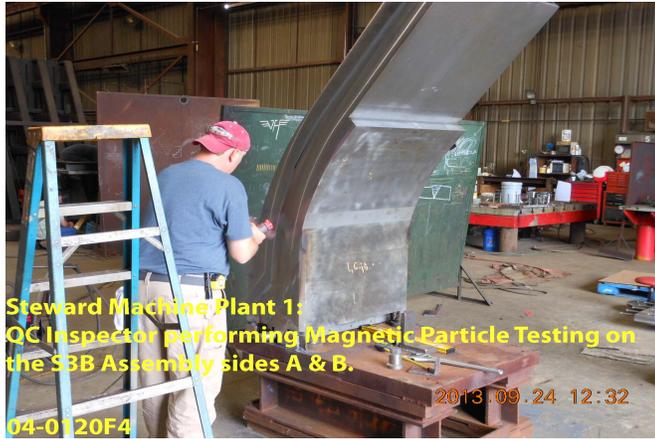
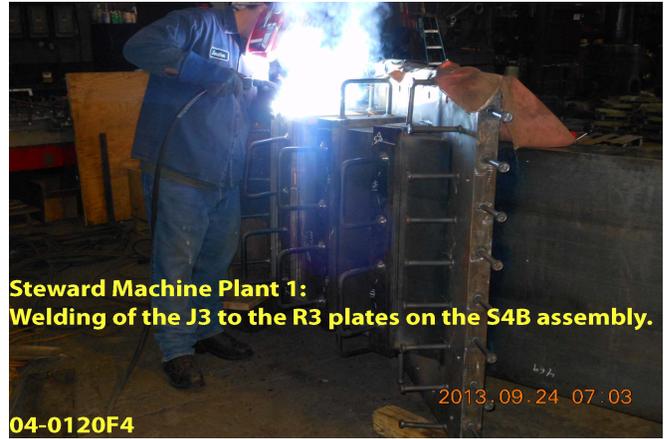
The welder was also observed removing and rewelding the S3 round bars to the correct location on strap plates J3 after a closer examination revealed the rounds bars were out of position. The welder utilized Welding Procedure Specification (WPS) P2-W101-B for Flux Core Arc Welding-Gas Shielded (FCAW-G) in the 2F.

The QA Inspector inquired of the QC Inspector what corrective actions they were contemplating for the out of position welding of the S3 round bars to the J3 plates. The QC Inspector relayed to the QA Inspector that an NCMR will be submitted and that a RFI to remove and reweld all the S3 round bars to the J3 in the correct position will be submitted.
